**Presentation to ANSAC**

Bob Mussetter, Ph.D., P.E.

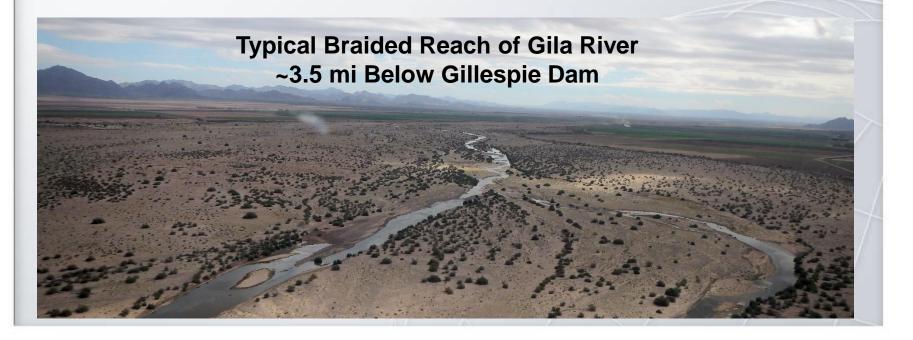
## **Channel Pattern IS Relevant to Navigability**

#### Braided channels:

- Wide, shallow cross section
- Multiple, unstable (i.e., shifting) channels
- NOT conducive to boating

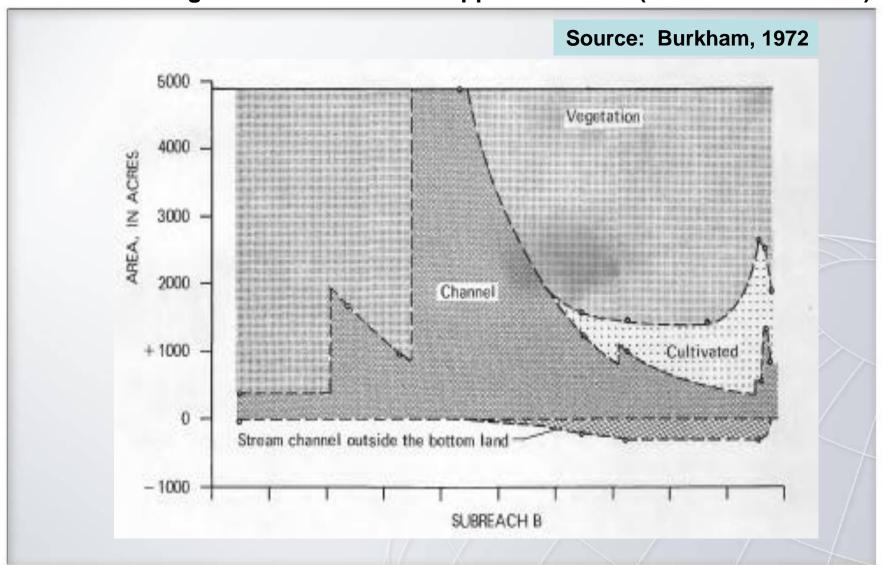
#### Historical changes in channel area of upper Gila River (San Simon to Pima)

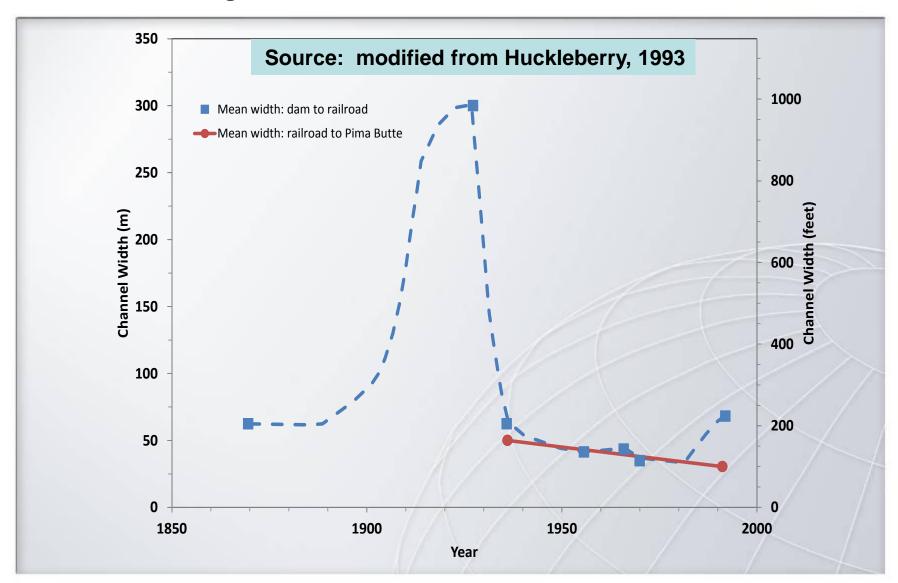
#### Changes in channel width for the Middle Gila River

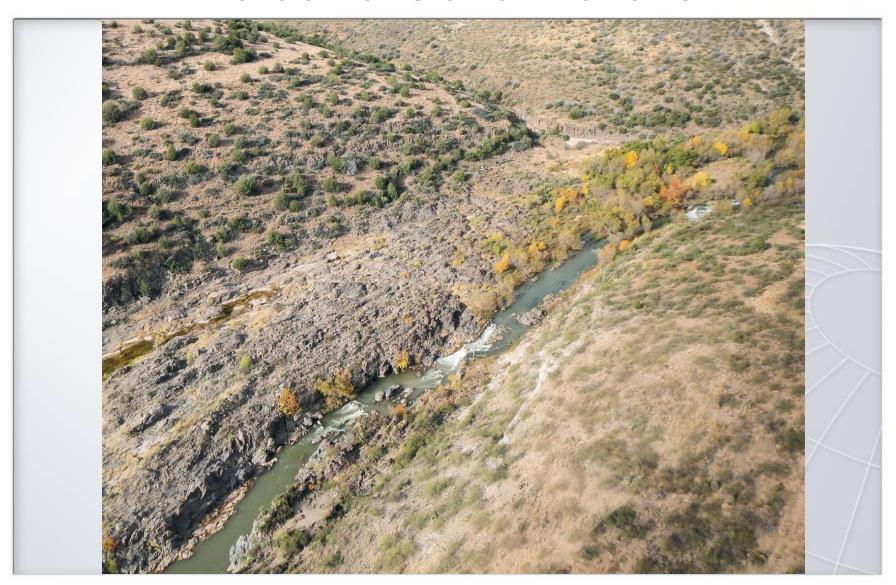
## **Verde Falls and Pre-falls**

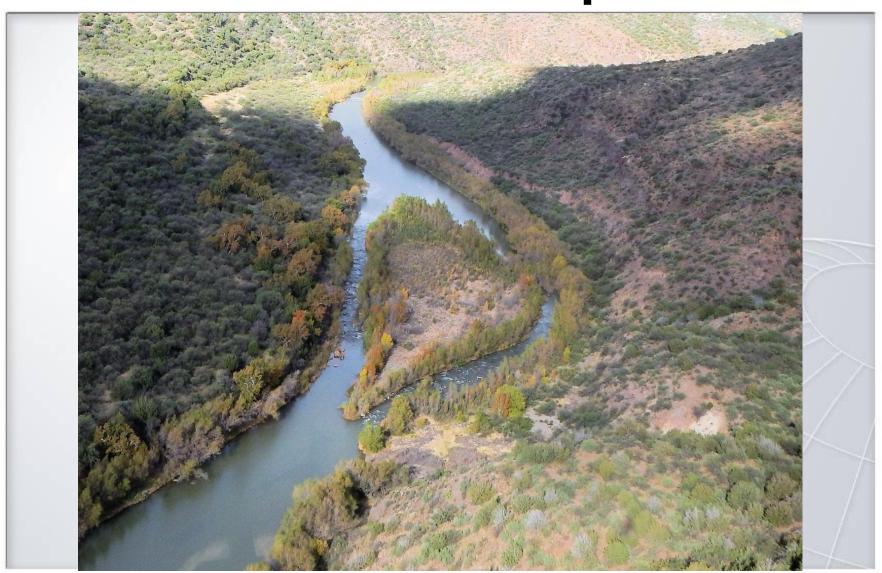
# **Black Hole Rapid**

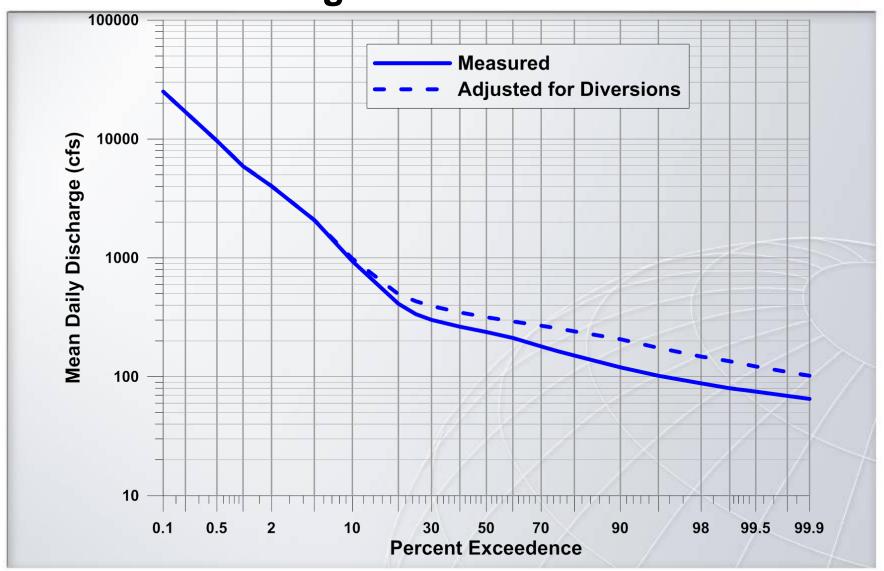
## **Verde Below Tangle Creek Flow Duration Curve**

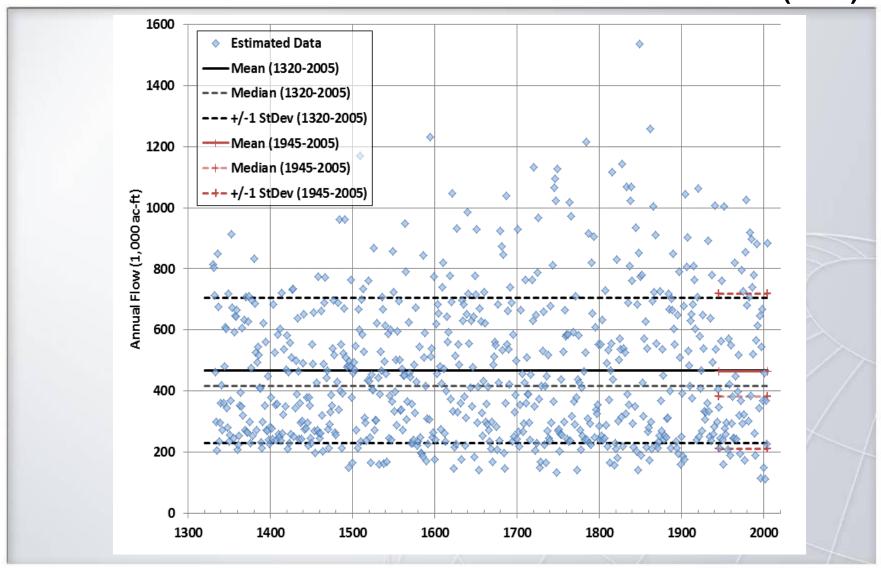
#### Estimated annual flow volumes from Meko and Hirschboeck (2008).

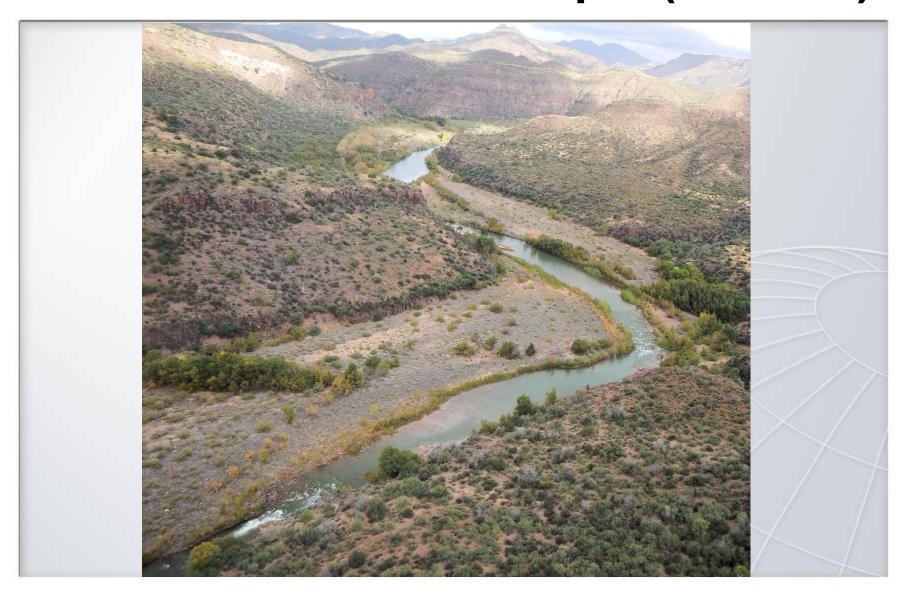
## **Shoots and Ladders Rapid (Class III)**

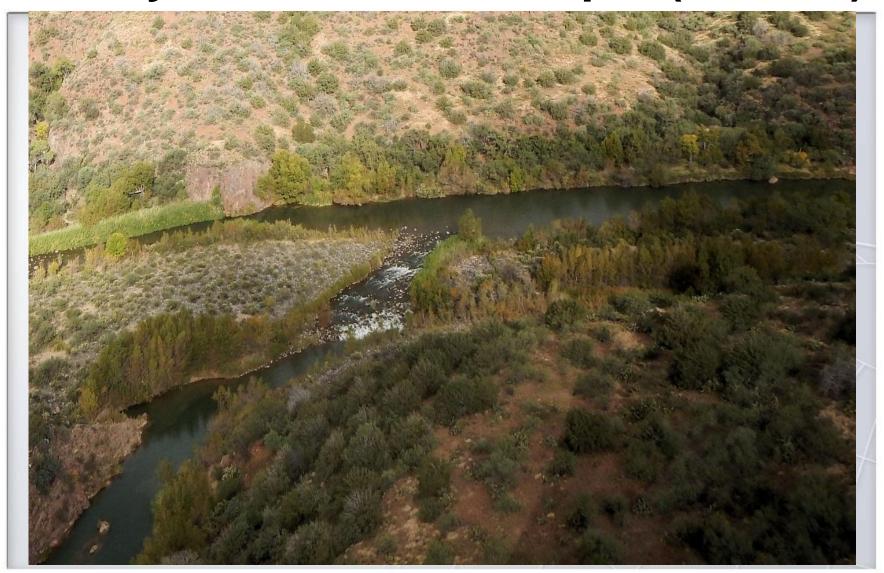
## **Gnarly Little Rockbar Rapid (Class II)**

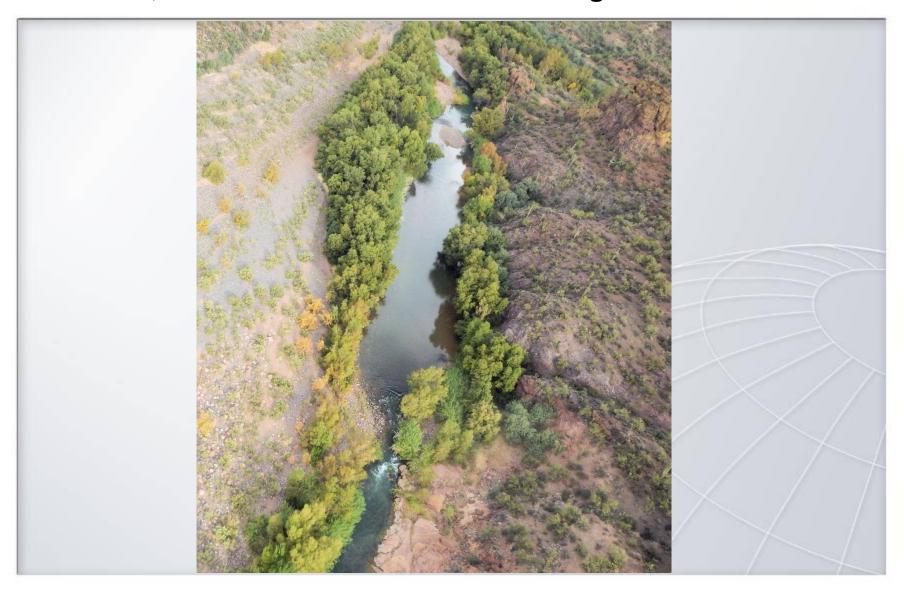
## Shallow, boulder-strewn riffle near the Tangle Creek confluence

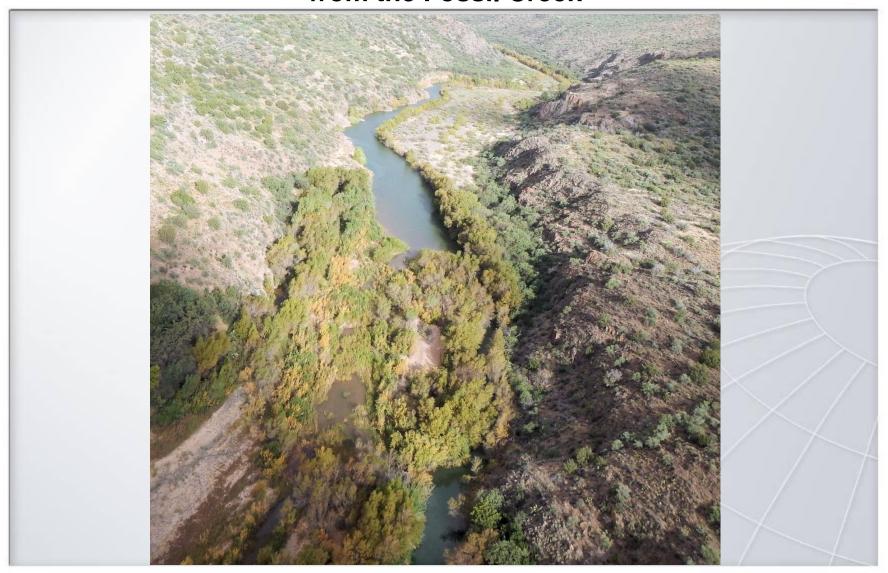
# Tree-choked cobble/boulder bar just upstream from the Fossil Creek

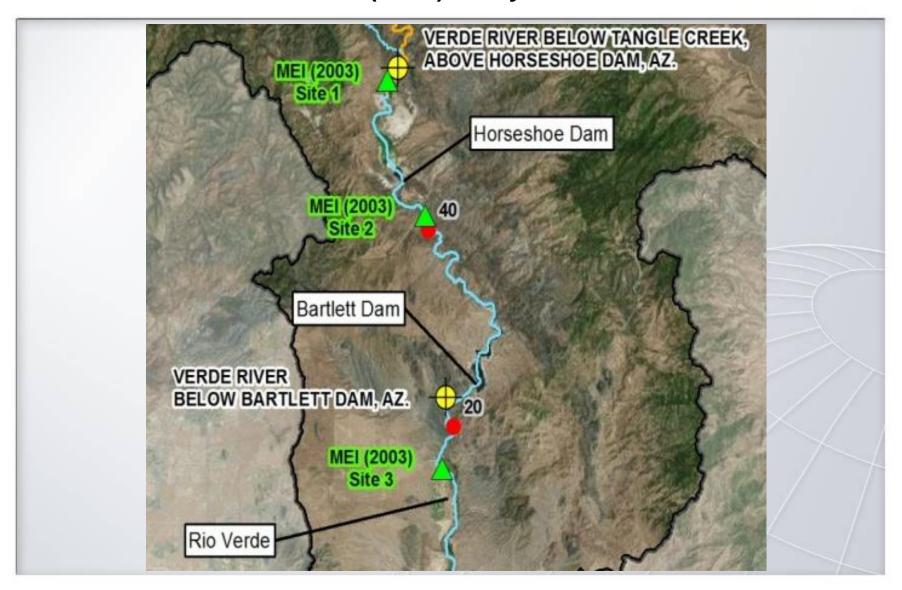
#### MEI (2003) study sites

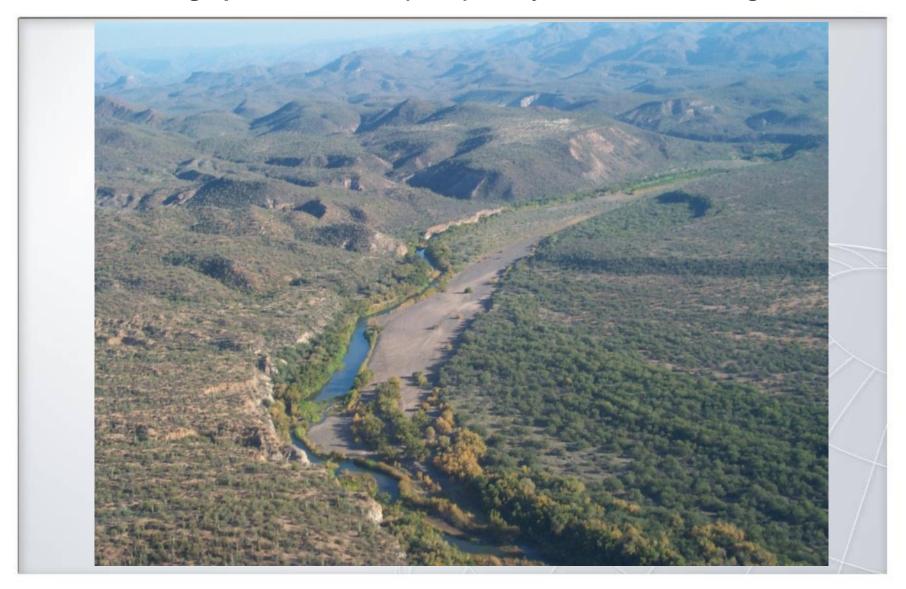
### View looking upstream of MEI (2003) Study Site 1, below Tangle Creek

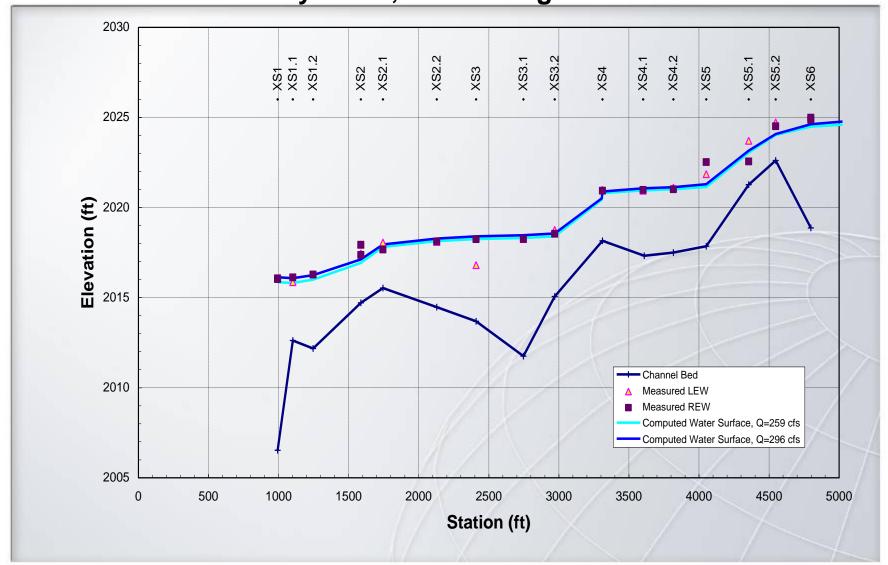
# Thalweg and water-surface profiles at the MEI (2003) Study Site 1, below Tangle Creek

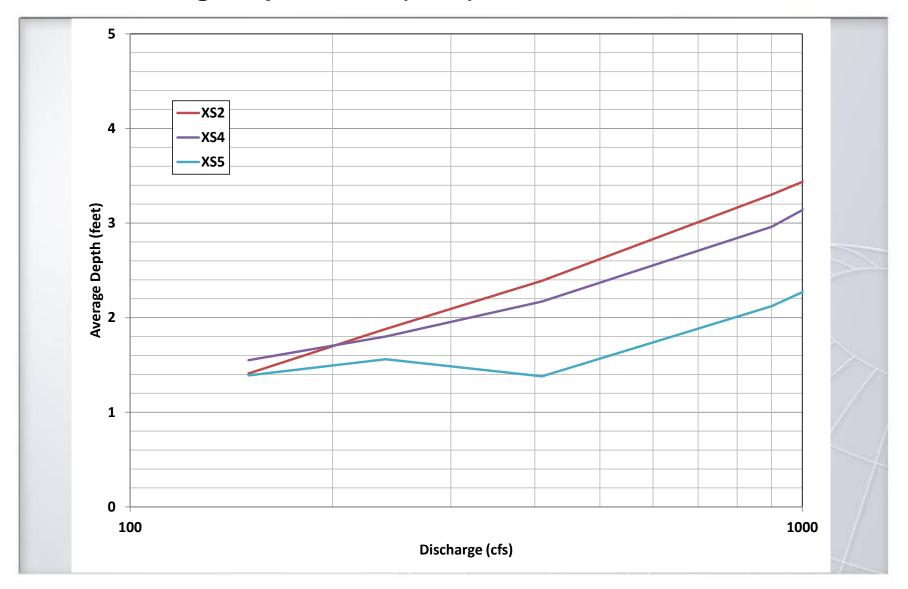
## Average depth at MEI (2003) Site 1 XS2, XS4 and XS5

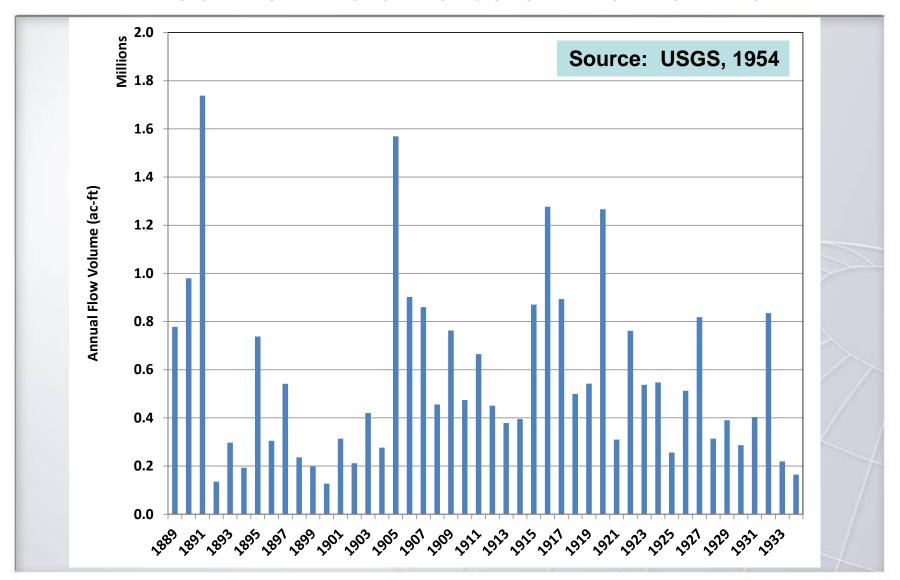
### **Annual flow volume below Bartlett Dam**

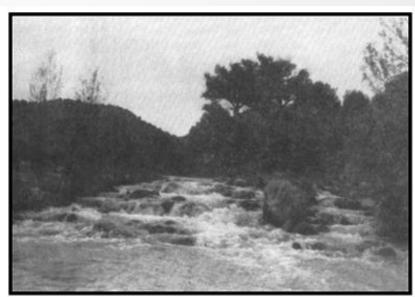
"Duff Drop" (River Mile 14.8)

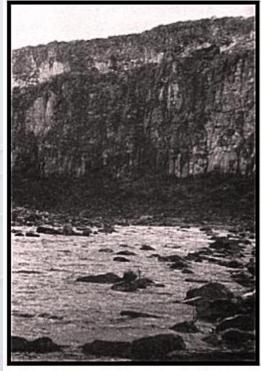
"USGS Rapids" (River Mile 40.3)

- ASLD Segments 3 and 4
  - Narrow, bed-rock confined canyon
  - Numerous rapids
  - Not navigable using boats in customary use for commerce at date of statehood

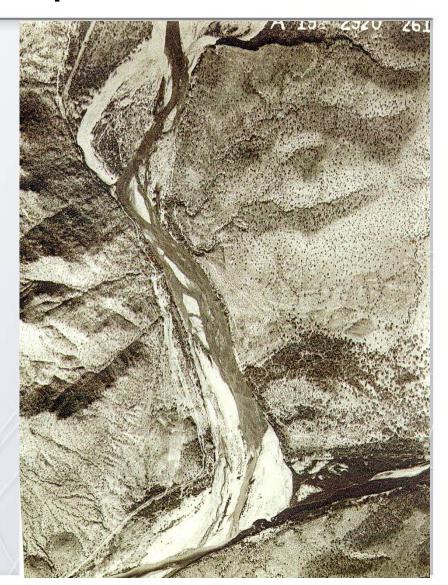
#### ASLD Segment 5

- Wider valley bottom bounded by alluvial terraces
- Island-braided character under modern (post-statehood) conditions
- Braided and highly-responsive to large floods under pre-statehood conditions
- Unstable, multi-channel character would have precluded reliable navigation with boat in customary use for commerce at statehood
- Not navigable using boats in customary use for commerce at date of statehood
