# NAVIGABILITY ALONG THE NATURAL CHANNEL OF THE VERDE RIVER, AZ

Detailed analysis from Sullivan Lake to the USGS gage near  
Clarkdale. and  
General analysis from Clarkdale gage to mouth.

An assessment based on history, Federal GLO surveys,  
hydrology, hydraulics and morphology

## **ADDENDUM TO REPORT OF OCTOBER 4, 2014**

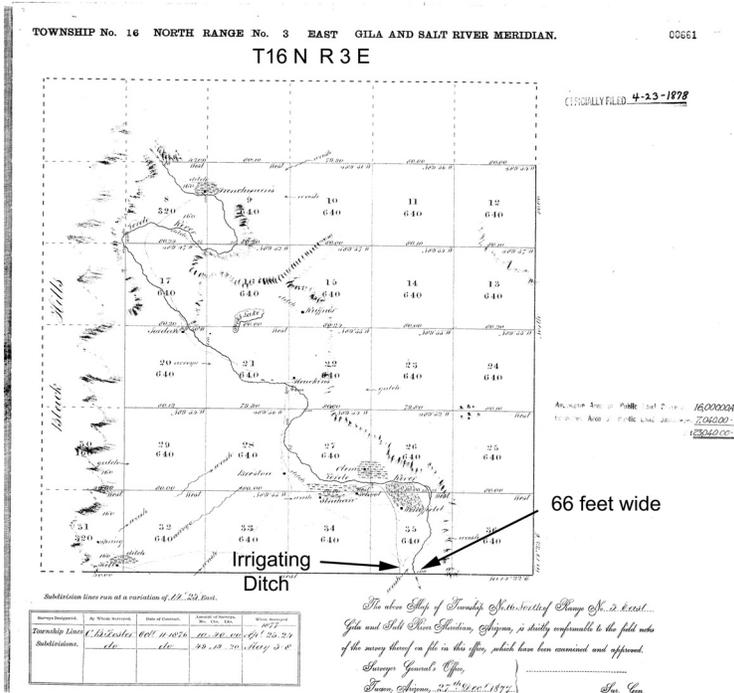
General description of T16N R3E is to the left. Survey was by C. B. Foster during April 23-24 and May 3-8, 1877. For this Township the Verde River was described as a beautiful stream with an average width of 66 ft (100 links) and an average depth of 3 ft.

Thus, for roughly 10 miles along the single meandering channel of the Verde River (see map above) the average depth was 3 ft.

Several settlers were engaged in farming in the Township. Note the ditch on above map.

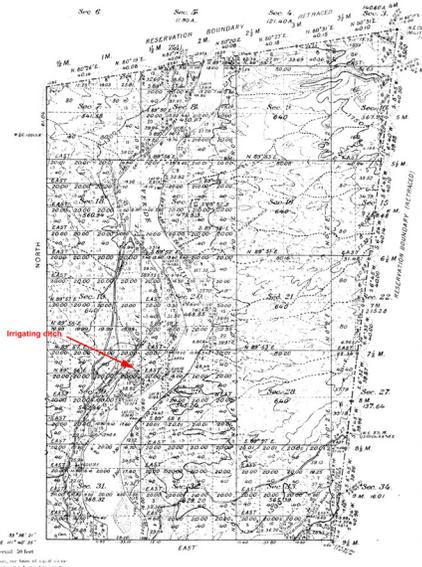
T4N R7E  
Field notes Book 2397 -- Survey of March 1-20, 1911

43 measurements of channel bank height were recorded with typical heights of 8 to 10 ft. Maximum bank height was 20 ft and minimum was 4 ft.

Four measured depths of flow in the main channel were 3,3,3 and 4 ft. Width of main channel was about 260 ft.

A few sand bars were noted in the survey notes.

Split flow (two channels) was noted for at least four locations and depths of flow in the smaller channel was noted as 1-2 ft.

An abandoned ditch along much of the reach to the west of the river is noted. Also, an active irrigation ditch located closer to the Verde River is also noted along most of the reach. This ditch was about 10-13 ft wide.

**T4N R7E**  
**Field notes Book 2397 -- Survey of March 1-20, 1911**  
**Summary of notes by Win Hjalmarson follows:**  
**Sec. 11** 43 measurements of channel bank height were recorded with typical heights of 8 to 10 ft. Maximum bank height was 20 ft and minimum was 4 ft.  
**Four measured depths of flow in the main channel were 3, 3 and 4 ft. Width of main channel was about 260 ft.**  
**A few sand bars were noted in the survey notes.**  
**Sec. 14** Split flow (two channels) was noted for at least four locations and depths of flow in the smaller channel was noted as 1-2 ft.  
**An abandoned ditch along much of the reach to the west of the river is noted. Also, an active irrigation ditch located closer to the Verde River is also noted along most of the reach. This ditch was about 10-13 ft wide.**

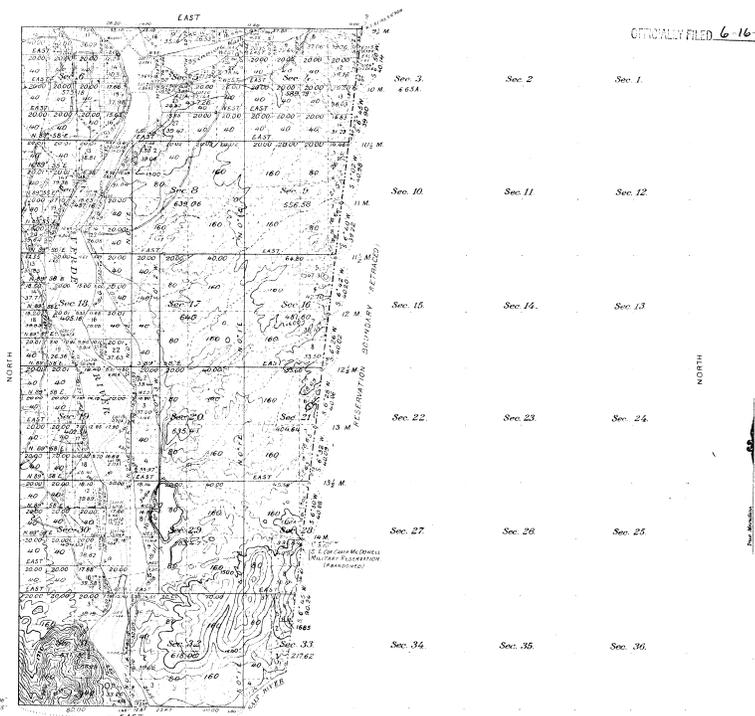
X00148

1st-7000 1st-20 00  
2nd-1000 1st-20 00  
Checked correct 30 feet  
Total number of acres 30,271.7

Surveys Investigated	By Whom Surveyed	When Surveyed
Standard lines	R.A. Farmer	
Township		July 8 - Feb 27, 11
Subdivision		Feb 18 - Mar 2, 1911
Meander		Mar 3-9, 1911
Boundary		Feb 20-22, 1911

**A 5 ft. depth of flow** was noted for a survey on Feb. 20, 1911 in T4N R7E by Farmer, RA., 1911 (page on left); General Land Office Survey Notes, Book 2398.

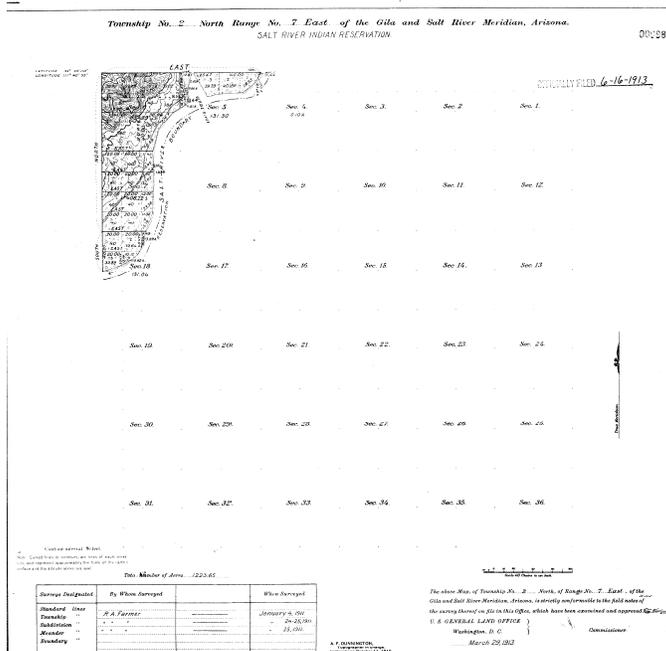
The total width of the Verde River along the boundary line between T3N R7E and T2N R7E was about 850 ft. ( 66 x (14.33-1.46) ) with a main channel of 264 ft. wide. A sand bar is noted on the west side of the main channel. This condition is consistent with the description by Dr. Pearthree in section G3a.--

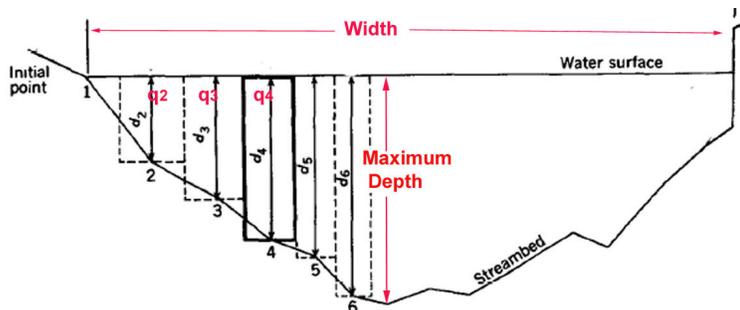
Measurements of discharge are made by wading, using boats and from cableways. Wading and cableway measurements are shown in the USGS photographs below. The man wading the stream is using a wading rod to measure depth and an acoustic velocity meter to measure velocity. A tape is across the stream to measure location and width perpendicular to the direction of flow. Wading is limited to depths of about 3 ft depending mostly on velocity of flow and condition of the channel bottom.

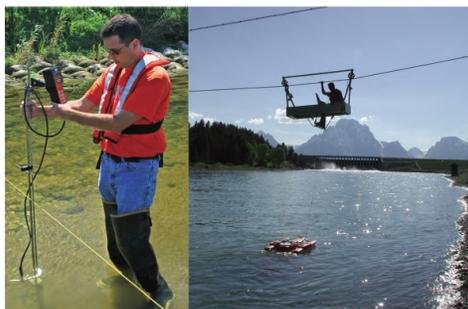
For greater depths the measurement is from a cableway. An Acoustic Doppler Current Profiler (ADCP) is used in the scene to the left. The ADCP measures velocity magnitude and direction using the Doppler shift of acoustic energy reflected by material suspended in the water column, providing essentially a complete vertical profile of velocity (and also the depth of water).

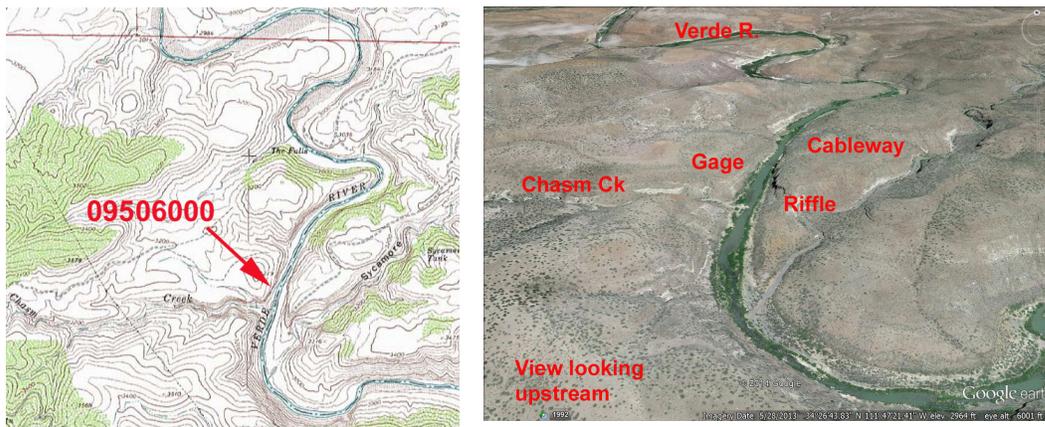
An example of the difference of depth for a riffle and the depth for corresponding upstream pool. Measurement data are from USGS website for station 09506000.

Site is the USGS gage 09506000 Verde River near Camp Verde, AZ. Low flow measurements normally are made at the riffle 800 ft downstream near the mouth of Chasm Creek. On December 5, 2013 a measurement of low flow (No. 344) was made at the cableway located in the pool about 1000 ft upstream of the gage. Nearly the same discharge (210 cfs versus 205 cfs) was measured (No. 345) at the riffle 13 days later on December 18, 2013.

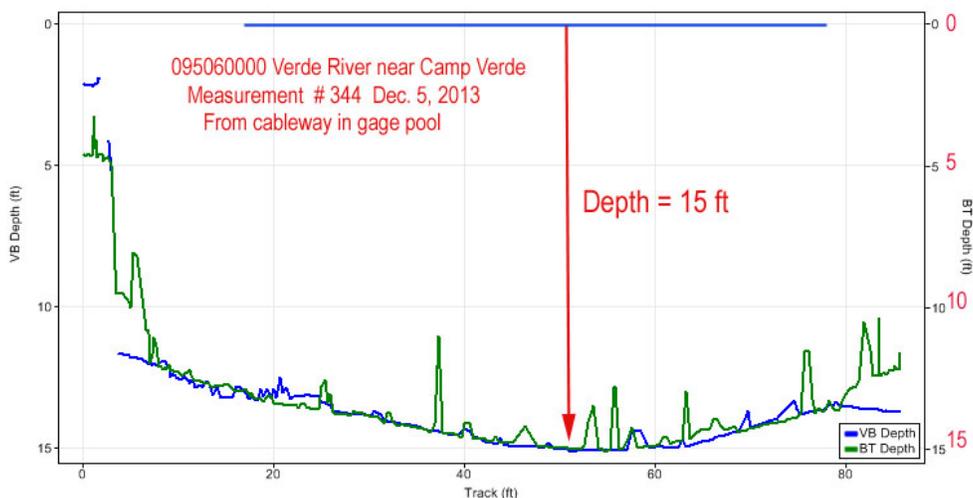
The measured cross section in the pool for USGS measurement 344 was determined by the USGS using an Acoustic Doppler Current Profiler (See below). The BT graph is what the USGS considers the real depth. The VB graph can have some spurious results from the effect of the beam reflecting off of some type of debris in the water (algae mat, clump of floating grass, etc.). The **maximum measured depth of flow in the pool at USGS gage 09506000 was 15 ft** during a base discharge of 205 cfs on Dec. 5, 2013.

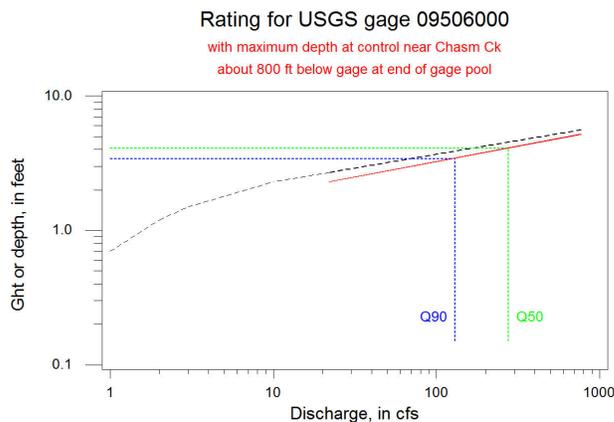
The rating for USGS gage 09506000 that reflects hydraulic conditions at the riffle (a constriction formed by deposited sediment at mouth of Chasm Ck.) control about 800 ft downstream of the gage is shown below. The maximum depth of flow (red line) is also shown. **A maximum flow depth of about 3.7 ft. at the riffle area corresponds to a discharge of 205 cfs on Dec. 5, 2013** for USGS measurement 344. Obviously, the depth in the pool of 15 ft. is considerably greater than the depth of 3.7 ft. at the control (condition defined by the rating curve) for the gage.

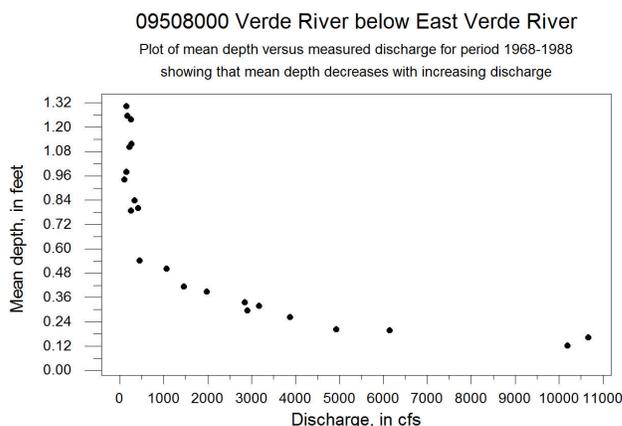
A plot of mean depth of flow for measurements of discharge at USGS gage 09508000 is shown below. The relation of decreasing mean depth as discharge increases clearly shows how worthless the use of mean depth for a channel can be for the assessment of navigability. Obviously, both the maximum and mean depth in the main channel, where potential navigation would occur, increases with increasing discharge.

I (Win Hjalmarson) personally made one of the measurements of discharge shown on the plot and can assure ANSAC that mean depth, especially when the computation includes an overflow area, is a meaningless measure of navigability at this and nearly all locations. Also, the low water control for the gage is very unstable. The gage has been operated by the USGS to define high flow conditions.

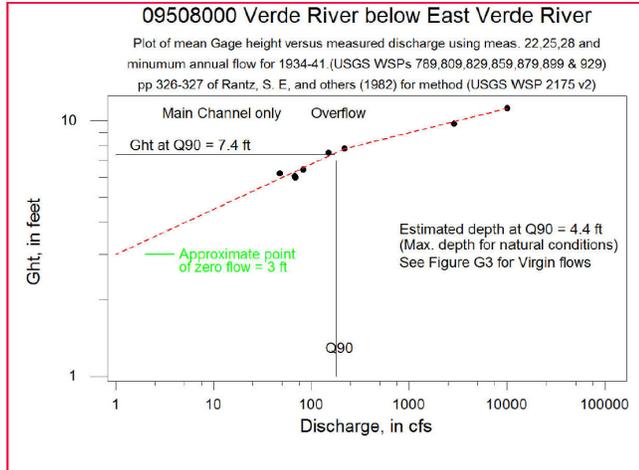
The stage versus discharge relation for 09508000 is to the right. This relation uses low flow data (discharge and corresponding gage height) for annual minimum daily discharge for the 1930s. Corresponding measurements of higher flows, available on the USGS web site, that represent similar control conditions are also plotted. USGS rating methods are used and the estimated maximum depth for the main channel below the gage is about 4.4 ft. Care was taken to identify where overflow on the flood plain first occurs to avoid confounding the estimate of channel depth.

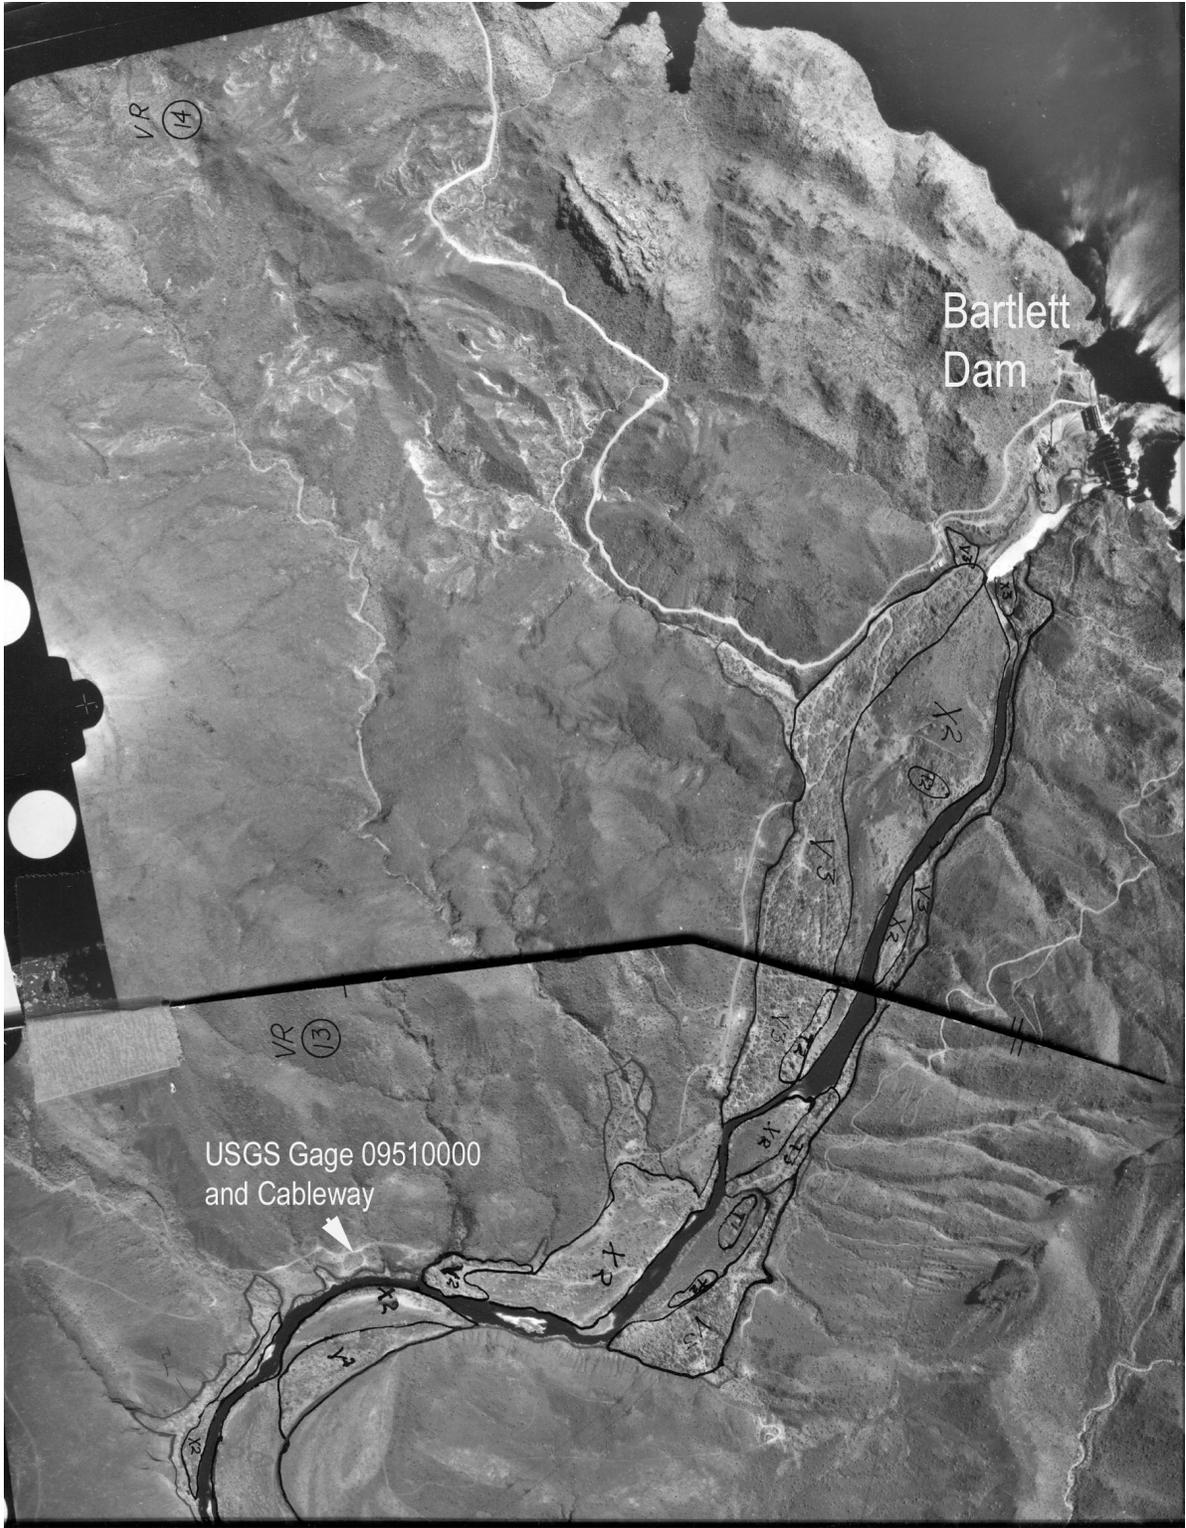
Following from Anderson, 1976:

The gage area is shown on the next page.

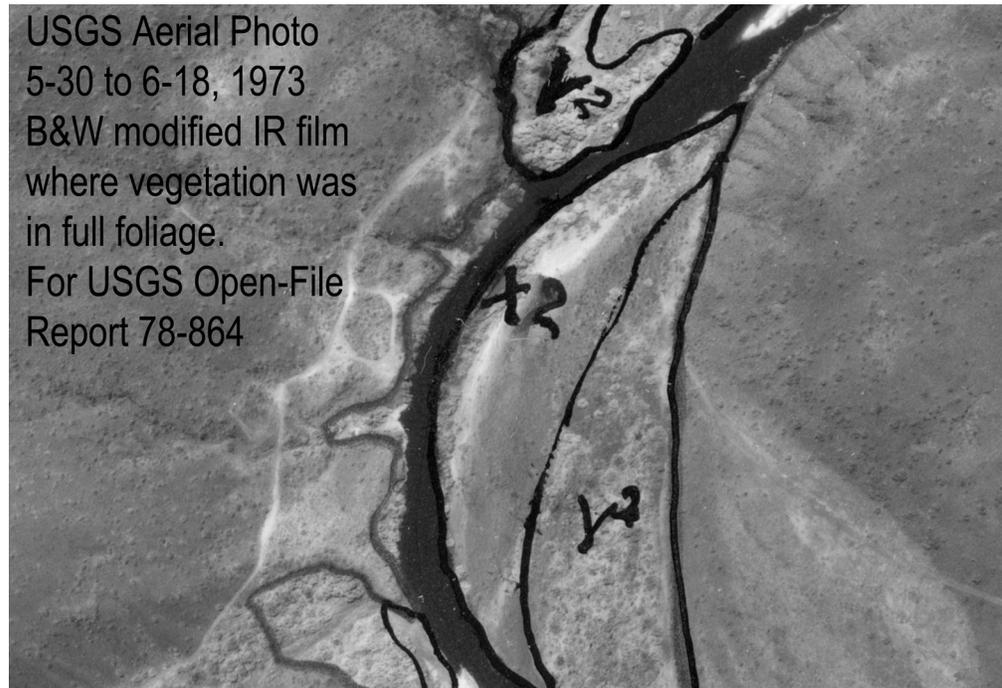
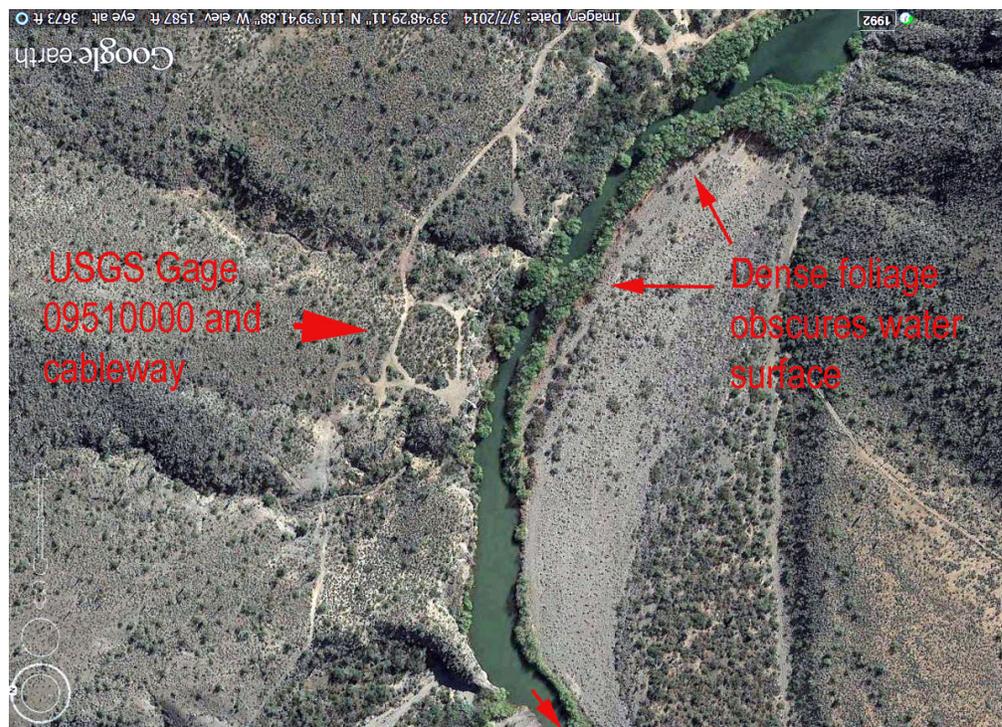
The number and size of trees along the channel of the Verde River in 2014 is considerably different than in 1973 as shown in the two photos below.

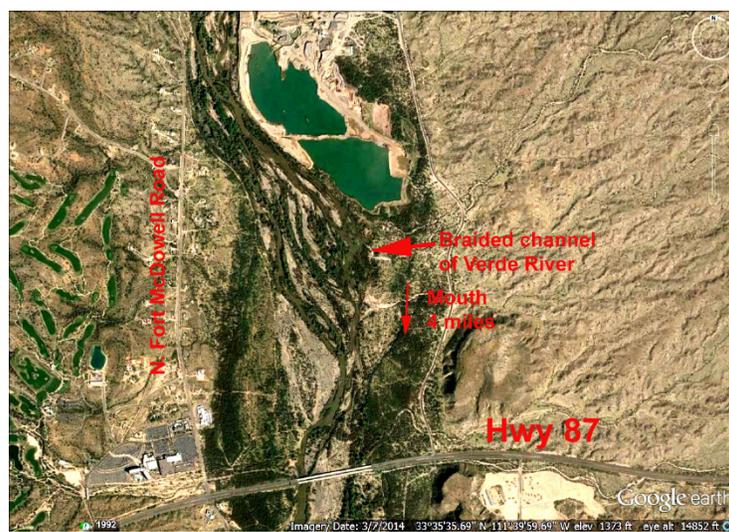
Note the recent (post 1973) braiding upstream of Highway 87 shown below.

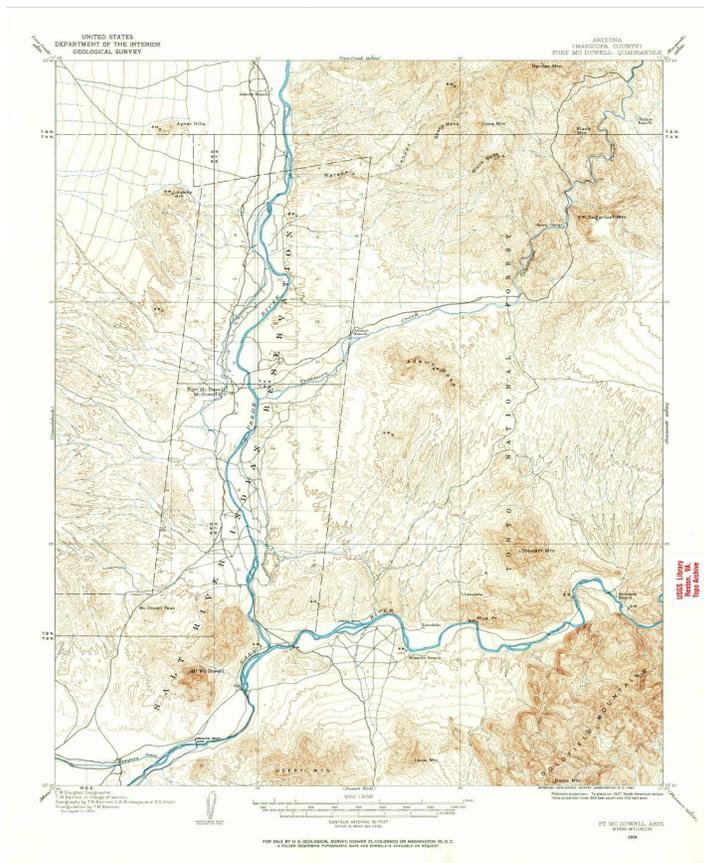
**Item 1.--** The 1904 USGS map below shows a single channel for the same reach that Dr. Mussetter says was a wide-braided channel with a braided pattern and unstable low-flow channels. Also, the 1913 (survey of 1911) Federal Land Survey map on the following page shows a single channel. Other plats presented previously (Addition 1) also show a single channel.

Note the diversion canal on the west side of the Verde River.

**Summary of Addition 5.**-- Based on the Verde River that is shown in both the 1904 USGS Ft McDowell Quadrangle map and the Federal Land Surveys (for example of 1911 for T4N R7E), information in the USGS report by McDonald and Padgett (1945) and the science based distinction between meandering and braided of Leopold, Wolman and Miller (1964), the natural single channel of the Verde River was meandering. Also, the 1973 channel shown in the USGS aerial photos of the preceding section (Addition 4) was meandering.

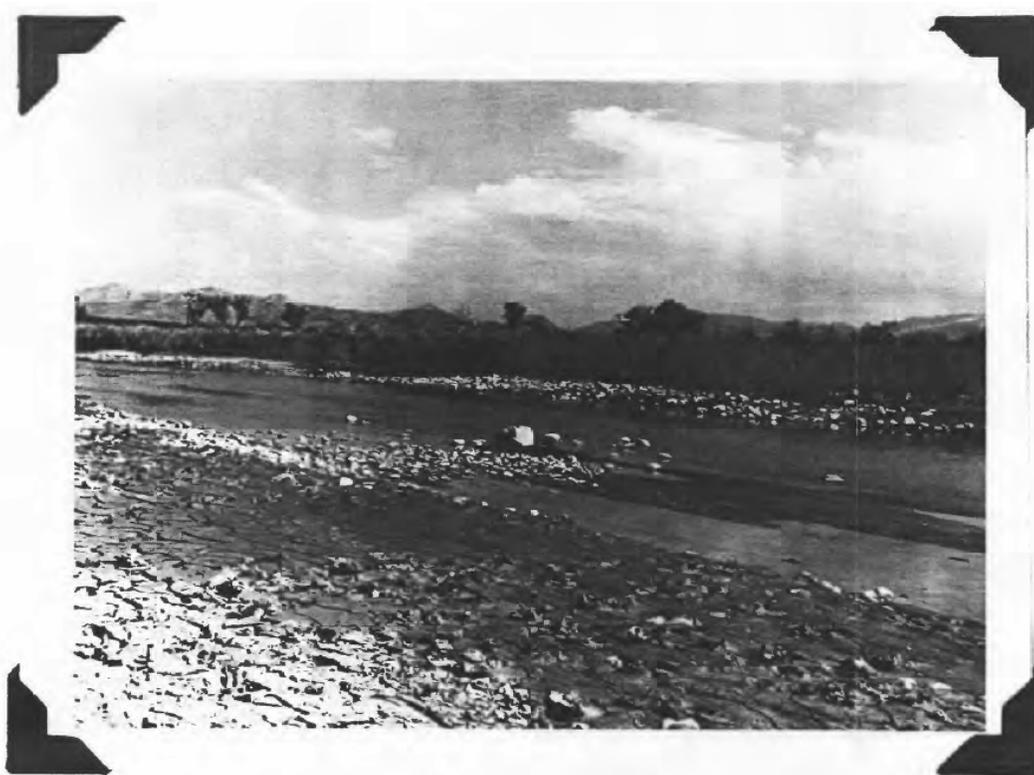
Plate 5. View of the Verde River channel near the upper well field of the City of Phoenix, showing silt deposits near the banks of the stream.

The City of Phoenix had an early history of deposited silt sealing its infiltration gallery and wells along the west side of the Verde River near the mouth. In fact, the USGS wrote a report on the issue that stated “Sediments deposited by the river are highly effective in sealing up the gravels that supply the city's wells, the amount of sealing depending on the silt content of the water and the discharge of the river at the well fields.” (McDonald, Harris B. and Padgett, Harold D., Jr., 1945, *Geology and ground-water resources of the Verde River Valley near Fort McDowell, Arizona*, USGS Open-File Report 45-109, 119p., page 82 and others).

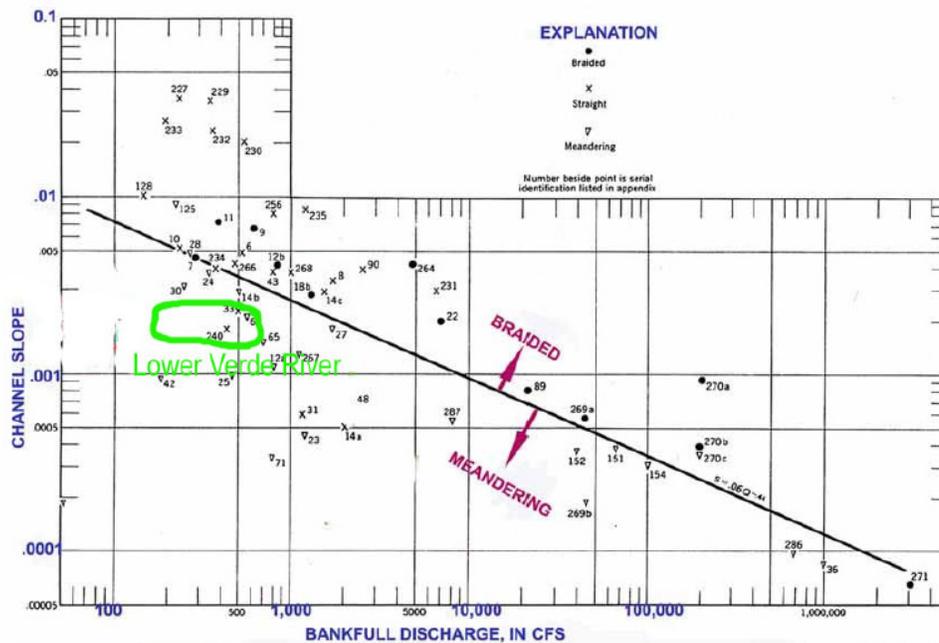
(USGS PP 282-B RIVER CHANNEL PATTERNS: BRAIDED, MEANDERING AND STRAIGHT)

**Item 3.**--For the same discharge, rivers like the Verde River with low slopes tend to have meandering channels (Leopold, L.B., Wolman, M.G., and Miller, J.P, 1964, Fluvial processes in geomorphology: New York, Dover Books on Earth Sciences, 503 p.). The plot below is the result of a scientific study where characteristics of many natural river channels were examined. The USGS scientists found a distinction between meandering and braided channels based on slope. This distinction shown below has withstood the test of time. Thus, why would Dr. Mussetter expect braiding? Surely Dr. Mussetter isn't basing his opinion on a single aerial photo in 1934 of local flood debris at the mouth of the Verde River.

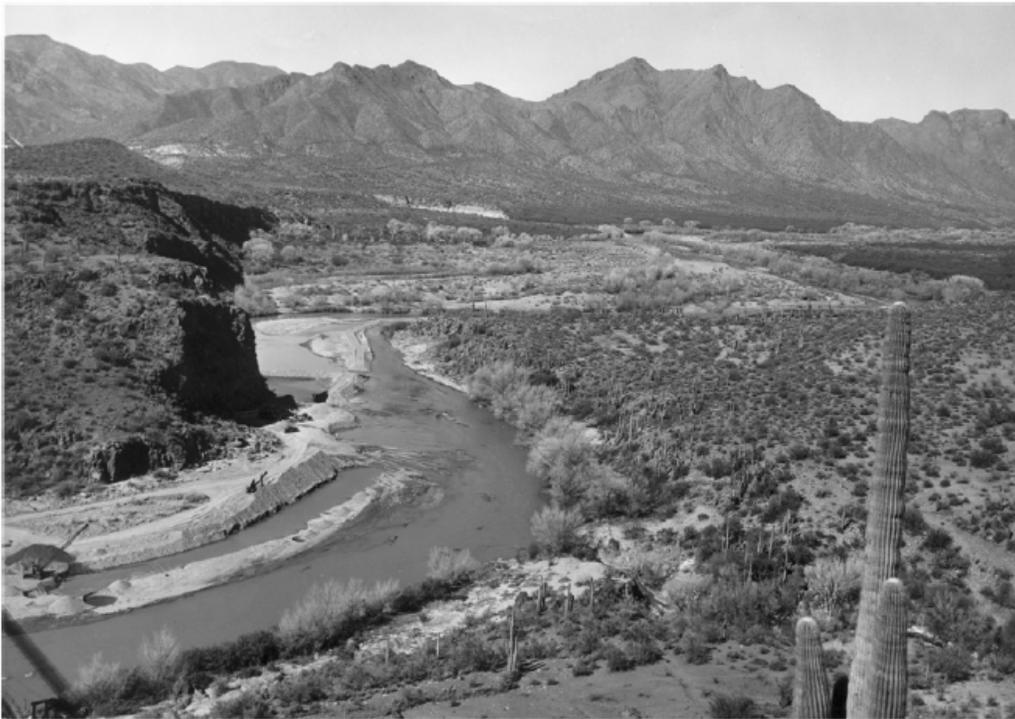
**Figure III-21. Horseshoe dam site in 1944, looking upstream from the east dam abutment.**

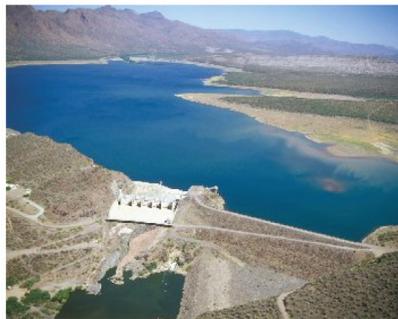
Photograph from: [www.usbr.gov/projects/PrintFacilityAttributes.jsp?fac\\_Name=Horseshoe Dam](http://www.usbr.gov/projects/PrintFacilityAttributes.jsp?fac_Name=Horseshoe%20Dam)

The normal water surface elevation is 2026 ft. The original corresponding water storage of 131,500 ac-ft has been reduced to 109,200 ac-ft (2007 SRP report p. 14, and 2003 survey of reservoir area) by sediment deposition in the reservoir area. As of 2003, deposited sediment had reduced the water storage capacity behind Horseshoe Dam by about 22,300 ac-ft.

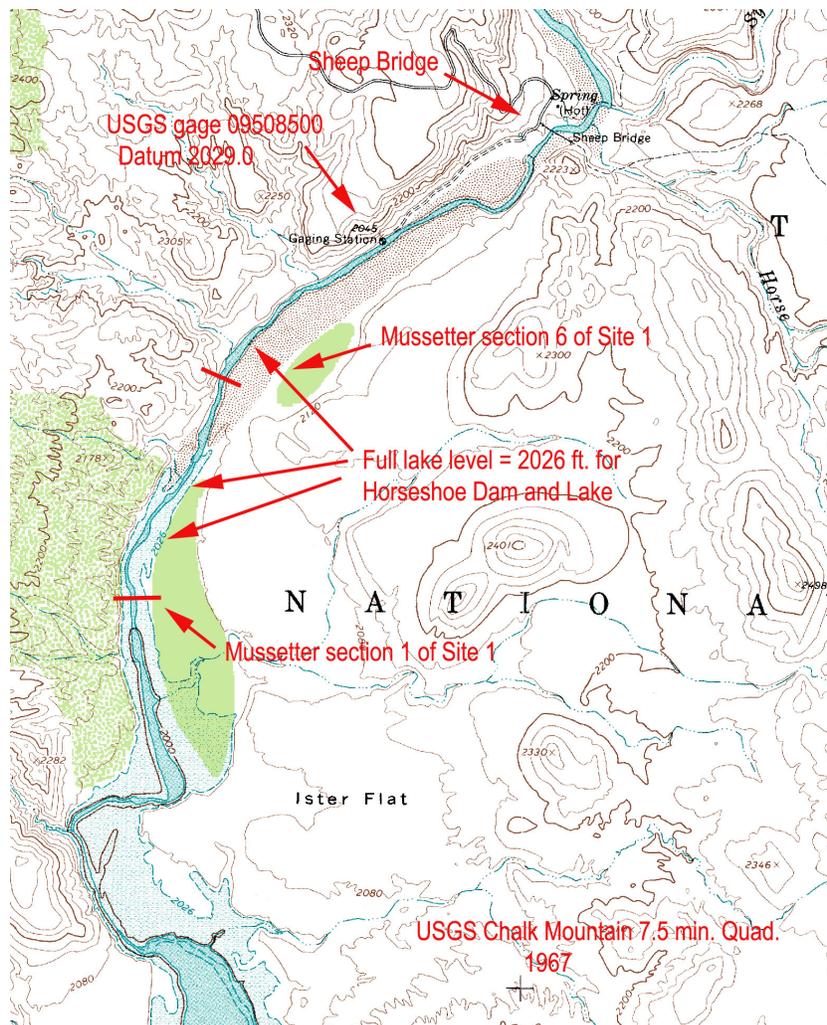
Site 1 is interesting because Dr. Mussetter neglects to mention that it lies within the normal water surface elevation of Horseshoe Reservoir (see map below) and has been inundated a few times by water stored behind Horseshoe Dam. Also, site 1 has been subjected to backwater and associated deposition of river transported sediment during large floods especially when storage in Horseshoe Reservoir was large. The amount of reduction in reservoir storage by deposited sediment captured by Horseshoe Dam is on the order of 620 AF per year (SRP 2007, p. 90). The relatively recent (historically speaking) deposited sediment along the Verde River in and along Site 1 is easily scoured, especially during storm runoff, and is quite variable in amount and location because of the influence of fluctuations in lake levels. Site 1 is located in one of the most unstable areas along the human impacted Verde River.

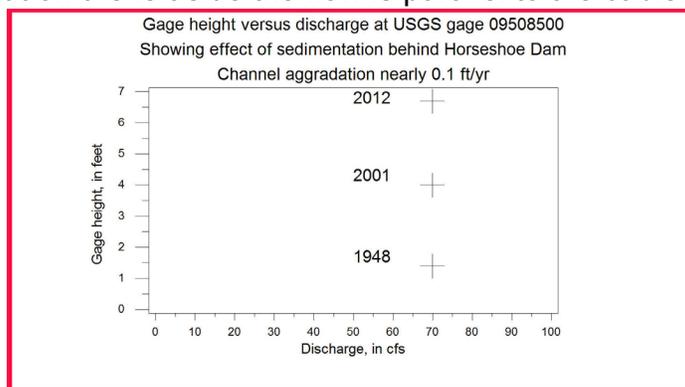
The relation below shows the effect of the aggrading channel of the Verde River at gage 09508500 where a delta like environment has been created by backwater and associated sediment deposition at the USGS gage and cableway above Horseshoe Dam and reservoir. On the right side of the cableway the flow is perpendicular to the cable but on the left side the flow is parallel to the cable. A small human caused delta has formed at the cableway. The channel geometry is ever changing in this human caused unstable environment. Site 1 is downstream of the USGS gage, (see map on previous page)

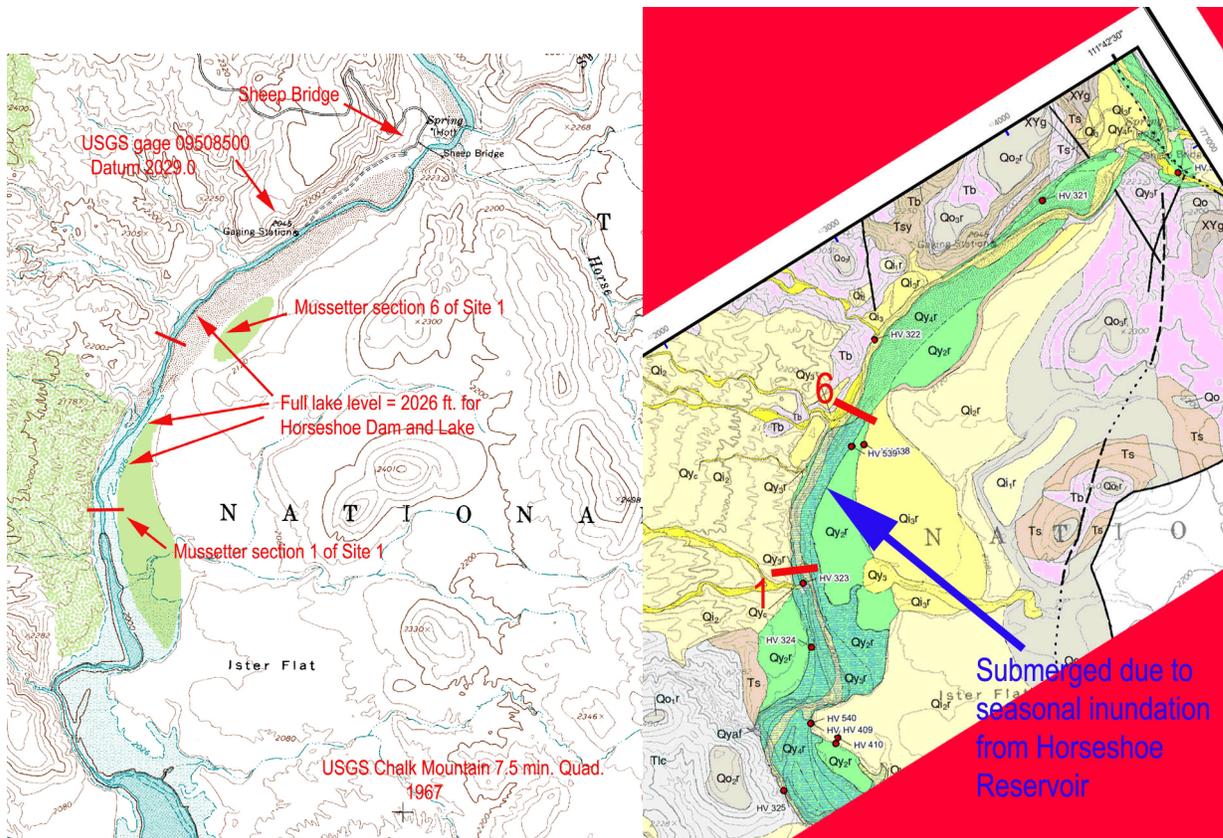
Above to the right is the surficial geologic map of the upper end of Horseshoe Reservoir that corresponds to the USGS map on the left. Site 1 of Mussetter's report clearly is seasonally submerged.

The surficial geologic map of the upper end of Horseshoe Reservoir is shown on the next page.

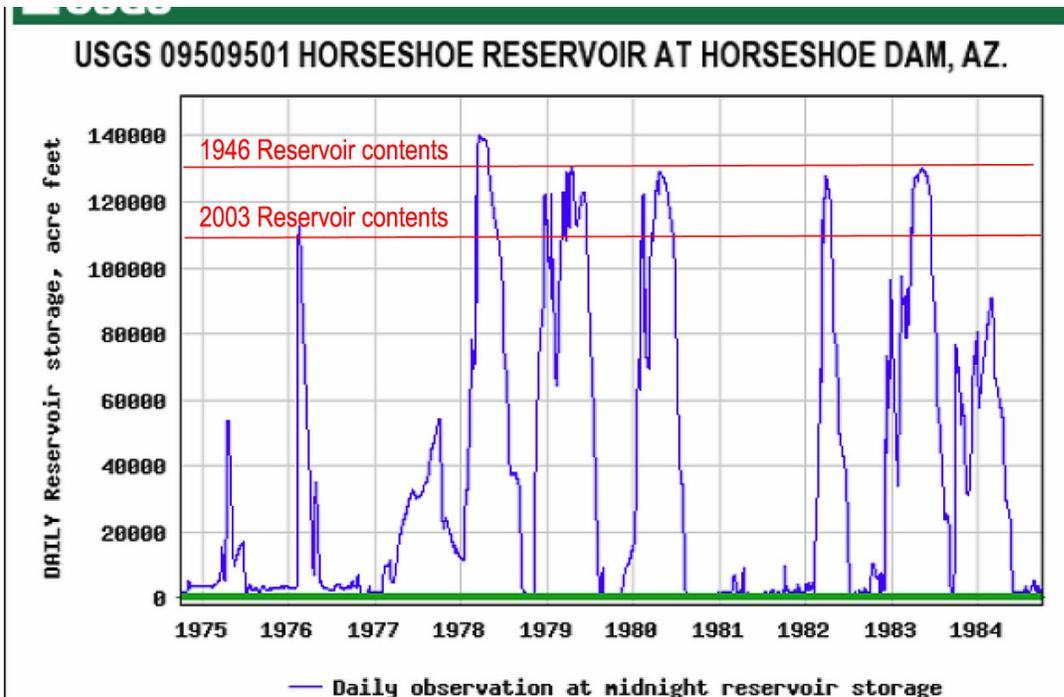
Samples of when reservoir storage was large enough to impact Site 1 are shown on the following page. Site 1 has been inundated by the reservoir and by backwater associated with the reservoir a few times since Horseshoe Dam first stored water on Nov. 15, 1945.

Because of reduced storage from deposited sediment since Horseshoe Dam was constructed, Site 1 was inundated more frequently and at greater depth in recent times. This changing inundation of Site 1 is depicted in the above USGS figure.

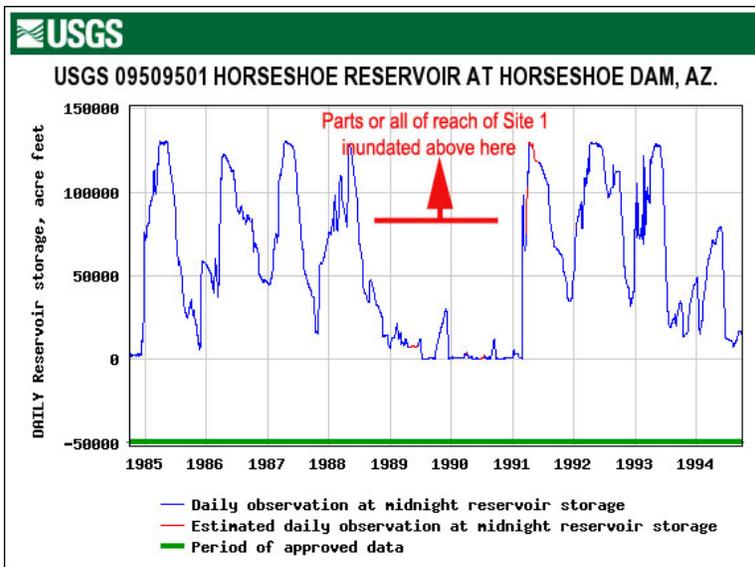
Probable backwater during high flows starts a few feet above reservoir elevation of 2000 ft. (sill of spillway) at 67,000 ac-ft capacity. Capacity is from p. 103 of Giordano (2010).

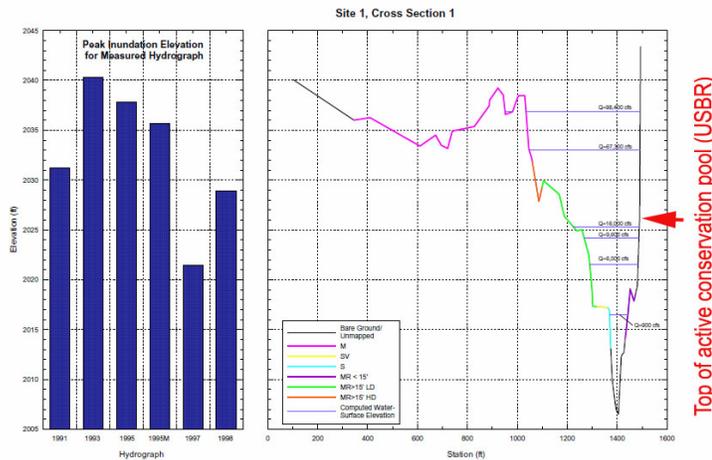
Below are cross sections 1 and 6 for Dr. Musseter's site 1 that is located within the active conservation pool according to the USBR. Clearly the channel condition is impacted by the reservoir where there would be backwater effects during high flows when storage in the reservoir was great. An obvious impact would be sediment deposition in and even upstream of the reach of site 1.

Figure 5.4. Peak discharge elevations for the 1991, 1993, 1995, 1995M, 1997 and 1998 floods plotted with the cross section profile for Cross Section 1 at Site 1. The cross section is color coded to show the distribution of the various types of vegetation at the site (refer to Table 5.1 for full descriptions of the vegetation codes).

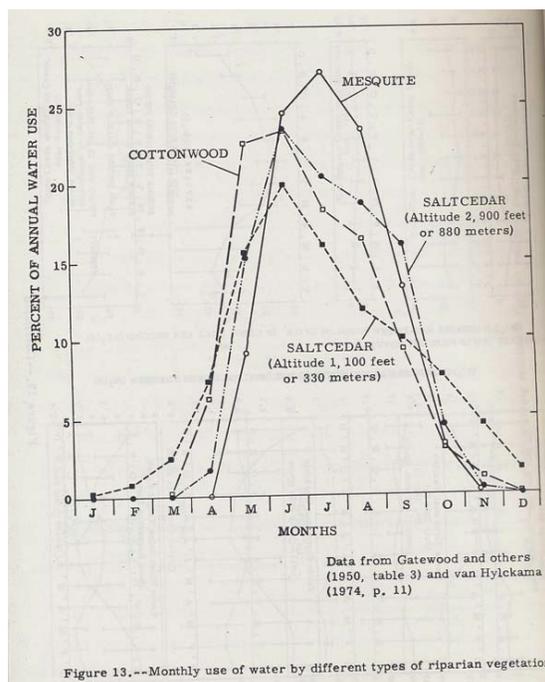
Figure 13.--Monthly use of water by different types of riparian vegetation.

The monthly water use by plants (transpiration), in percent of the annual water use, is shown to the right. Nearly all of the water use is during the growing season of May through September. There is very little water use during the months of November through March.

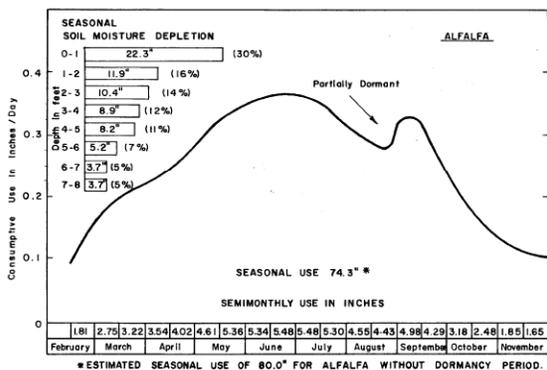
Figure 7.—Mean consumptive use for alfalfa at Mesa and Tempe, Ariz., 1946, 1950, 1952-63.

A few samples of the within-year distribution of water consumed by crops are shown below. These samples are simply to give the reader an idea of how water use varies by crop type and throughout the year. Source: Erie, L. J. and others, May 1982, Consumptive use of water by major crops in the southwestern United States, U.S. Dept. of Agriculture, Conservation Research Report No. 29, 41p.

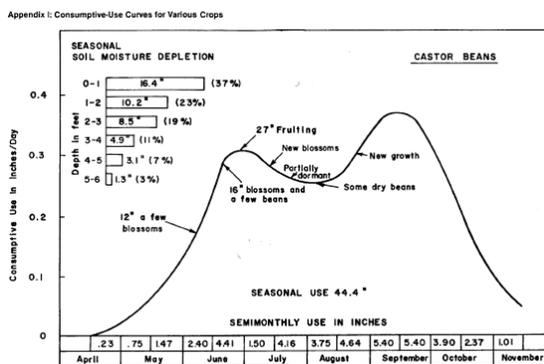
Figure 1.—Mean consumptive use for castor beans at Mesa, Ariz., 1958.

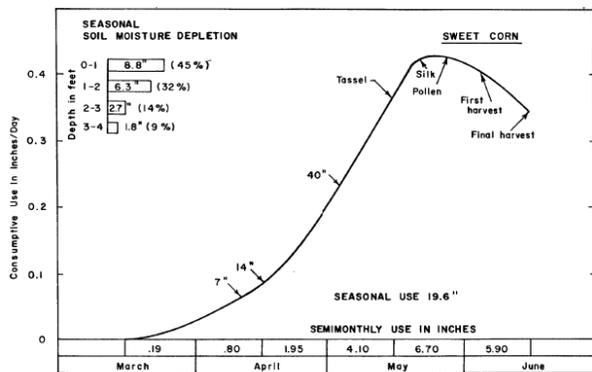
Figure 30.—Mean consumptive use for sweet corn at Mesa, Ariz., 1959, 1961-62.

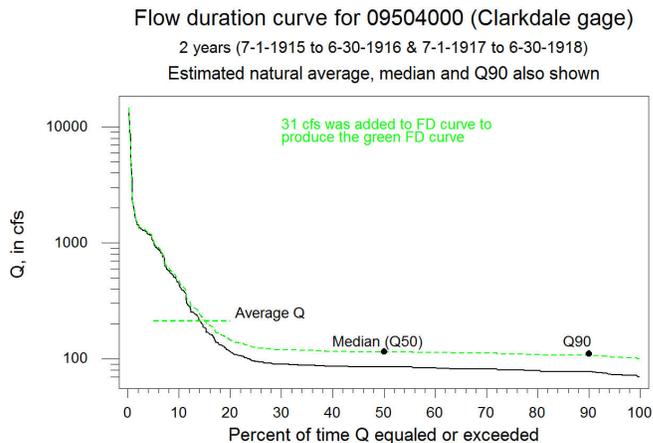
**Methods 1 and 2.**--Below is a simple example (a flow-duration relation) of the annual water budget method that simply adds an average value (31 cfs) for consumptive use by crops to the human impacted river flow.

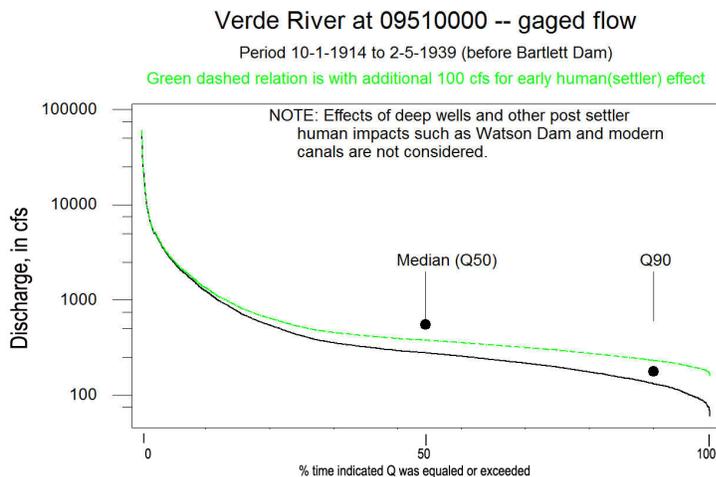
Another simple example of using the average annual consumptive use by crops method is shown below. This example is related to Method 2 (pages 28-30 of the report and pages 52-53 of Appendix G). In Figure G3 is stated: *Graphs are smoothed in places but show sufficient detail for assessment of navigability.* Detail is needed to define lower flows that potentially limit navigability but less detail is needed for high flow. Of particular importance for the assessment is the lower flow (Q90) as discussed in item B on p. 106 of the report and also in section G4d of Appendix G. The conservative nature of this method of analysis can be seen using the flow-duration relation below where the Q90 value for this assessment is below the green relation that doesn't even account for much of the human effects. This method produced a conservative assessment of navigability.

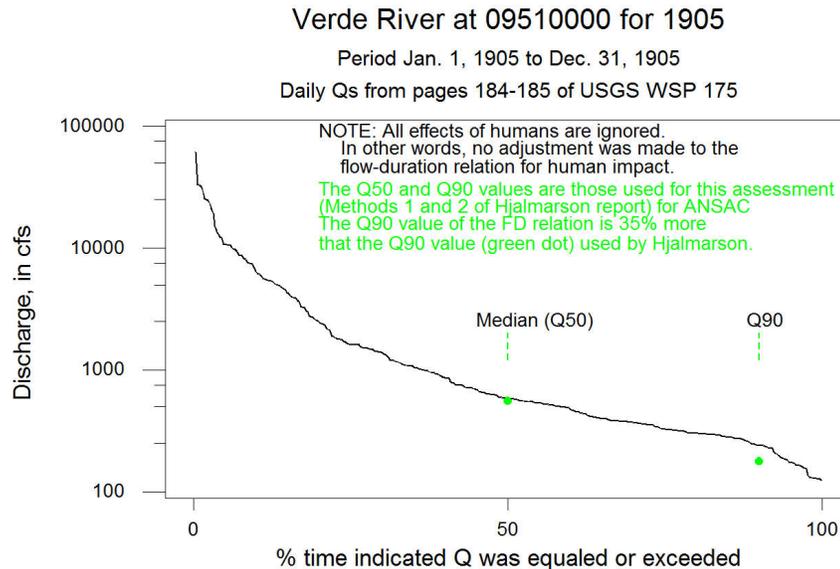
A third simple example that is also related to Method 2 as discussed in the previous example uses supplemental evidence Item No. X023, 10/15/14, FMI-Sean Hood, Freeport X002 (USGS Water Supply and Irrigation Paper 175). As with the previous example, the conservative nature of this assessment of navigability is further demonstrated in the following flow-duration for the lower Verde River.
