# NAVIGABILITY ALONG THE NATURAL CHANNEL OF THE VERDE RIVER, AZ

Detailed analysis from Sullivan Lake to the USGS gage near  
Clarkdale. and  
General analysis from Clarkdale gage to mouth.

An assessment based on history, Federal GLO surveys,  
hydrology, hydraulics and morphology

## **ADDENDUM TO REPORT OF OCTOBER 4, 2014**

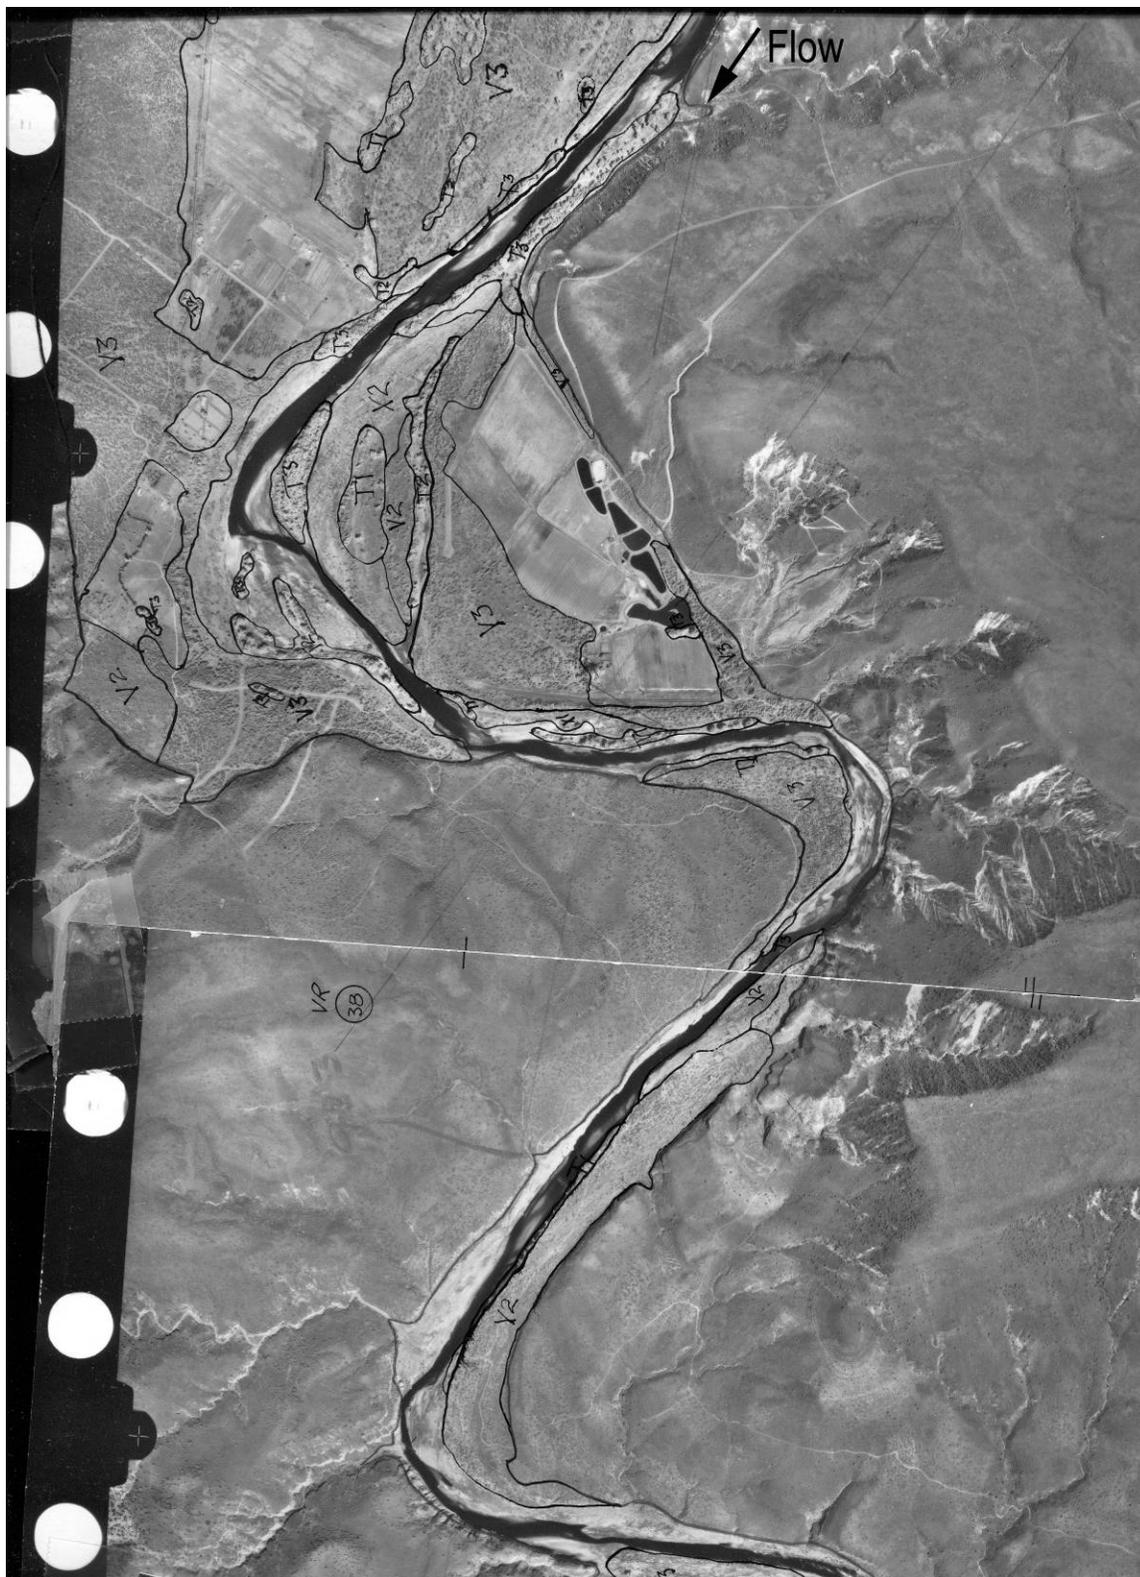
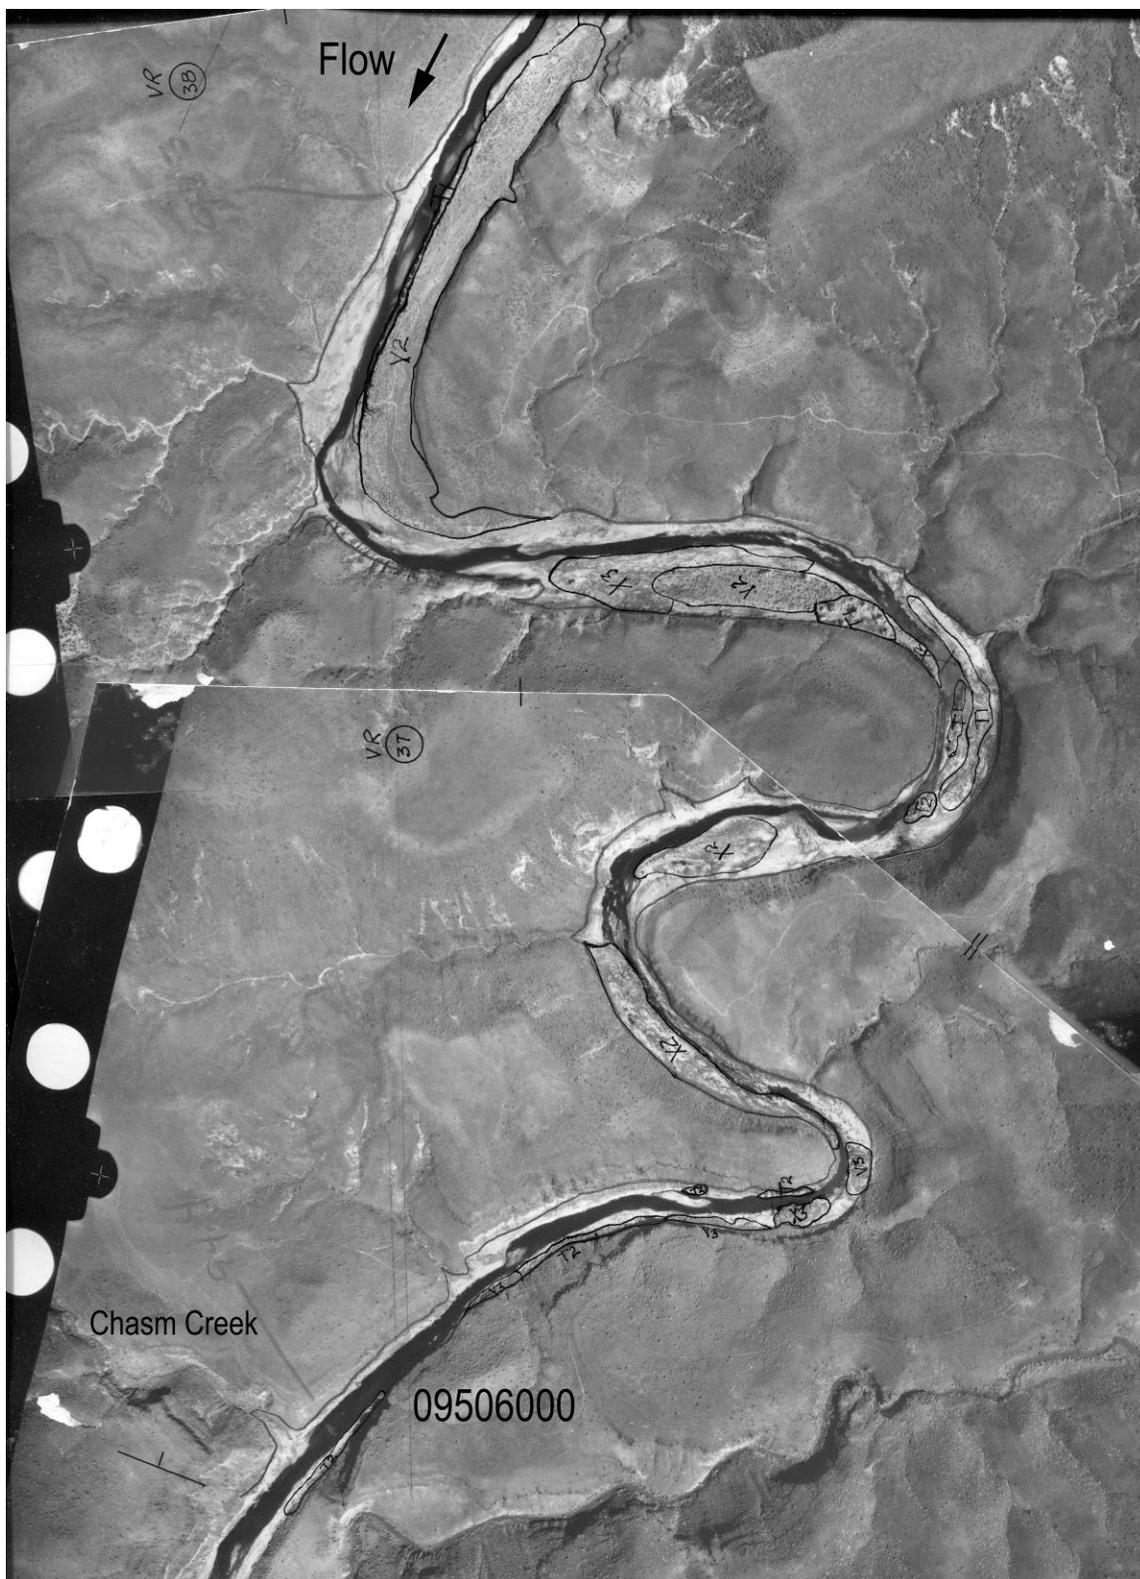
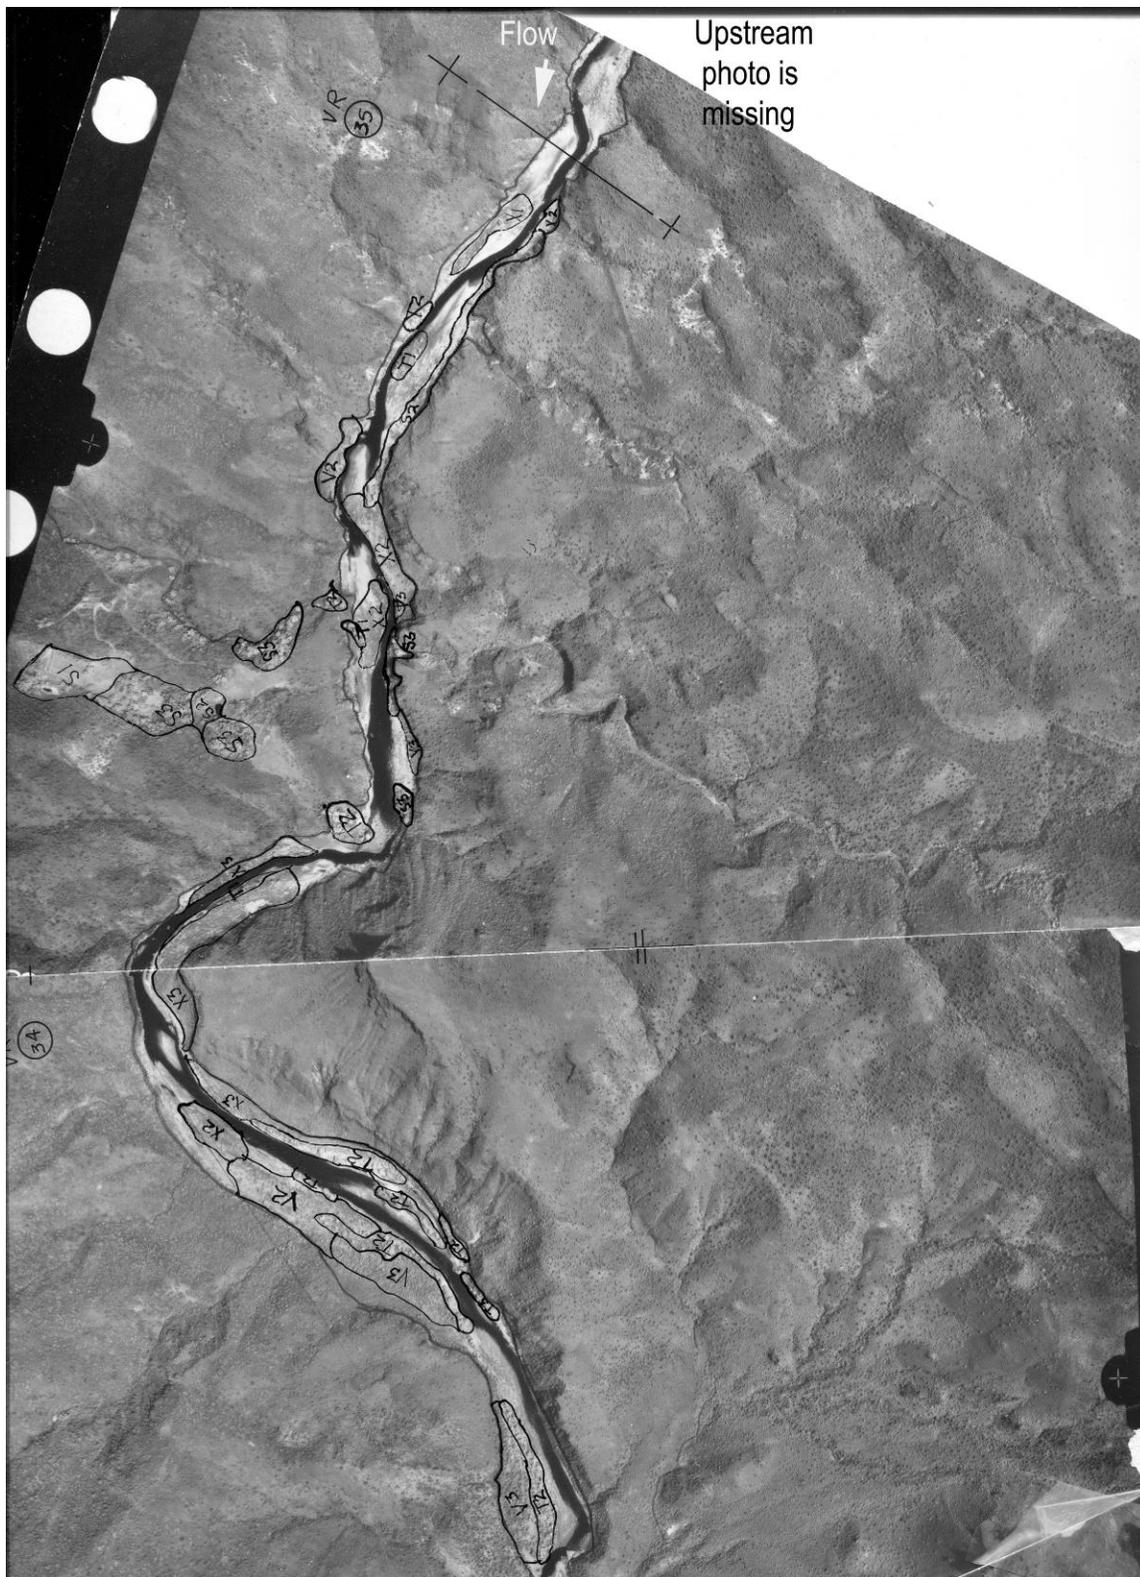
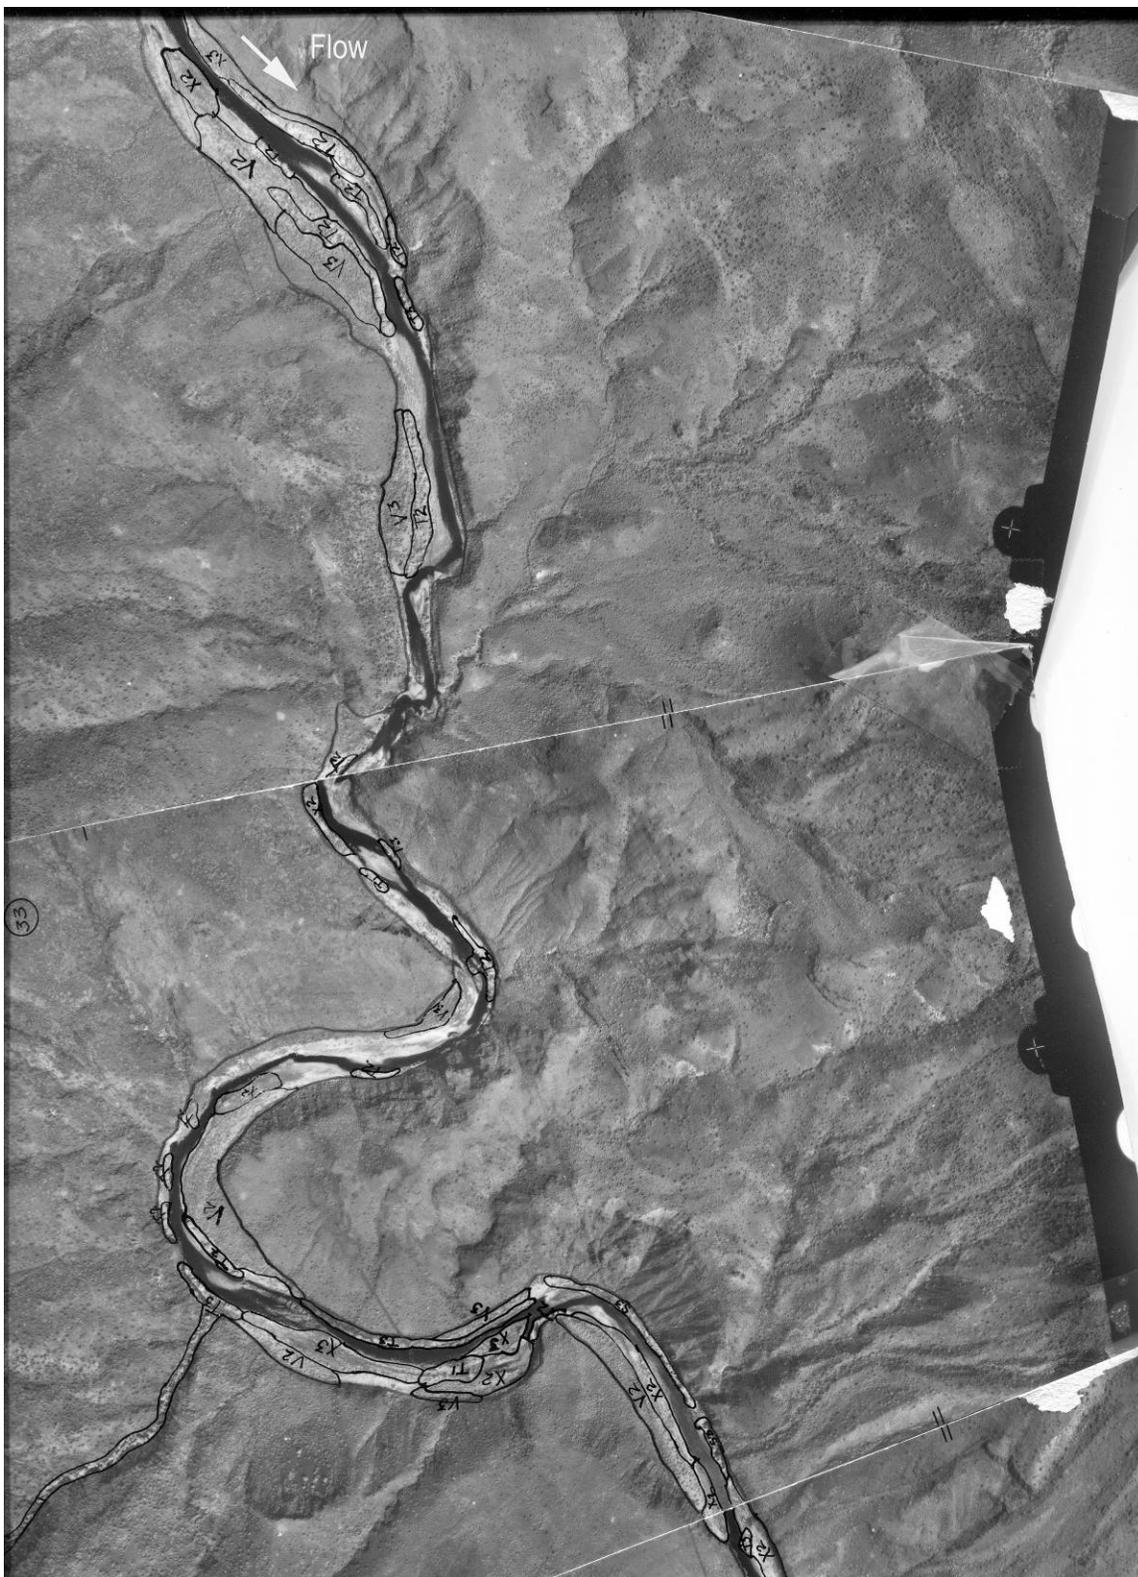
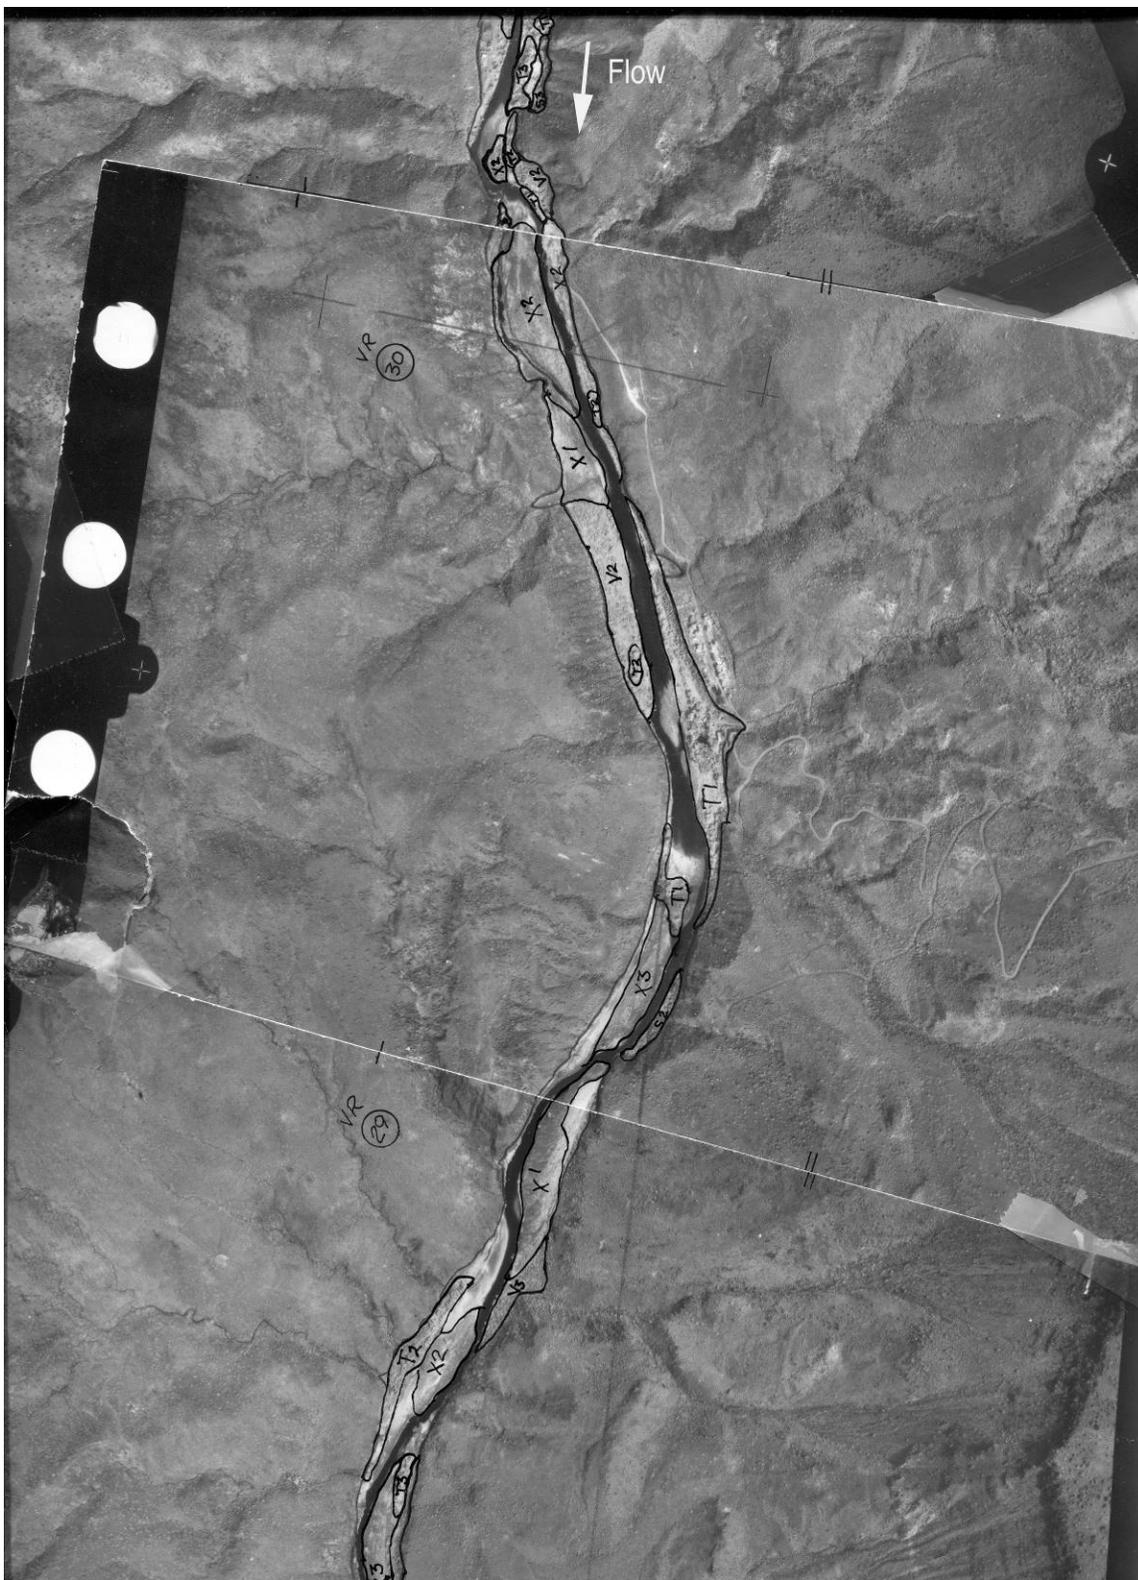
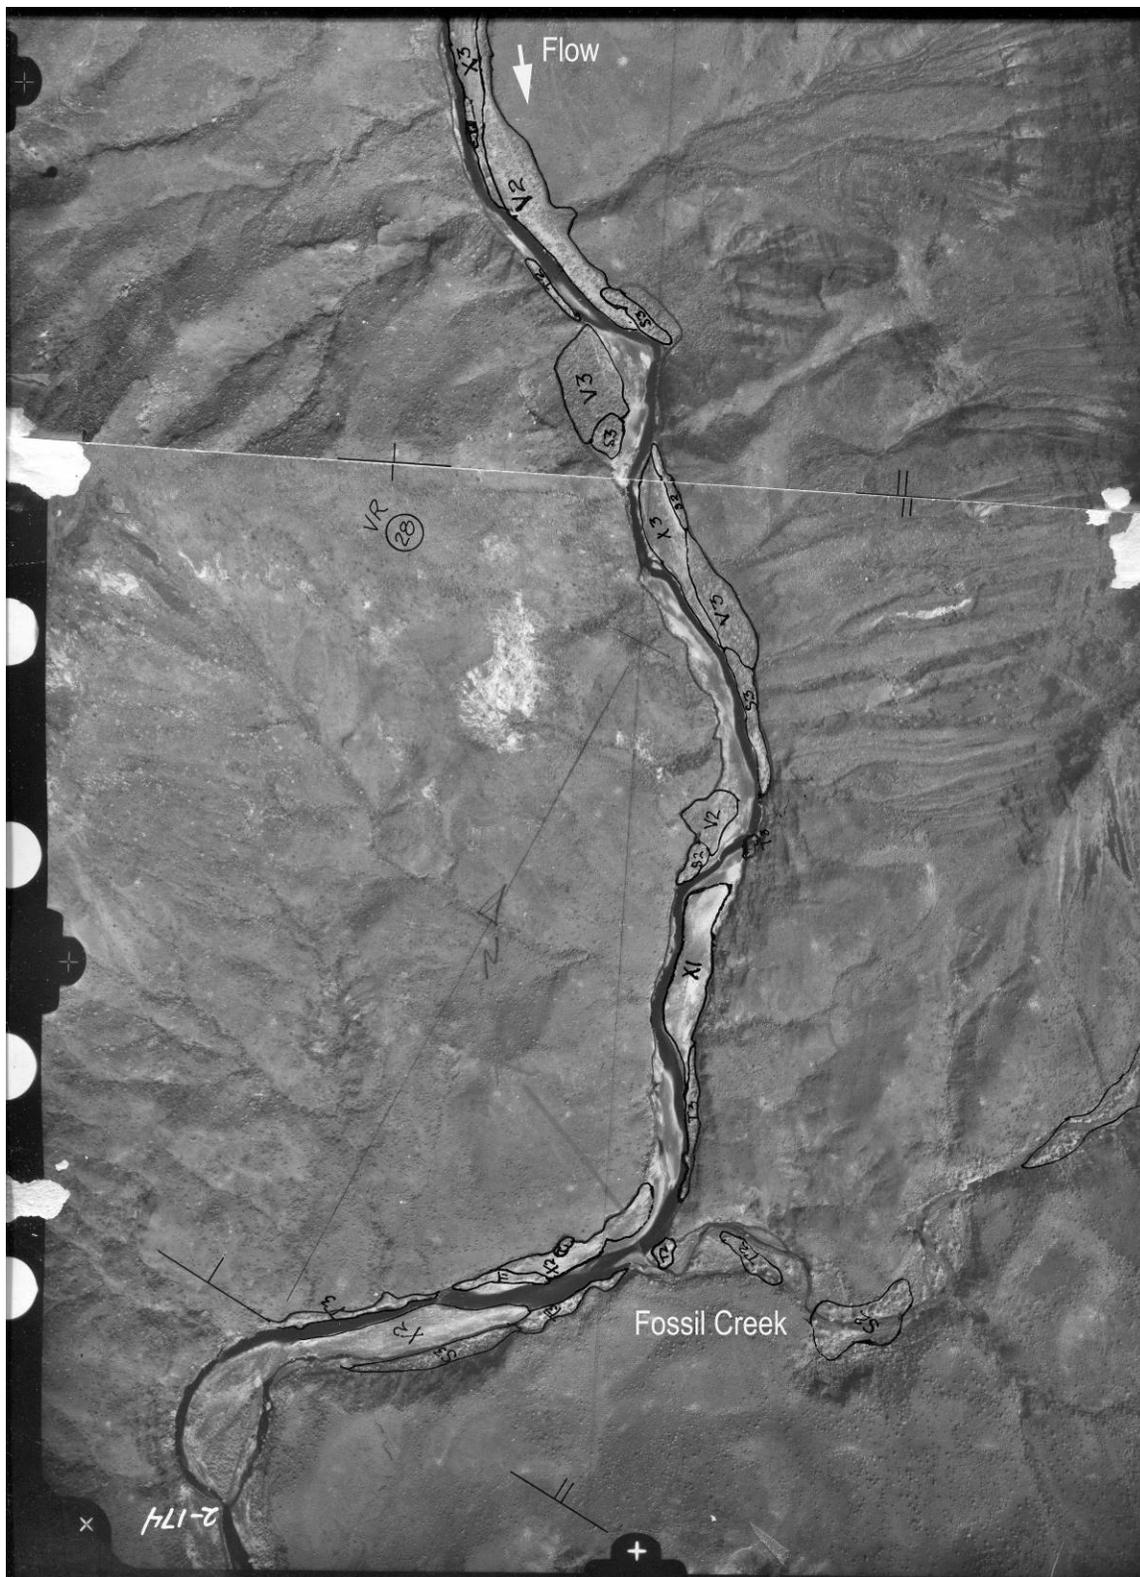
The channel depicted in the following unpublished 1973 aerial photos clearly is a pool-riffle meandering channel. Much of this area was not surveyed by GLO surveyors. The explanation for the mapped vegetation is given in Addition 4.

Following from Anderson, 1976:
