**NAVIGABILITY ALONG THE
NATURAL CHANNEL
OF THE VERDE RIVER, AZ
-- ANSAC --**
Win Hjalmarson, PE Oct. 2014
For ACLPI

Detailed analysis from
Sullivan Lake to the USGS
gauge near Clarkdale.

General analysis from
Clarkdale gage to mouth.

**Was the Verde River
susceptible to navigation
at the time of Arizona statehood
(February 14, 1912)
in its ordinary
and natural condition ?**

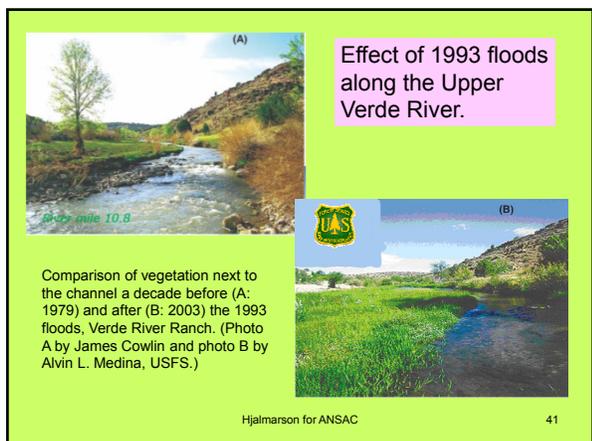
Comparison of vegetation next to the channel a decade before (A: 1979) and after (B: 2003) the 1993 floods, Verde River Ranch. (Photo A by James Cowlin and photo B by Alvin L. Medina, USFS.)

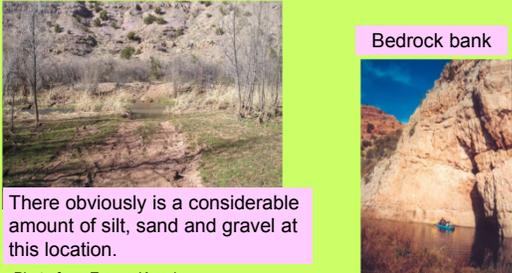
Bedrock bank

There obviously is a considerable amount of silt, sand and gravel at this location.

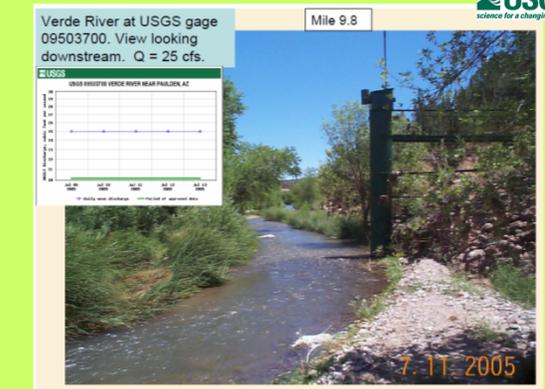
Mile 9.8

Verde River at USGS gage 09503700. View looking downstream. Q = 25 cfs.

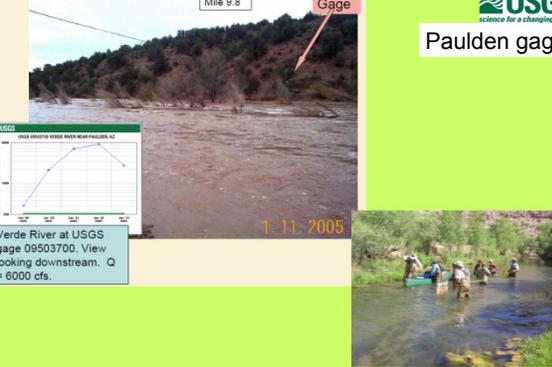
Mile 9.8 Gage

Verde River at USGS gage 09503700. View looking downstream. Q = 6000 cfs.

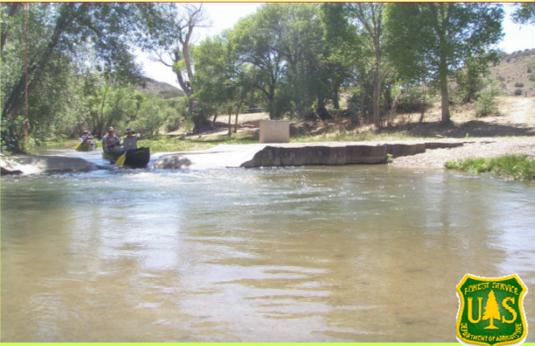
Photos of electro fishing. Sillas, Albert USFS [mailto:asillas@fs.fed.us] 2010 Mile 3.2

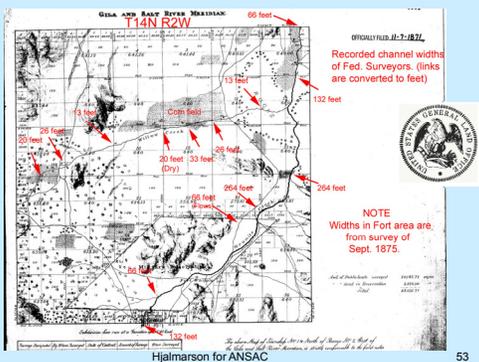
Sample plat-- one of many used for ANSAC analysis

Cultivated acres were determined along intermittent and perennial Granite Creek, Williamson Valley Creek and Walnut Creek using the original Federal Land Survey plats and field notes on file at the Government Land Office (GLO).

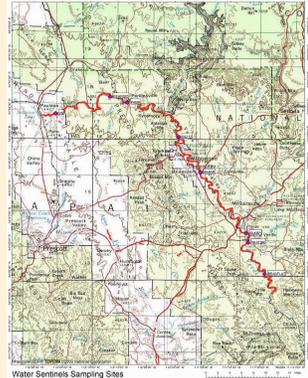
Water Sentinels Sampling Sites

Miles	Site	Q cfs	W ft
9.8	Paulden gage	*	*
10.2		*	*
10.4		*	*
10.8	SR01	17.46	19.7
11.0	SR02	16.35	22.4
11.5	SR03	*	*
13.0	SR04	18.27	25.0
16.0	SR05	16.00	14.0
17.0	SR06	14.42	20.0
18.0	SR07	16.49	12.0
19.4			52.0
19.7	SR08	11.85	*
20.5	SR09	11.59	24.0
21.3	SR09A	11.86	12.5
22.0	SR10	11.42	11.0
22.8	SR11	12.9	23.0
23.7	SR12	13.9	9.8
