NAVIGABILITY ALONG THE NATURAL CHANNEL OF THE VERDE RIVER, AZ -- ANSAC --

Win Hjalmarson, PE Oct. 2014
For ACLPI

**Was the Verde River
susceptible to navigation
at the time of Arizona statehood
(February 14, 1912)
in its ordinary
and natural condition ?**

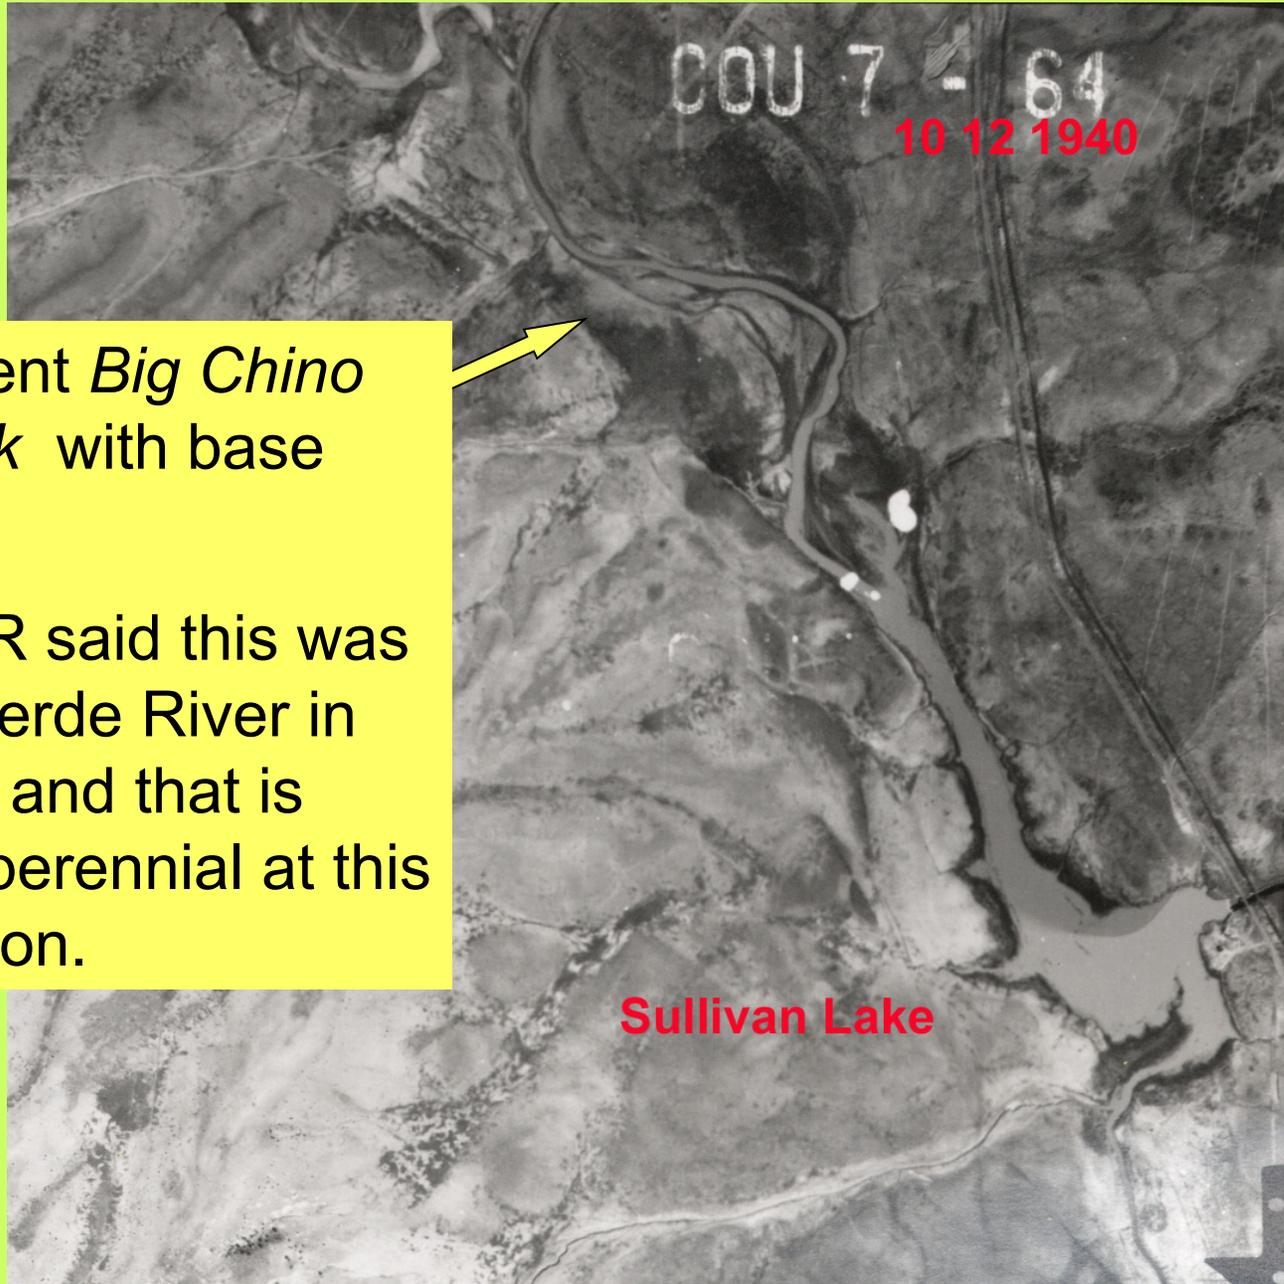
Present *Big Chino Creek* with base flow.

USBR said this was the Verde River in 1946 and that it was perennial at this location.

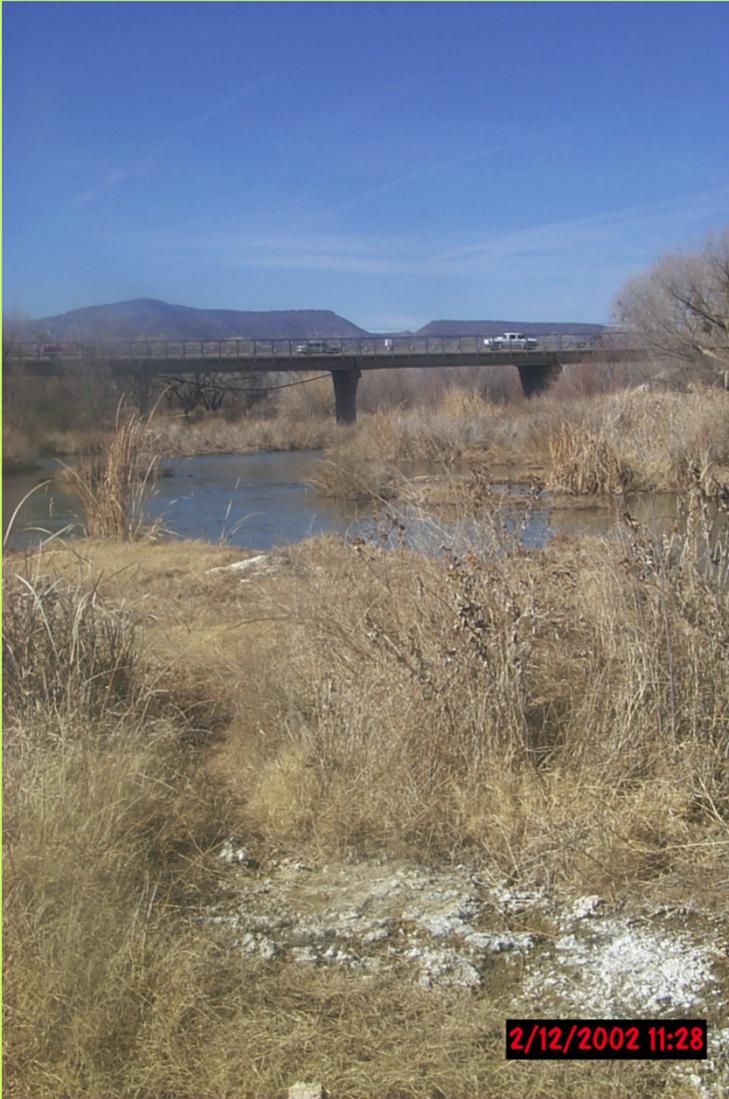
View looking upstream at Verde River Channel from below Black bridge in Camp Verde. The river channel has scoured through the alluvial sediments (Holocene material) into the Verde Formation (light colored material).

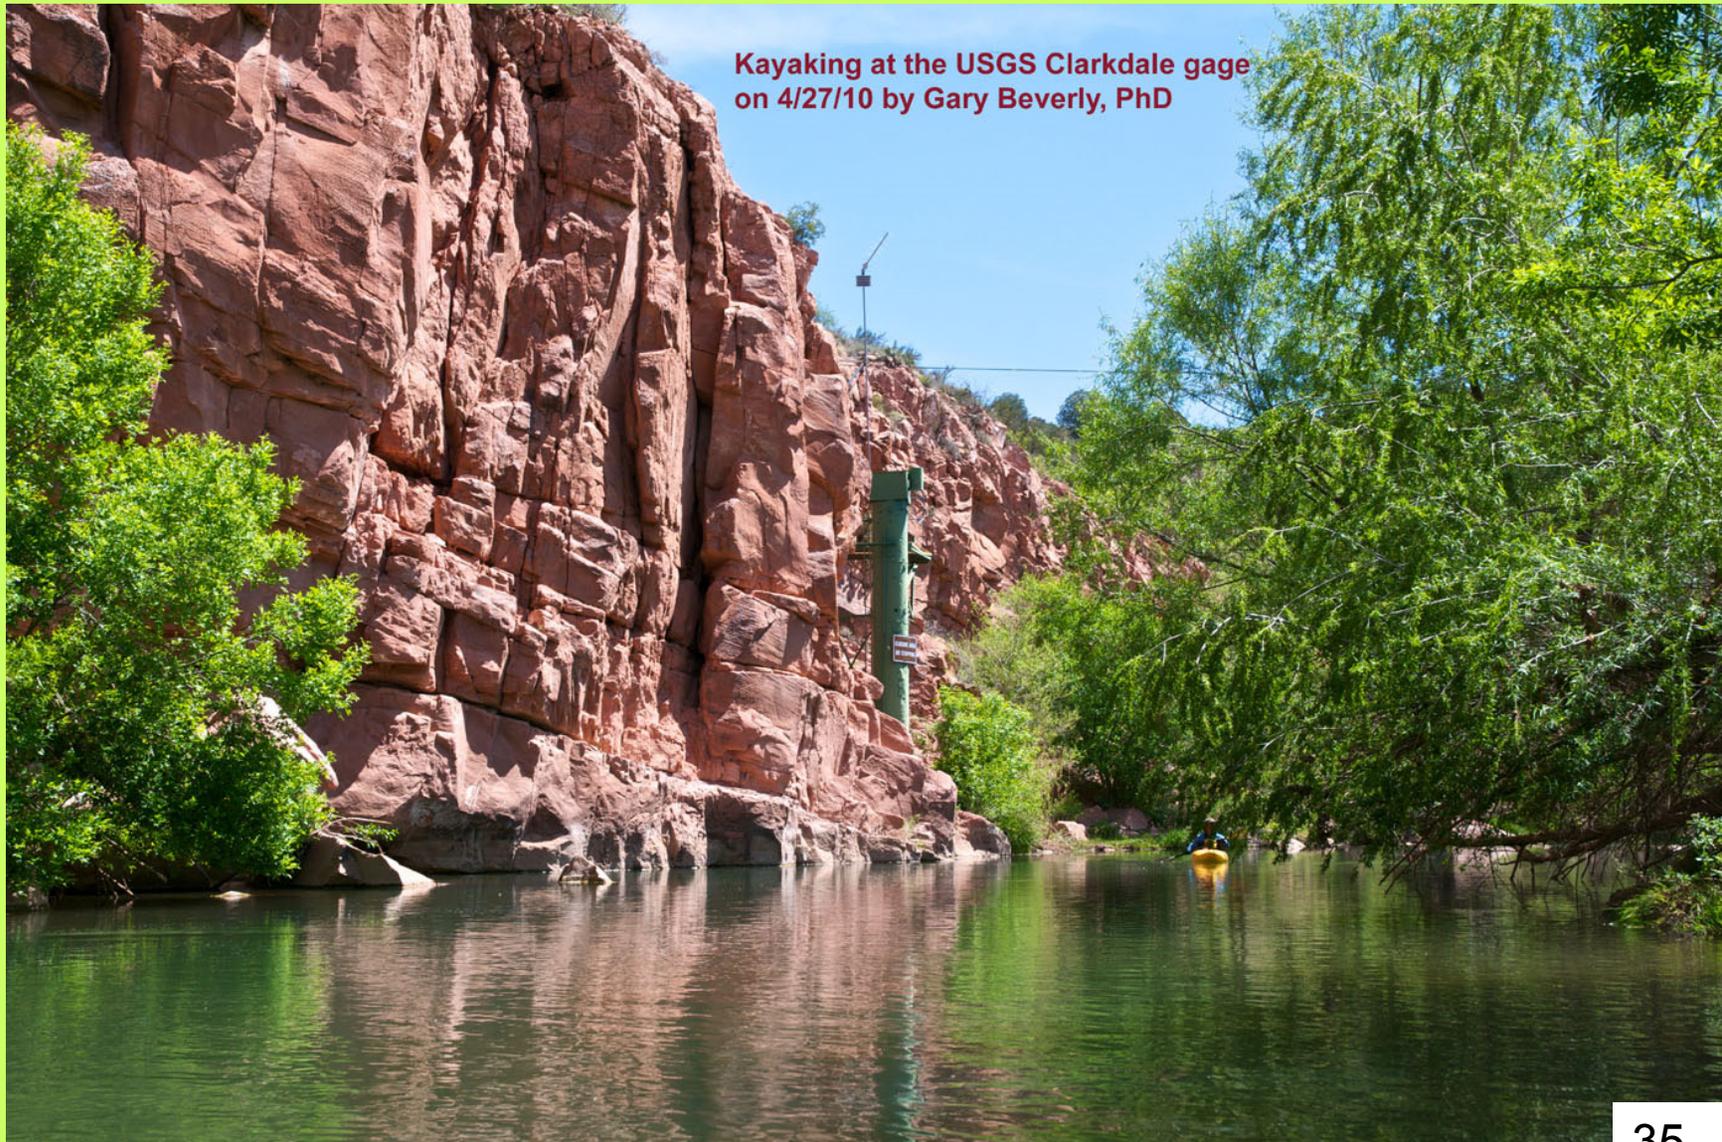
Clarkdale gage

The riffle to the left “drowns out” as discharge increases as shown in the photo below. It’s common for riffles and “section controls”, where critical velocities exist, to become channel controls with sub-critical flow velocities as stage increases. Thus, I would expect fewer riffles under natural when the base flow was large.

Verde River at USGS gage 09504000. View looking down and upstream. Q = 67 cfs.

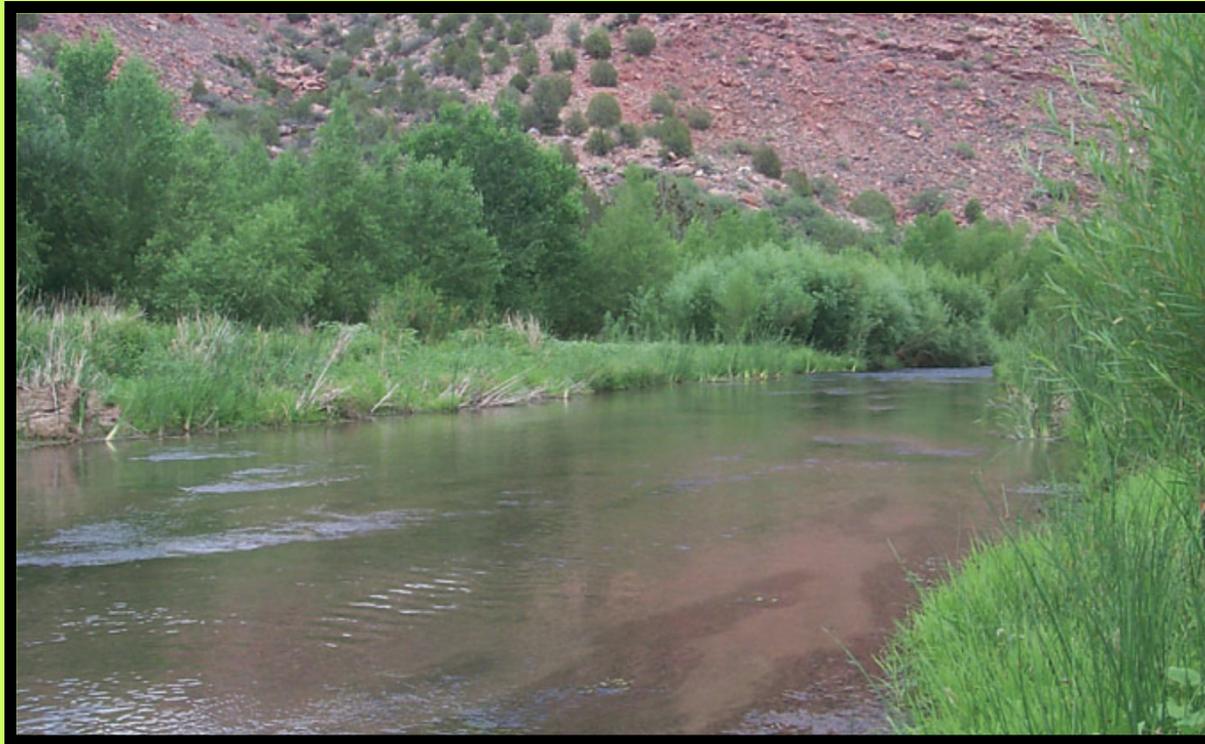
Pools along the river act as small sediment traps that partially fill during small discharges and are flushed during large discharges.

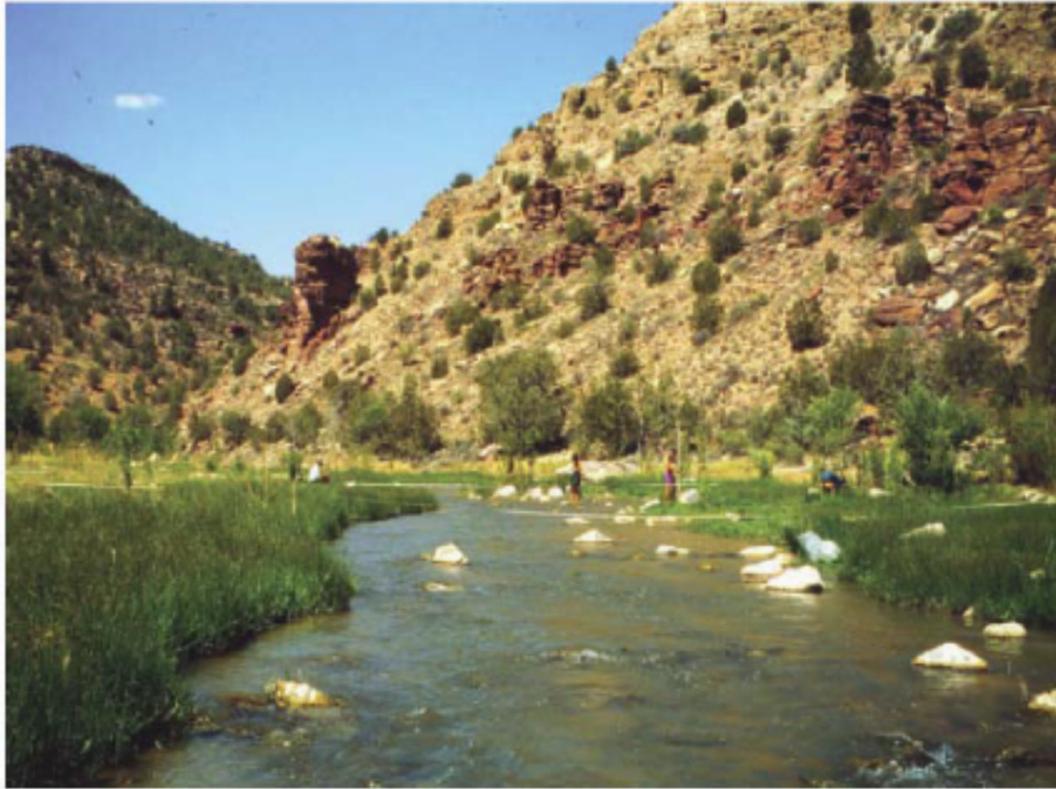
Figure 5.3—Limestone and siltstone bedrock near Duff Springs in the UVR. (Photo by Alvin L. Medina.)

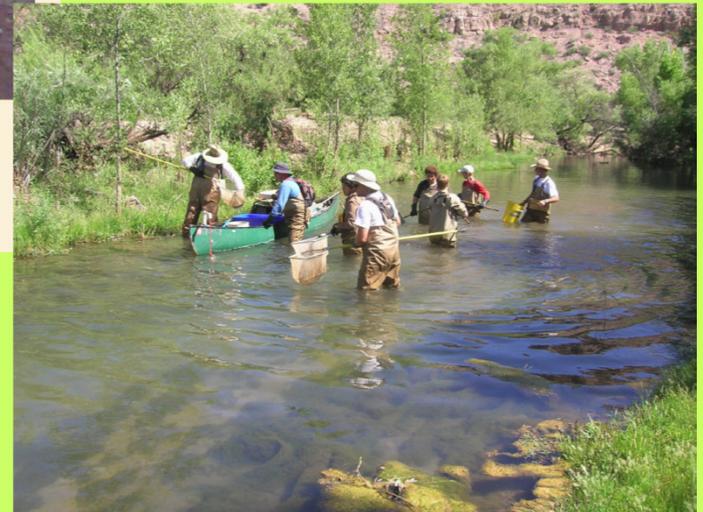
Vegetation along the banks tends to stabilize channel banks and cause scour of the main channel. This scene is along the upper Verde following the 1993 flood. Flood debris (of 1993 flood) is on the trees with a beaver fallen tree in the left bank foreground of the scene. All along the Verde River the main channel bed generally stabilized and recovered to a navigable channel within days after the 1993 flood.

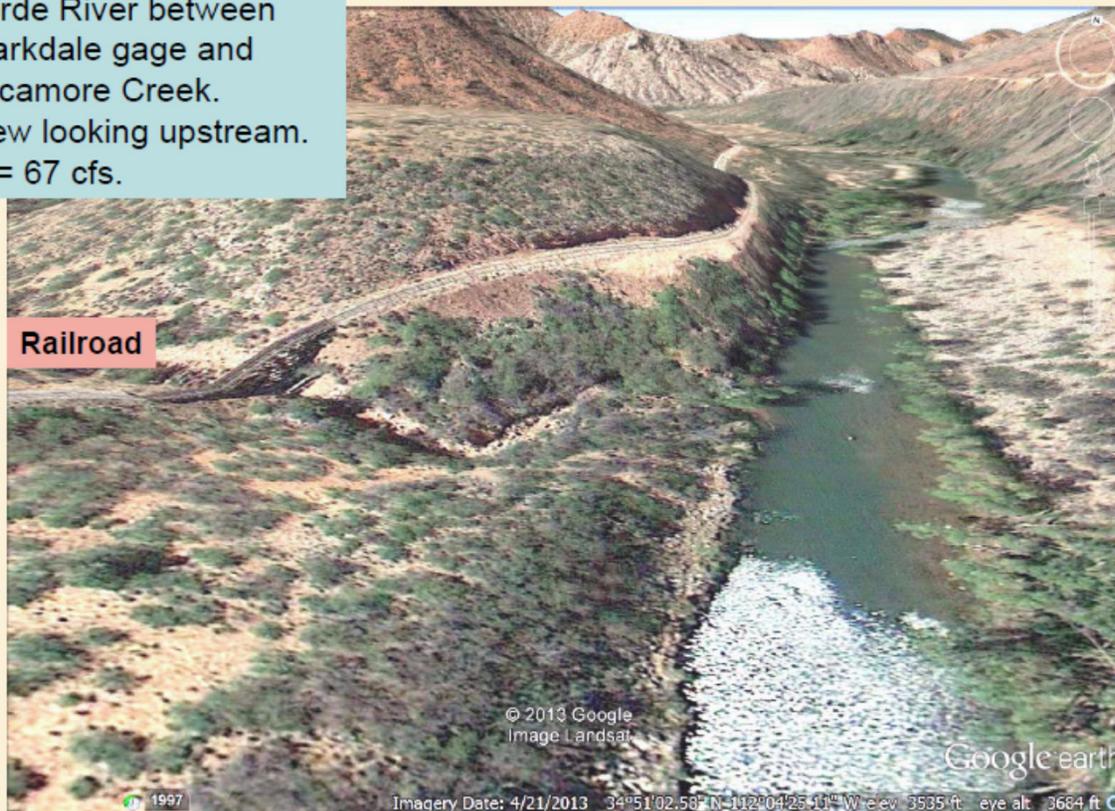
The Verde River is a pool and riffle gravel-cobble bed stream. A typical riffle is shown below at the mouth of the tributary stream where tributary sediment has been deposited.

Verde River between
Clarkdale gage and
Sycamore Creek.
View looking upstream.
Q = 67 cfs.

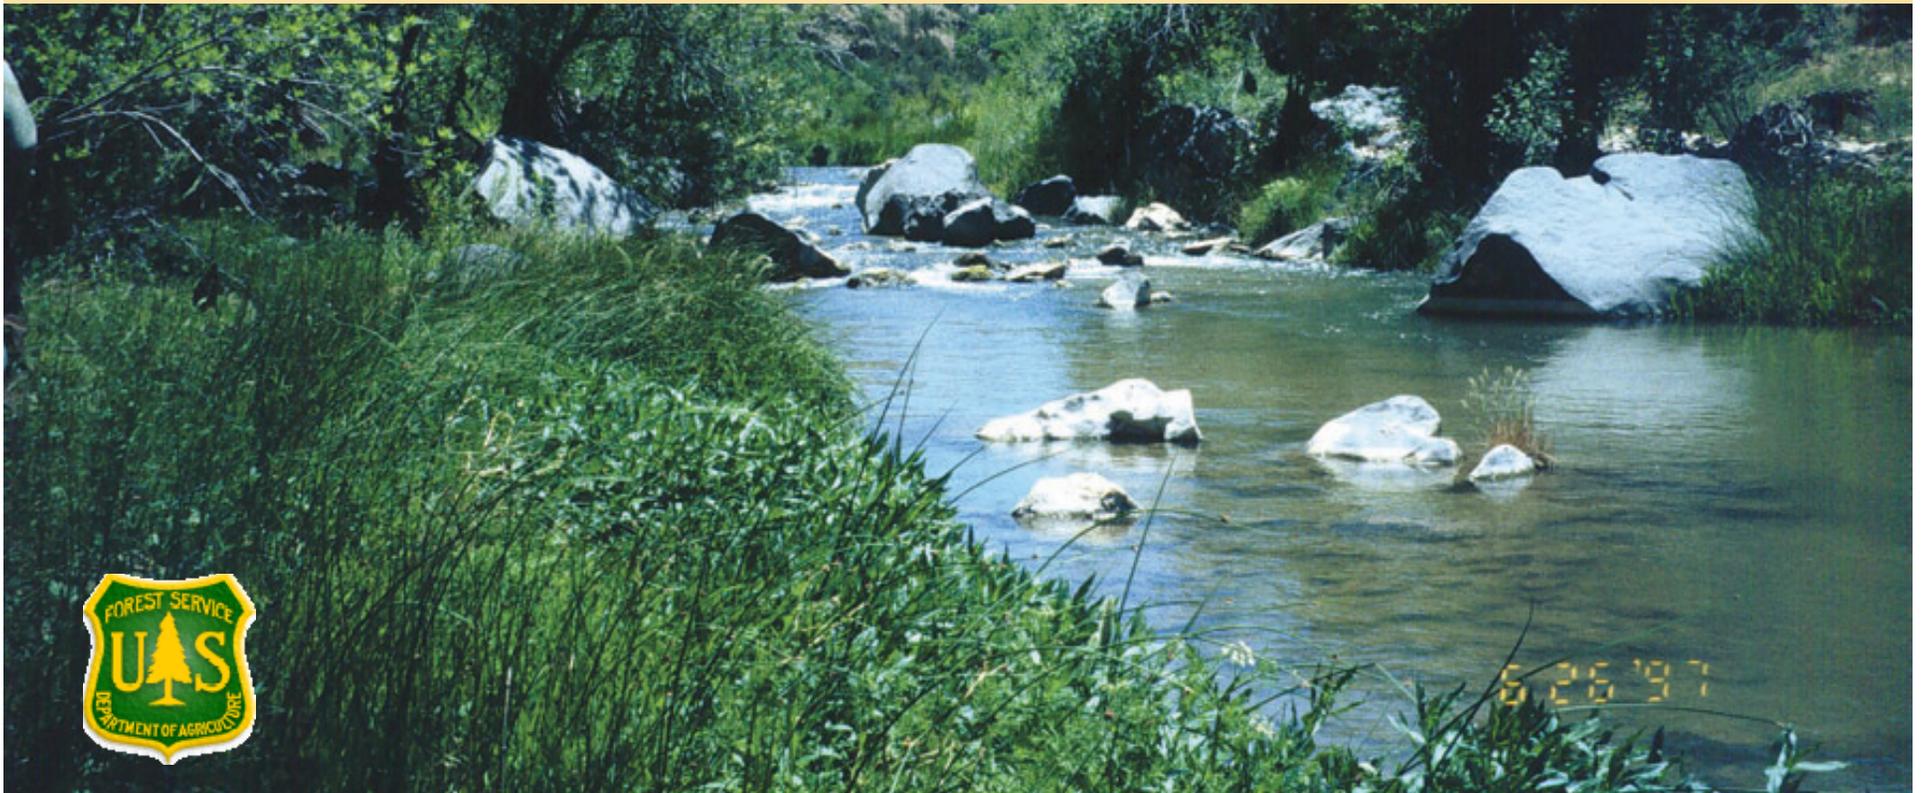
Large debris (boulders) from side slopes. Obviously only very large high (kinetic) energy flow will move such large obstructions. Also, energy is lost (with a corresponding decrease of velocity and increase in depth) as streamflow encounters this rough channel material.
