CHANNEL CHANGE IN SOUTHERN ARIZONA--
IMPLICATIONS FOR FLOODPLAIN MANAGEMENT

Marie S. Pearthree
Pima County Department of Transportation
and Flood Control District

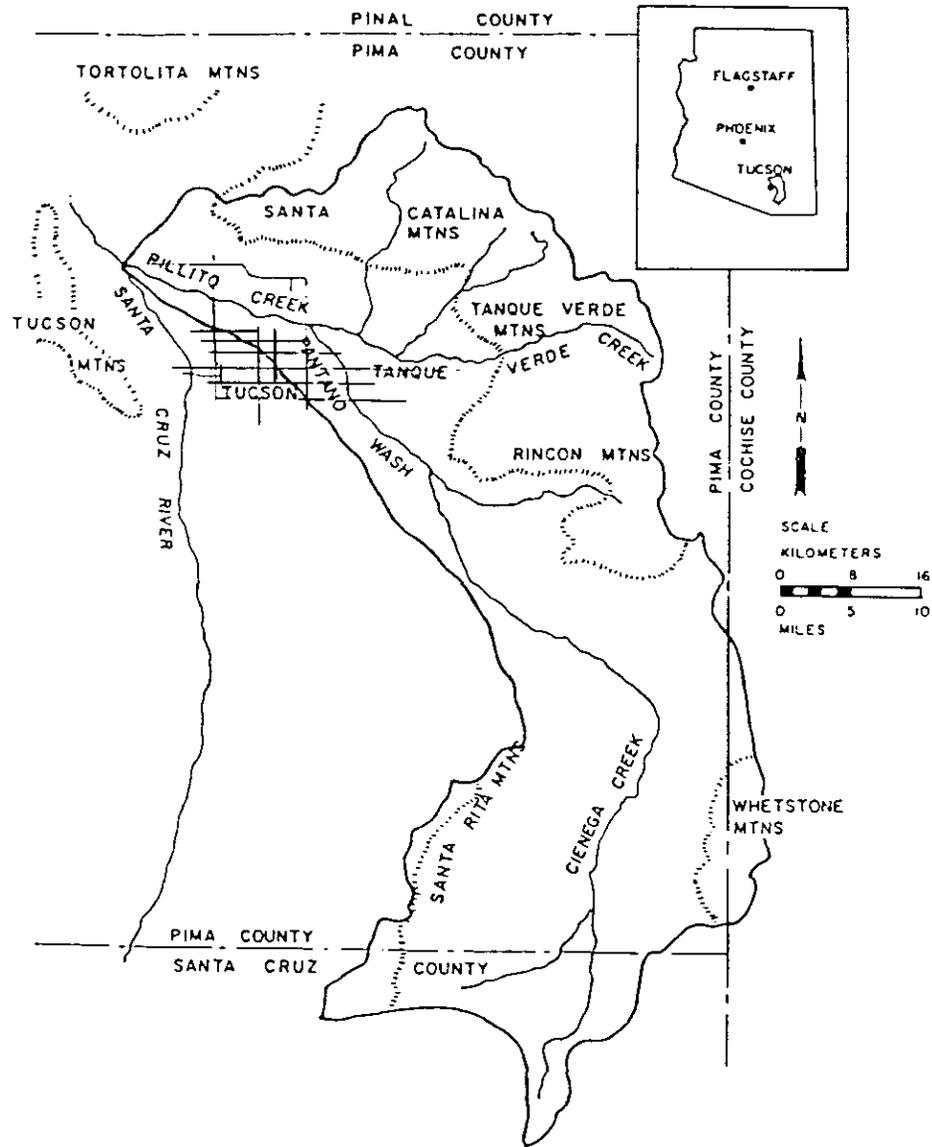
FIGURE 1. Map of the Rillito Creek watershed.

The Rillito Creek system drains approximately 934 square miles (2419 square kilometers) of southeastern Arizona (see Figure 1). The watershed consists of large lowland areas surrounded by mountains, with elevations ranging from 2200 feet (690 m) to 9450 feet (2880 m). Vegetal cover varies from the Sonoran Desert communities of creosote bush, desert saltbush, and cacti in the lower-lying basin and foothill areas, to evergreen forest at the

Along the Santa Cruz River, to which Rillito Creek is tributary (Figure 1), preliminary erosion hazard boundary maps have been compiled based on qualitative and quantitative analyses of channel bank erosion and lateral channel migration (see Figure 7). These analyses have included investigations of historical channel positions and erosional sites seen on aerial photographs, and have considered present channel patterns, locations of sand and gravel operations, landfill sites, and existing and planned bank stabilization measures. When adopted by the Pima County Floodplain Management Board, these maps will be used to restrain urban development within zones determined to have a high potential short-term and long-term channel bank erosion and lateral channel migration. Where erosion hazard limits exceed mapped floodway and 100-year floodplain limits, the erosion hazard limits will form the basis for regulating development adjacent to the stream channels, as these represent estimated worst possible flooding and erosional conditions.

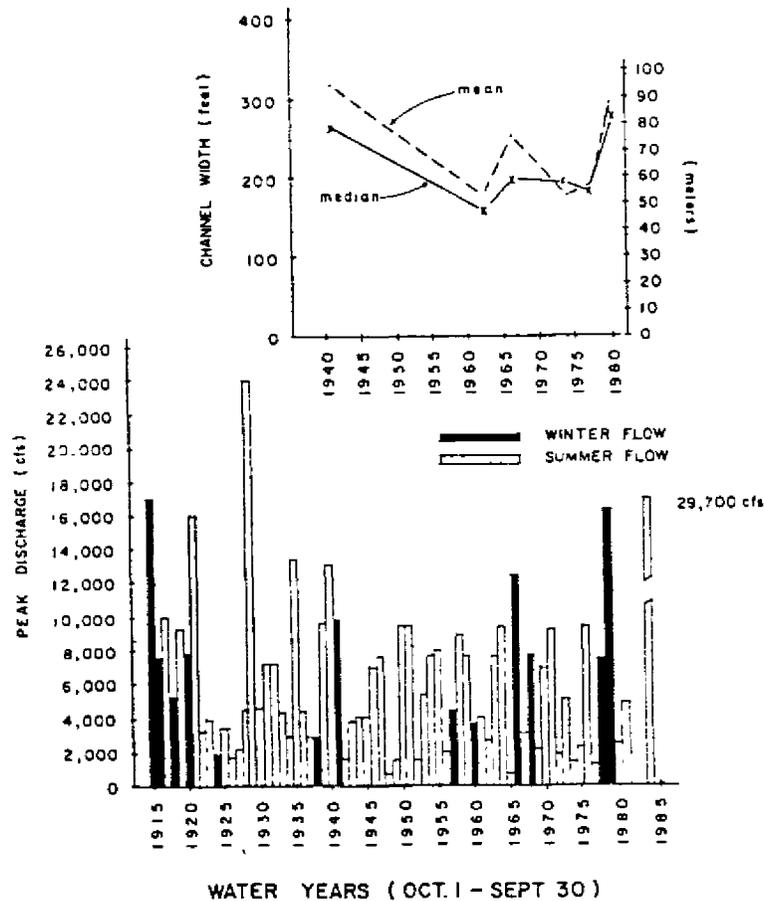
FIGURE 2. Variations in the mean and median widths of Rillito Creek from 1941 to late 1979 (upper graph) correlated with annual peak flows recorded at the Rillito Creek near Tucson gauging station (lower graph).

As in all semiarid regions, streamflow in the Rillito Creek system is extremely variable, due primarily to differences in watershed topography and to the temporal and spatial distribution of rainfall. Annual peak flow records are generally dominated by low flows with a few years of high flows (see Figure 2).

(Pearthree, 1982). Aerial photographs taken from 1941 through 1983 were utilized to investigate historical channel change in addition to longitudinal streambed profiles, annual peak flow records, climatic records, and historical observations. Variability of channel width along this stream system from 1941 to late 1979 is summarized in Table 1, and Figure 2 illustrates the correlation between directions of change in channel width and magnitudes of streamflow for the same time period.

In December of 1978, Rillito Creek and Tanque Verde Creek once again widened extensively (see both Figure 2 and Table 1). As in 1965, a winter storm over the Tanque Verde Creek watershed produced streamflow that included snowmelt. Little sediment was readily available for transport within the channels, having been removed by previous flow in March, 1978 (T. Maddock, Jr., University of Arizona, written communication, 1980). As a result, this flow eroded up to 190 feet (57 m) of the channel banks, and the streambed of Rillito Creek aggraded locally as much as 7.5 feet (2.3 m). The recurrence interval of this event was estimated at 22 to 24 years in Tanque Verde Creek and 20 years in Rillito Creek (B.A. Aldridge, U.S. Geological Survey, verbal communication, 1981). Channel recovery and reconstruction also followed this event.

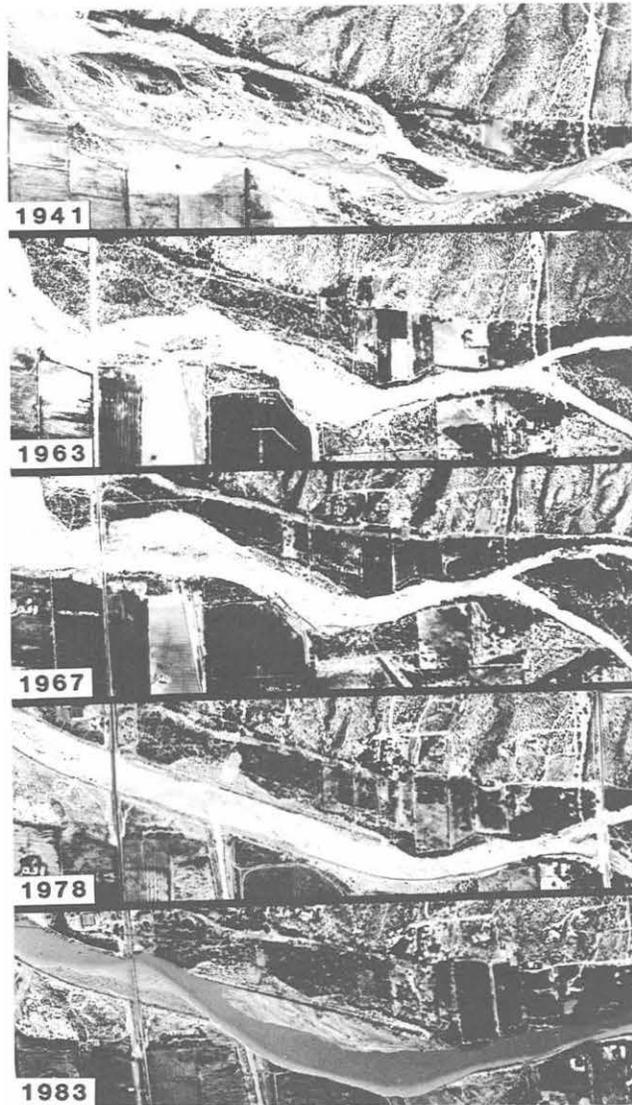
FIGURE 3. Channel change along Rillito Creek from 1941 to 1983 downstream of the confluence of Pantano Wash and Tanque Verde Creek from Craycroft Road to Swan Road. Note the change in plan-view pattern from 1941 to 1963. Extreme channel bank erosion resulting from the December, 1965 flow event is shown in the 1967 photograph. The 1978 photograph shows a smooth channel alignment produced by channel excavation and protection of the banks primarily with wired rock riprap, which failed in the October, 1983 flood event.

1900's when arroyo-cutting prevalent throughout the Southwest initiated channel entrenchment (Cooke and Reeves, 1976). Prior to 1941, the Rillito Creek system exhibited braided channel patterns resulting from extended periods of drought followed by one or more wet years (see Figure 3). Between 1941 and the early 1960's, single channel patterns developed in response to low-magnitude summer flows.

In contrast, Tanque Verde Creek and Rillito Creek have widened and narrowed in cyclical fashion (Figure 3). In December, 1965, the fourth storm in a series of five consecutive winter storms produced a flow event with an estimated recurrence interval of 27 years in Tanque Verde Creek and 16 years in Rillito Creek (Aldridge, 1970). Runoff was augmented by snowmelt from the higher elevations of the watershed. Extreme channel bank erosion ranging up to 680 feet (107 m) occurred along both stream channels in conjunction with general channel widening (Figures 3 and 4), resulting in 1.25 million dollars in damages (Arizona Daily Star, 1965). The largest increases in channel width were produced by erosion of the concave banks of channel bends, which migrated in the downstream direction. Following this event, many of the eroded areas recovered naturally through sediment deposition and growth of vegetation or were reconstructed artificially with fill material and bank stabilization measures such as rock riprap and wire fence revetments.

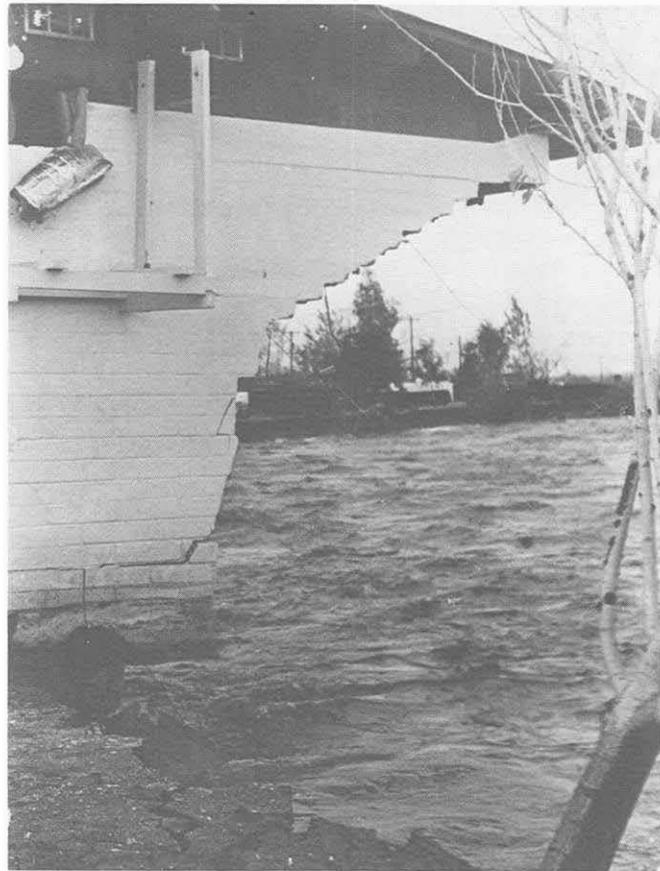
FIGURE 4. House being undercut by Rillito Creek in December, 1965. Photograph taken by L.O. "Pat" Henry, courtesy of Special Collections, University of Arizona Library.

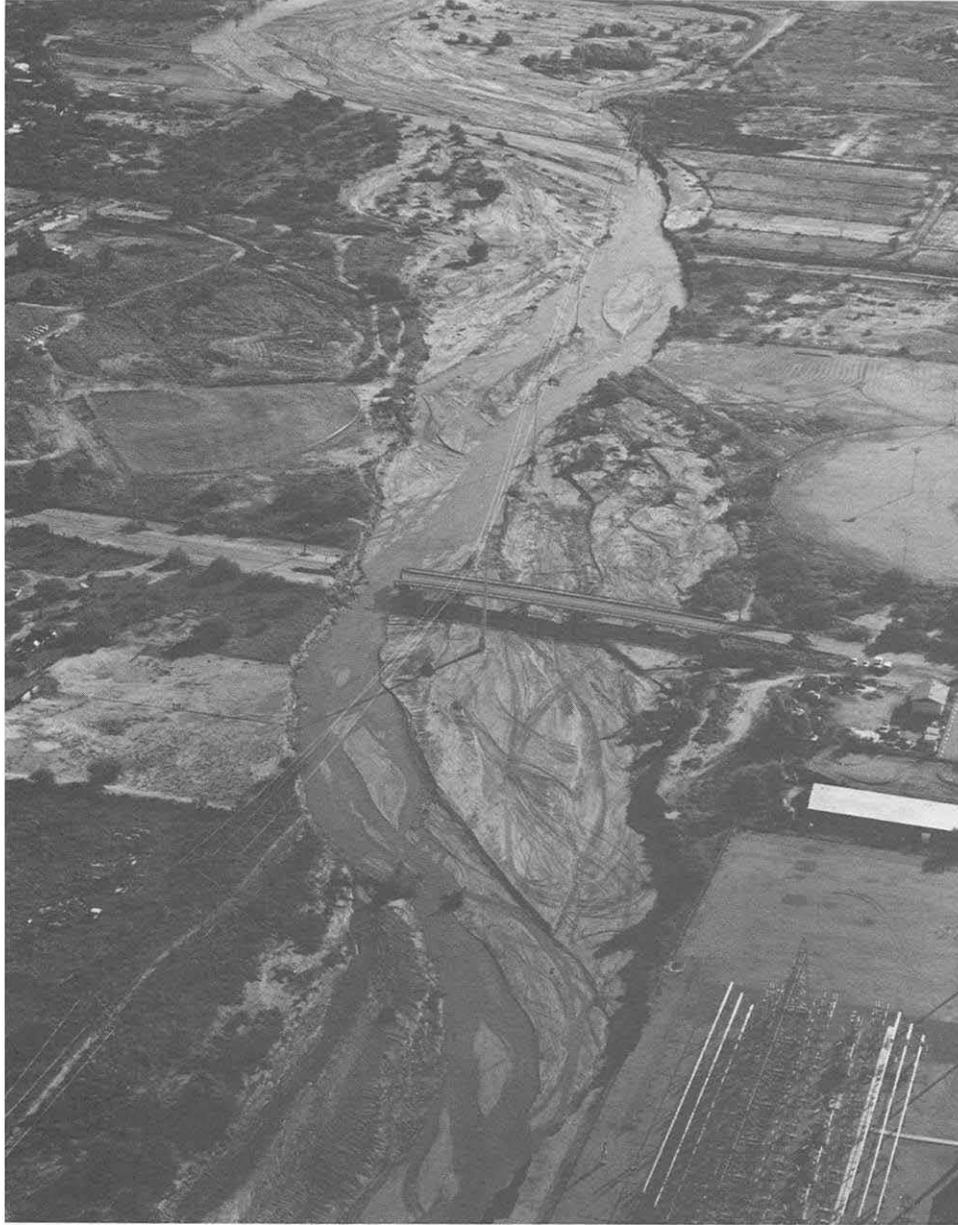
FIGURE 5. Damage to the northern (left) abutment of the Dodge Road bridge across Rillito Creek caused by channel bank erosion and lateral channel migration in October, 1983. Note the threat to the electric utility station on the opposite bank downstream. Photograph by Peter Kresan.

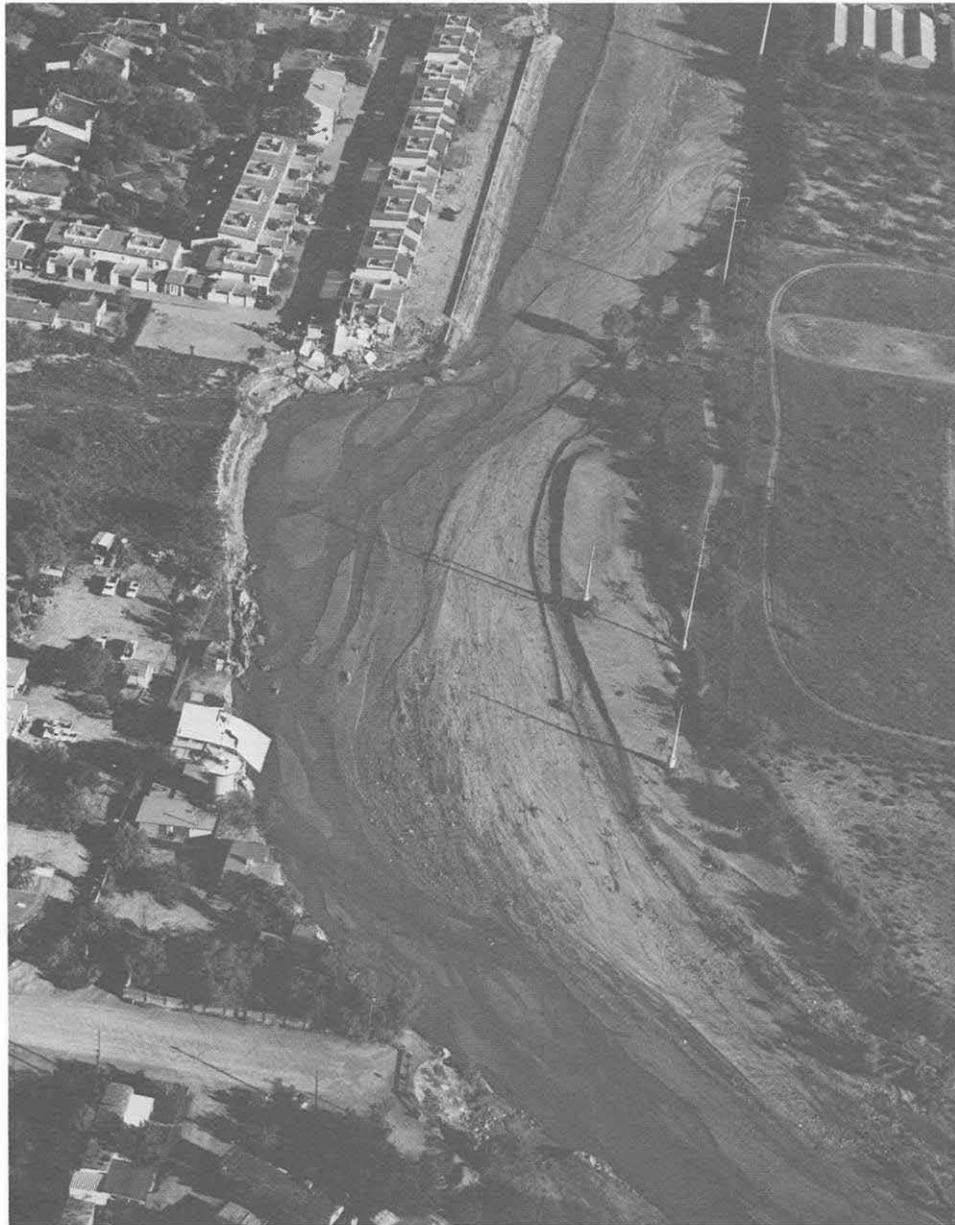
FIGURE 6. Damage to the Pima Park Townhomes caused by lateral migration of a prominent meander bend of Rillito Creek. Erosion occurred behind the soil cement bank protection shown adjacent to the townhomes, leading to its failure. Photograph by Peter Kresan.

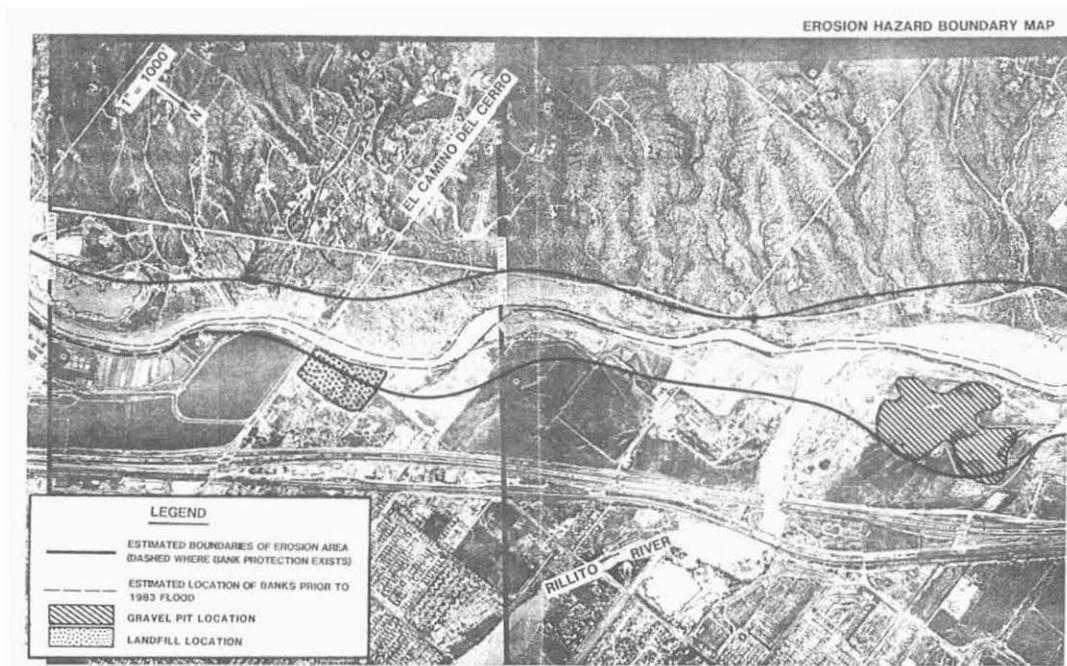
FIGURE 7. Erosion hazard boundary map for the Santa Cruz River at its confluence with Rillito Creek.
