Declaration Navigability of the Upper Salt River

Submitted To: Salt River Project
PO Box 52025
Phoenix, Arizona 85072-2025

Submitted by:   Robert A. Mussetter, PhD, PE
TETRA TECH
3801 Automation Way, Suite 100
Fort Collins, CO 80525

May 12, 2014

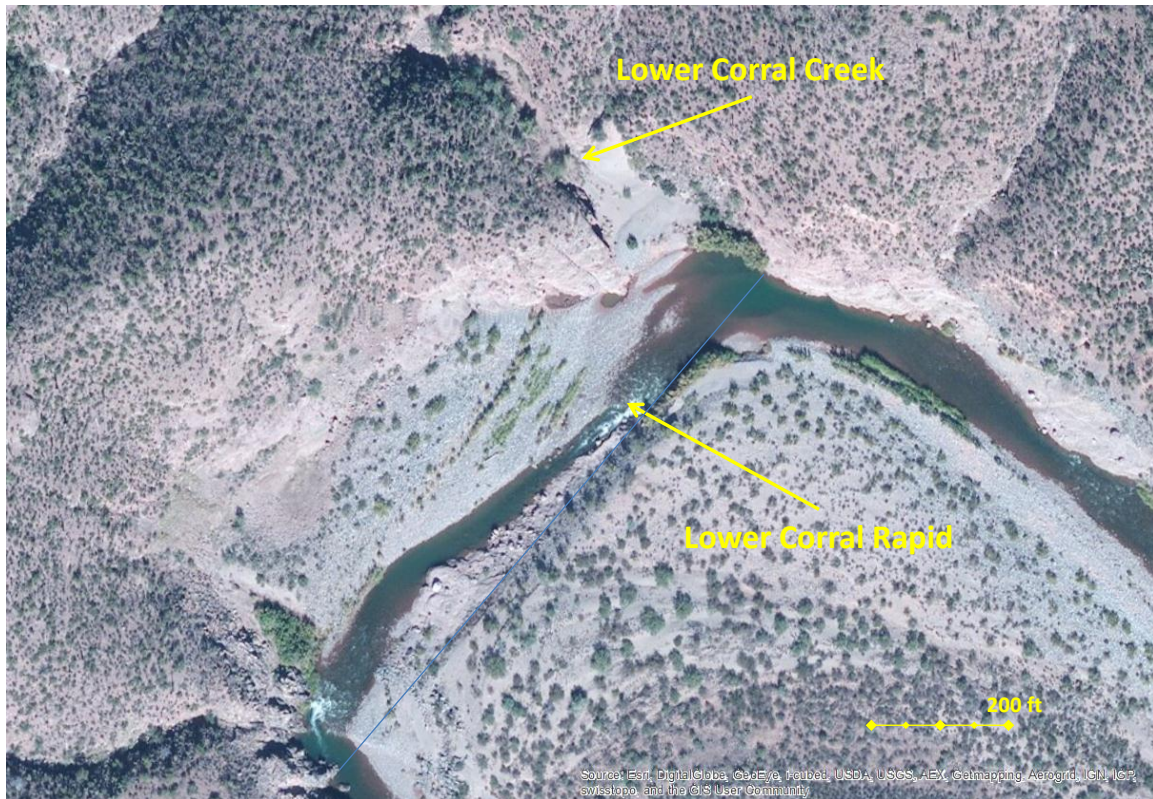
Figure 8. Aerial view of mouth of Lower Corral Creek and rapid (same name, ~RM 90.6) illustrating a typical location where sediment and debris from tributary constricts the river (Photo taken November 1, 2010; Discharge ~140 cfs).

Within the canyon-bound reach, bedrock is exposed in both the bed and banks of the river in many locations, providing direct vertical and lateral control that creates steep drops in the river bed elevation that form rapids (**Figures 6 and 7**). In many other locations, large caliber sediment and debris from the adjacent side canyons constrict the river (**Figures 8 and 9**). The large, mostly immobile debris controls the vertical profile, creating steep drops in bed elevation and rapids. In still other locations, constrictions in the valley width and bends in the valley alignment create upstream backwater⁶ conditions at high flows when coarse-grained sediment is being transported, causing the transported sediment to deposit and form large cobble bars. During subsequent lower flows, the river is constricted to a relatively narrow channel along the sides (or in some cases, across the middle) of the bars, forming rapids or shallow riffles (**Figures 10 and 11**). In many instances, large boulders that have fallen from the bedrock valley walls in the above-described areas create additional roughness and hazards to navigation. In all cases, the rapids and riffles represent significant impediments to navigation by the watercrafts that were in use at and prior to the time of Arizona's statehood.

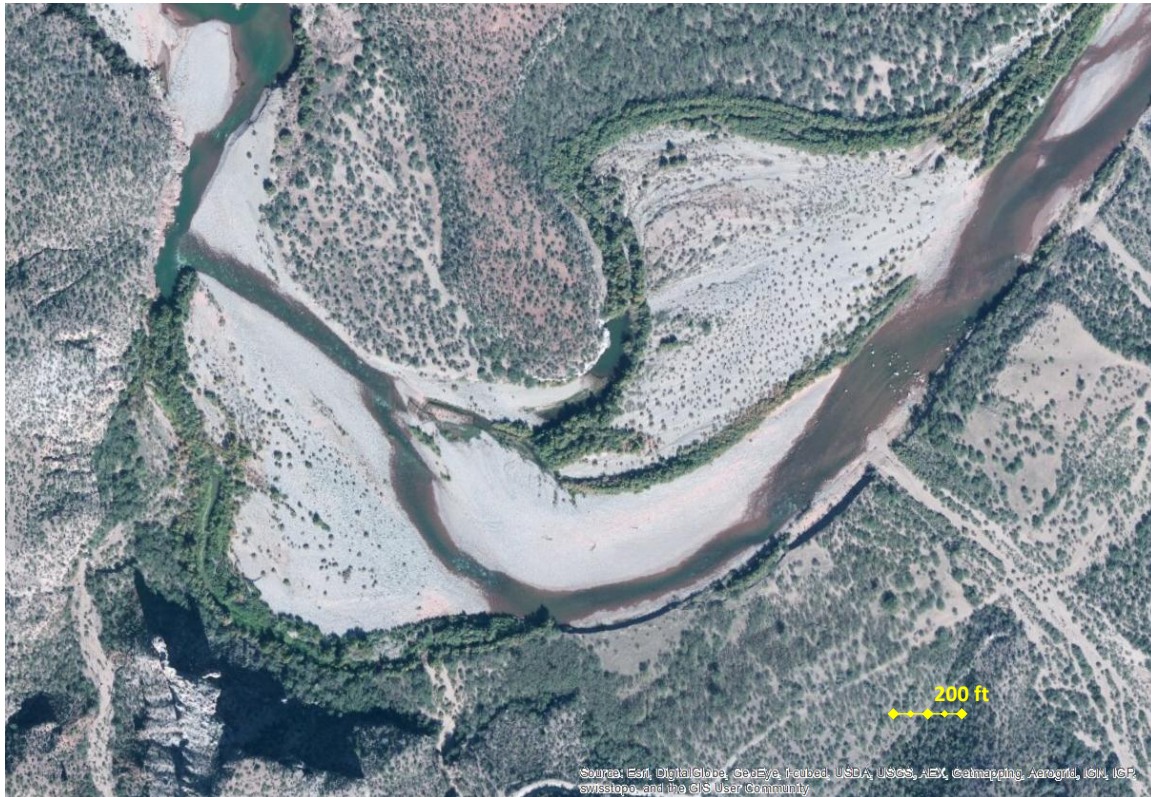
Figure 10. Aerial view of apex of Horseshoe Bend Rapid (~RM 81) showing a typical backwater-formed gravel bar and shallow riffles/rapids (Photo taken November 1, 2010; Discharge ~140 cfs).

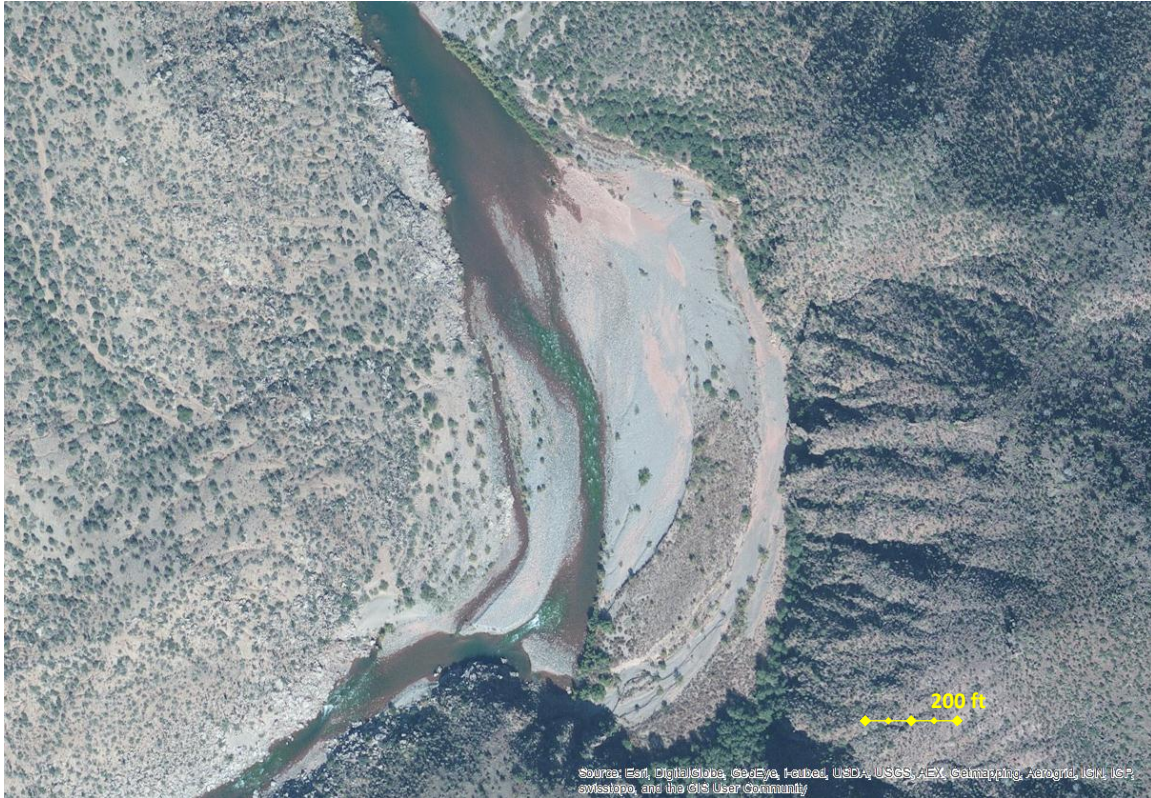
Figure 11. Aerial view of apex of portion of Upper Salt River near RM 105 showing a typical backwater-formed gravel bar and shallow riffles/rapids (Photo taken November 1, 2010; Discharge ~140 cfs).

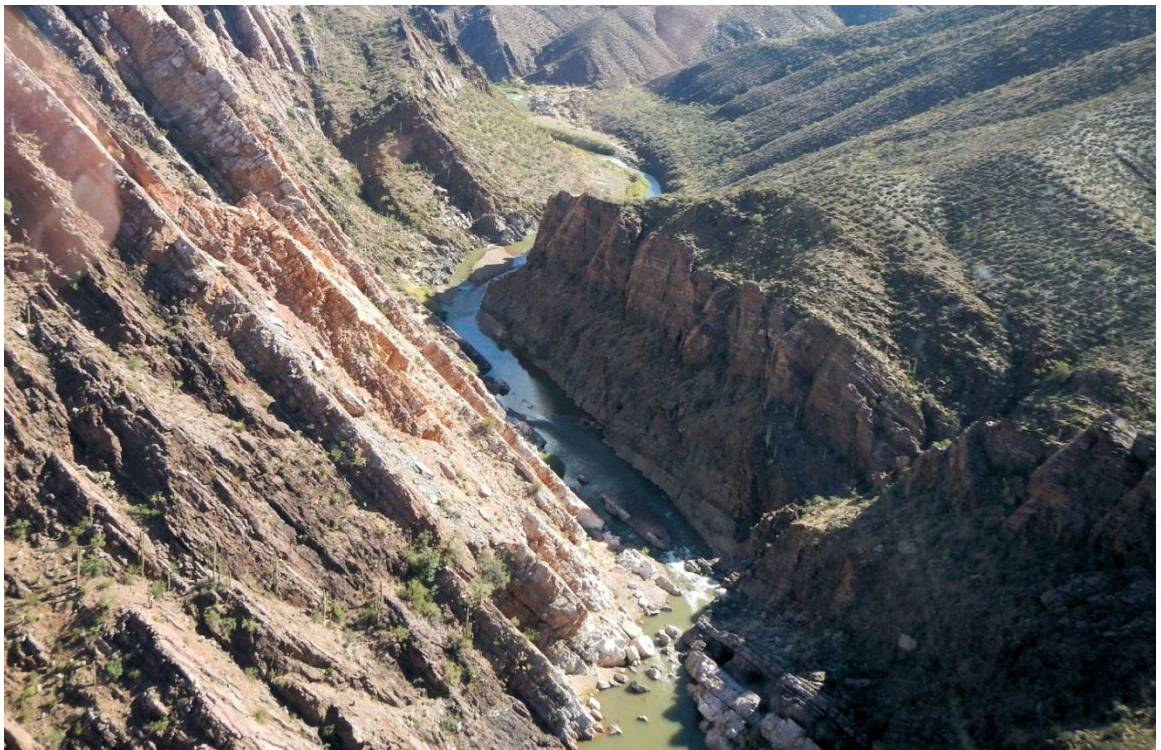
Figure 12. View looking upstream of Quartzite Rapid (lower, center) (Photo by B. Mussetter, October 29, 2013).

The USFS (1995) guide contains descriptions of at least 23 named rapids in the approximately 36-mile reach downstream from Highway 60. One of these rapids (Quartzite Falls, Figure 4, **Figure 12**) is notoriously dangerous, even for skilled whitewater boaters. This rapid required a difficult portage to pass prior its being surreptitiously modified by blasting in 1998, an act for which eight men were convicted for damaging government property. The individuals responsible for the blasting allegedly did so to remove the impediment to navigation out of concern for public safety, as a number of people had drowned attempting to navigate the rapid. Even after the blasting, this rapid remains one of the most challenging on the river.

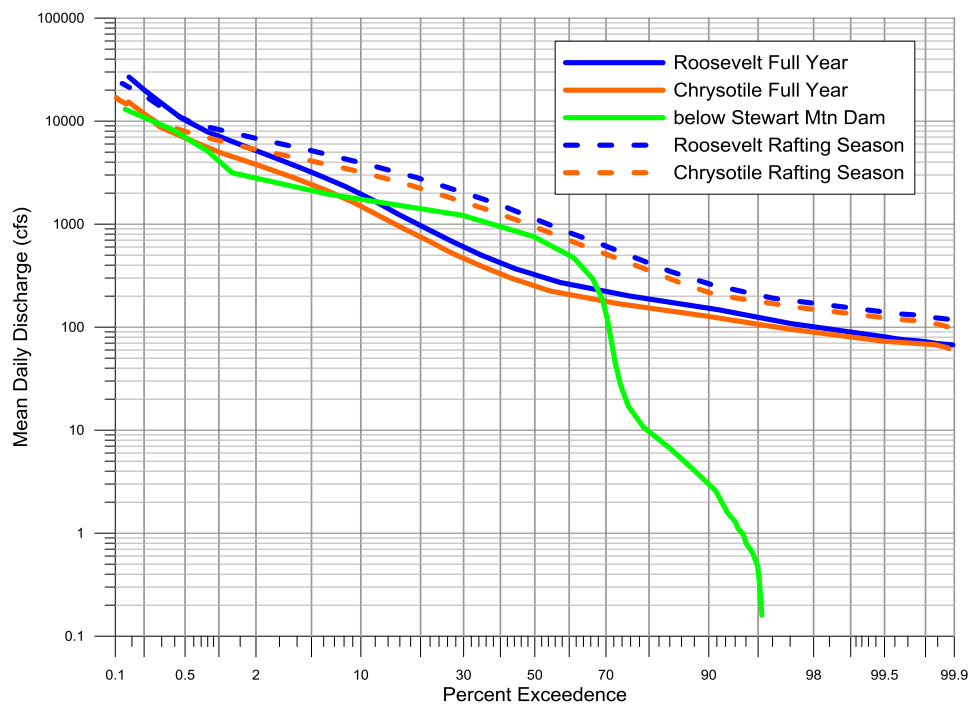
Figure 13. Mean daily flow duration curves for the *Salt River near Roosevelt* (USGS Gage No. 9498500) and *near Chrysotile* (USGS Gage No. 9497500) gages for complete water years and during the primary whitewater rafting season (March 1 – May 15).

Based on the data from the Salt River near Roosevelt and Salt River near Chrysotile gages (USGS Gage Nos. 9498500 and 9497500, respectively) that are located near the Highway 288 and Highway 60 Bridges, respectively, the discharge in this part of the reach is less than 400 cfs about 60 percent of the time, on average, over the entire year and about 20 percent of the time during the typical rafting season (**Figure 13**).

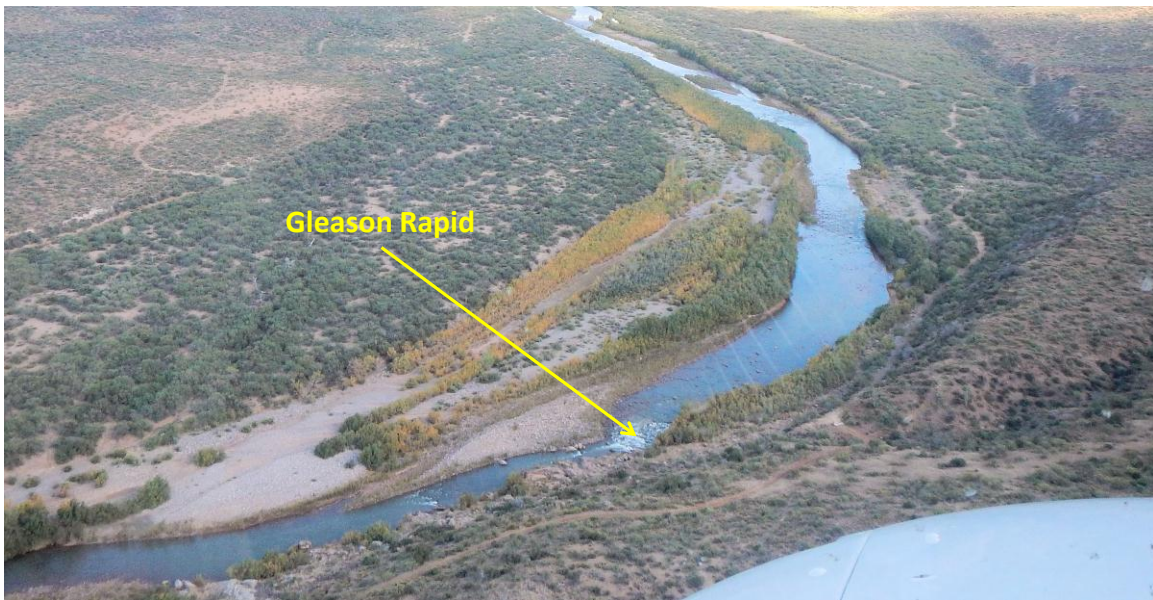
Figure 14. View looking upstream of the middle portion of Gleason Flats and Gleason Rapid (Photo by B. Mussetter, October 29, 2013).

An approximately 3-mile section of the canyon-bound reach between RM 99 and RM 102 known as Gleason Flats is relatively unconfined, and thus, responds to large floods by developing a braided, multi-channel planform with highly variable flow depths, as conceptually described in Section 2.1. Even this portion of the canyon-bound reach contains a named rapid (Gleason Rapid, **Figure 14**) that would have limited navigability.

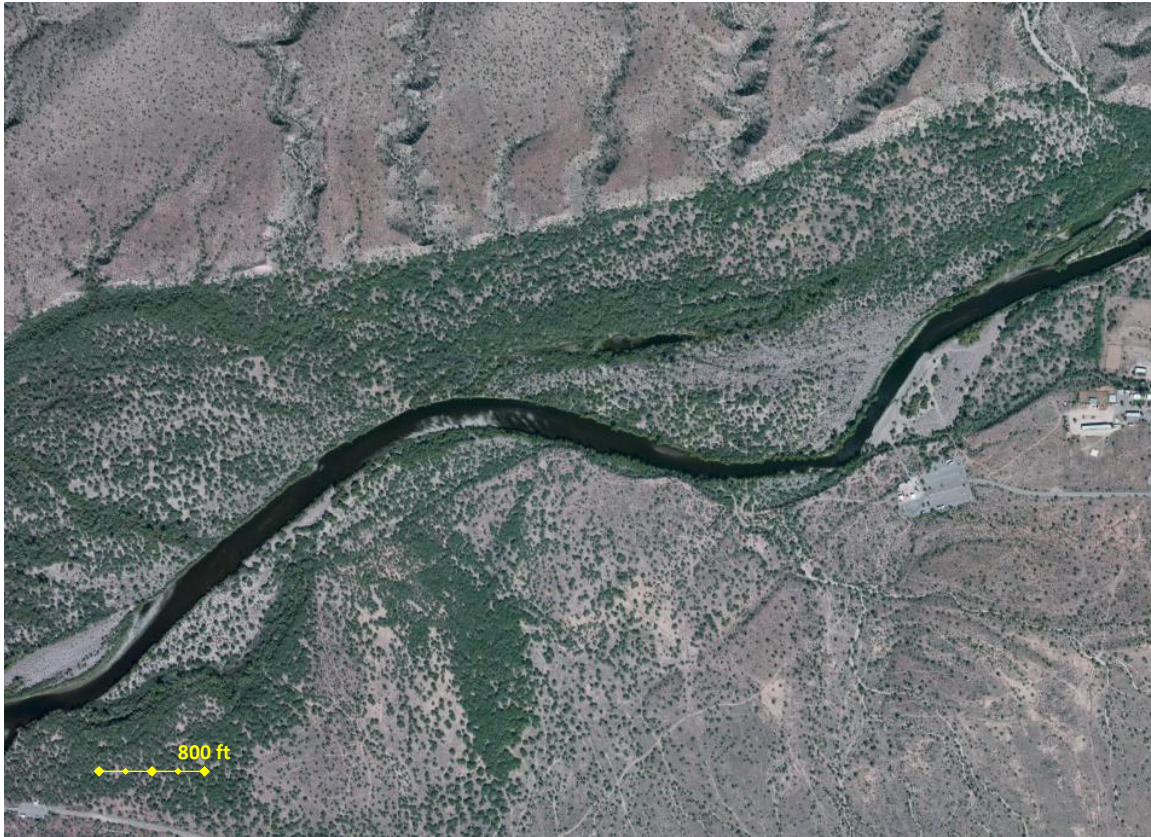
Figure 15. Aerial view of ~2-mile portion of Upper Salt River beginning ~1 mile upstream from Verde River showing typical historic braiding pattern (Photo date November 1, 2010).

The portion of the Upper Salt River between Granite Reef and Stewart Mountain Dams is generally braided, with the braiding corridor occupying much or all of the valley bottom (**Figure 15**). A photo of the same area taken in 1934 shows the same braiding pattern, but with considerably less vegetation (**Figure 16**). The 29-foot high Granite Reef Dam is located at the downstream end of this reach (**Figure 17**). Completed in 1908, this dam would have been a barrier to navigation at the date of Arizona's statehood. The backwater effect of the dam extends about 2 miles upstream (**Figure 18**). Prior to construction of the dam, the backwater-affected portion of the reach would have had wide, braided characteristics that are similar to the remainder of the reach below Stewart Mountain Dam.

Both photos shown in Figures 15 and 16 were taken after completion of the four upstream dams; thus, the geomorphic and vegetation characteristics of the river reflect the significant effects of the upstream flow regulation. Based on the data from the USGS *near Roosevelt* gage that is located upstream from Roosevelt Lake and the *below Stewart Mountain Dam* gage that reflects the effects of the regulation, the upstream facilities significantly reduce the annual peak discharges that create the disturbance regime that removes vegetation and drives the braiding process, but have a less significant effect on the total amount of flow passing through the reach (**Figures 19 and 20**). For the common period of record from Water Year (WY) 1935 through WY2013, the annual peak discharge at the *near Roosevelt* gage exceeded 13,300 cfs in half the years (i.e., the median discharge) and exceeded 60,000 cfs in 13 of the 79 years (~16 percent, or about 1 in 6 years); whereas, the median annual peak discharge at the *below Stewart Mountain Dam* gage was only 2,340 and 60,000 cfs was exceeded only once (WY1980; peak discharge of 64,000 cfs). In comparison, the average annual runoff volume past the *near Roosevelt* gage during this period was about 581,000 ac-ft, and about 667,000 ac-ft at the *below Stewart Mountain Dam* gage⁹. Prior to construction of the dams, large peak flows would

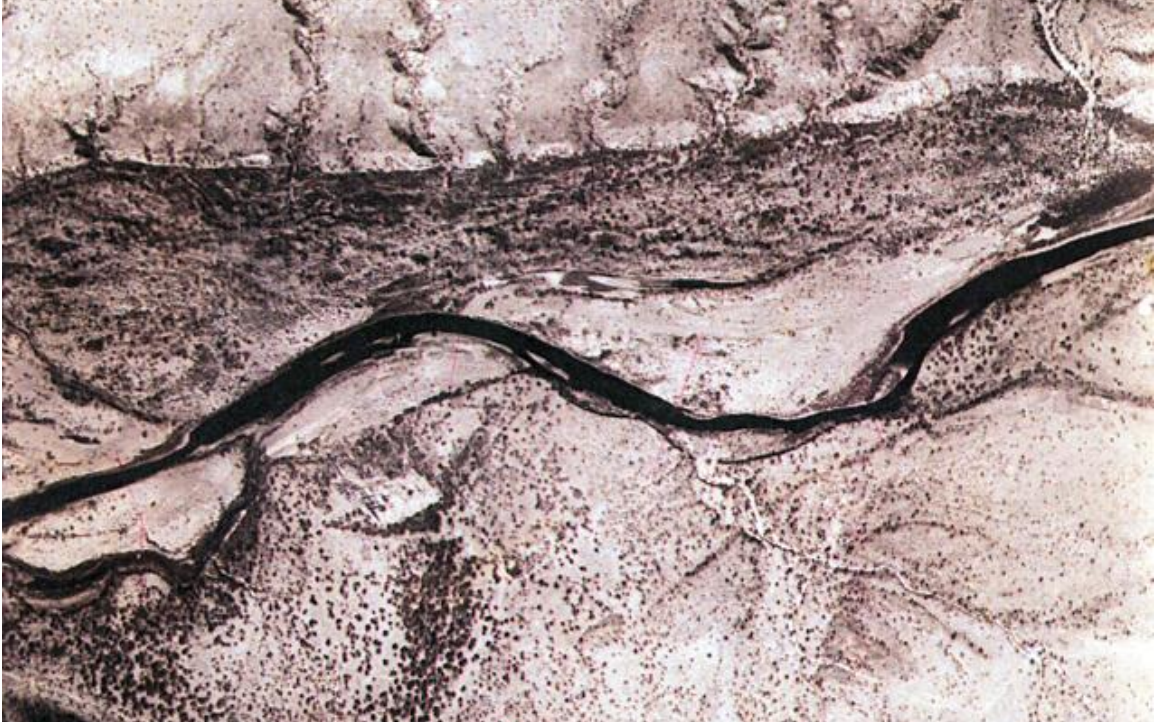
Figure 16. Aerial View of ~2-mile portion of Upper Salt River beginning ~1 mile upstream from Verde River (Photo dated 1934).

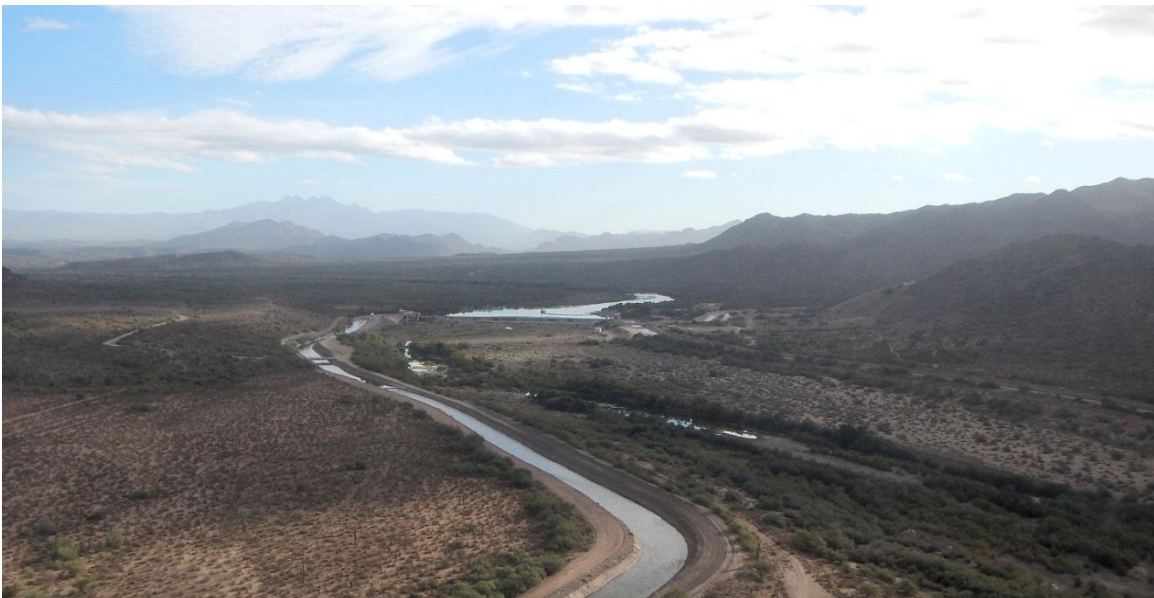
Figure 17. View looking upstream toward Granite Reef Dam (approximate center of photo) (Photo by B. Mussetter, October 29, 2013).

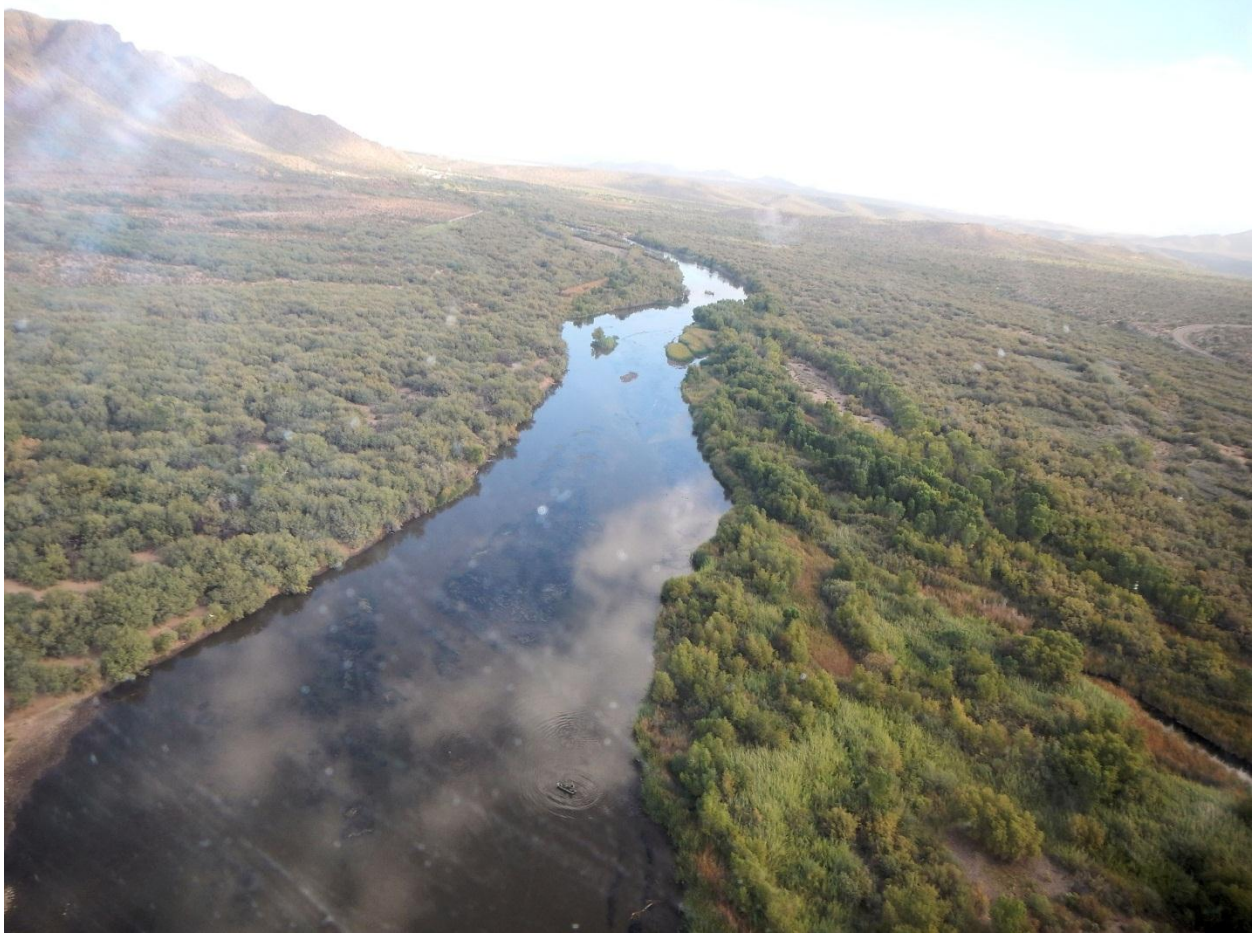
Figure 18. View looking upstream of the backwater-affected reach upstream from Granite Reef Dam (Photo by B. Mussetter, October 29, 2013).

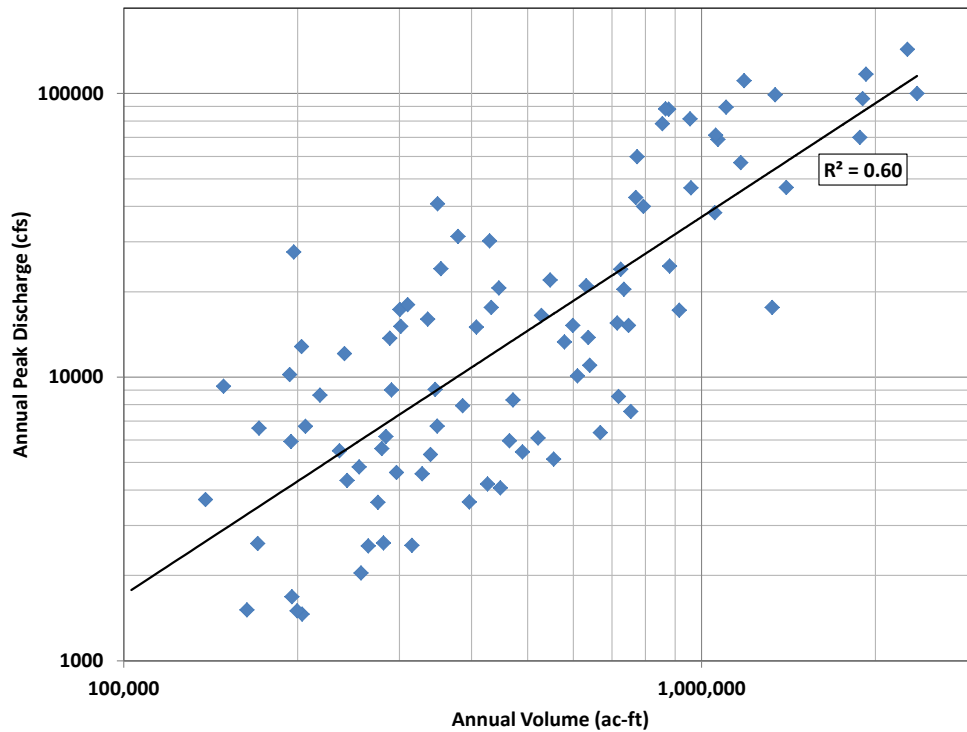
Figure 21. Comparison of annual peak discharge and annual runoff volume at the *Upper Salt River near Roosevelt* gage (USGS Gage No. 9498500).

As is true for most dryland rivers, there is strong correlation between the annual flood peak and the annual runoff in the Upper Salt River (**Figure 21**). The annual runoff volumes at the historic *Salt River at Roosevelt* gage that was located at the approximate site of the existing Roosevelt Dam show runoff volumes exceeding 1 million ac-ft during 6 of the 22 years for which data are available between WY1889 and WY1913 (Figure 20); indicating that large floods occurred during these years. The largest annual flows (and presumably, largest annual peaks) occurred in WY1891 and WY1905-WY1907, when there were no significant upstream diversions and prior to completion of the water storage projects that include Roosevelt Dam. Based on this information, the portion of the Upper Salt River below present-day Stewart Mountain Dam was most likely strongly braided, with little in-channel vegetation at the date of Arizona's statehood as a result of these floods.

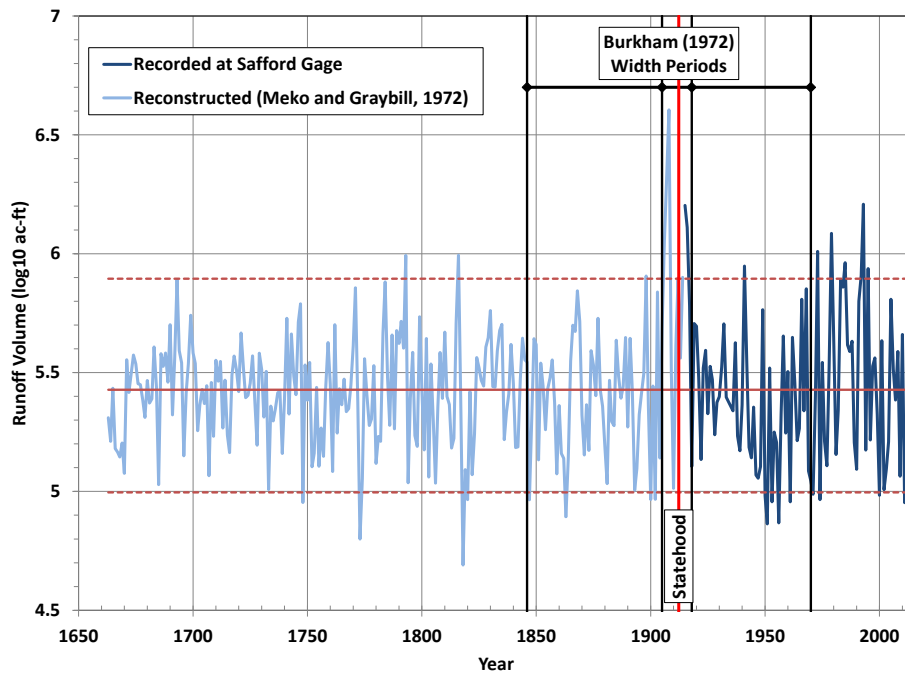
Figure 22. Time-series plot of Gila River annual discharge (1663-1914 from reconstruction of Meko et al., 1995; 1915-2012 from recorded flows at USGS Gage No. 09448500, Gila River at Head of Safford Valley. Also shown are the periods of different typical channel widths identified by Burkham, 1972). Solid horizontal line is median, dashed lines are 10th and 90th percentiles (i.e., 10 percent of the values fall above and below these lines, respectively).

The hydrologic history of the Upper Salt River is very similar to that of the Gila and Verde Rivers, and all experienced large floods in the late-19th and early-20th Centuries. Meko and Graybill (1995) reconstructed the annual flows in the Gila River in the vicinity of Safford using tree ring data. His results show that the mid- to late-1800s corresponded to an extended period of low flows, but these were punctuated by periods of unusually high flows (**Figure 22**). The Meko and Graybill (1995) analysis clearly shows that, while some of the floods in the early-1900s were unusually large, the Gila River experienced large annual flow volumes, and thus,

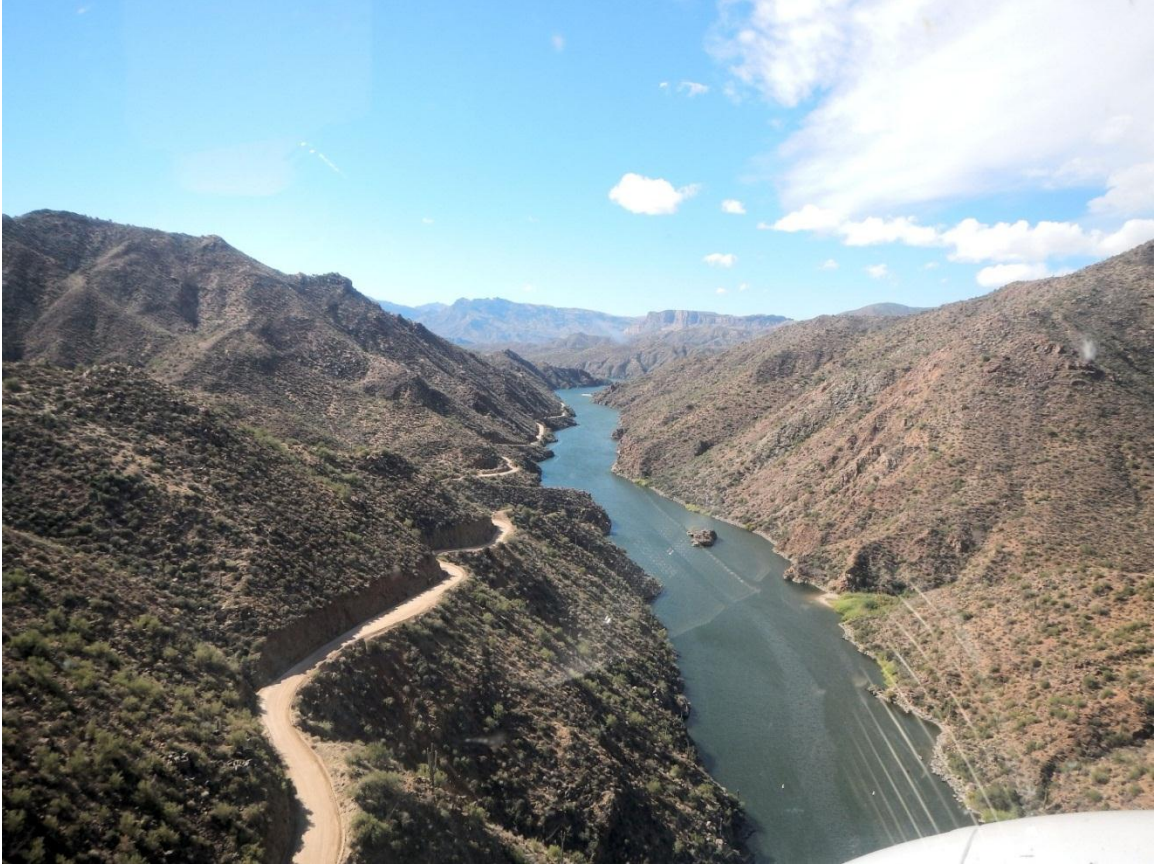
Figure 23. View looking downstream from approximately 2 miles below Roosevelt Dam showing the canyon-bound character of the reach (Photo by B. Mussetter, October 29, 2013). Note that the water shown in this photo is much deeper than it would have been under *ordinary and natural conditions* because of the backwater effects of Horse Mesa Dam.

Construction of Roosevelt Dam was completed in 1911; thus, the dam, itself, would have been an impediment to navigation at the date of statehood. The specific characteristics of approximately 53-mile reach through the existing reservoirs at and prior to the date of Arizona's statehood are less certain than the upstream canyon-bound reach and the downstream braided reach because historical information is limited and inundation by the reservoir prevents direct assessment of the characteristics of the valley floor. In spite of those limitations, the available information strongly suggests that this reach would also have been non-navigable at and prior to the date of statehood. A significant part of the inundated reach between the dams is canyon-bound; thus, would have very likely had geomorphic characteristics similar to the upstream reach, including rapids created by bedrock outcrops, tributary debris fans and colluvium (**Figures 23 through 25**). According to Gregory (1979) (as reported by Greenwald and Gilpin, 1997), an alluvial floodplain was present in the area occupied by Roosevelt Lake and this was *the first place where water from the upper Salt River would have been available for canal irrigation*. This portion of the Upper Salt River that is now inundated by Roosevelt Reservoir may have been similar to the downstream, alluvial reach and the upstream Gleason Flats reach that had a wide, braided character that would have also made navigation impractical using the watercraft in use at and prior to the date of Arizona's statehood.

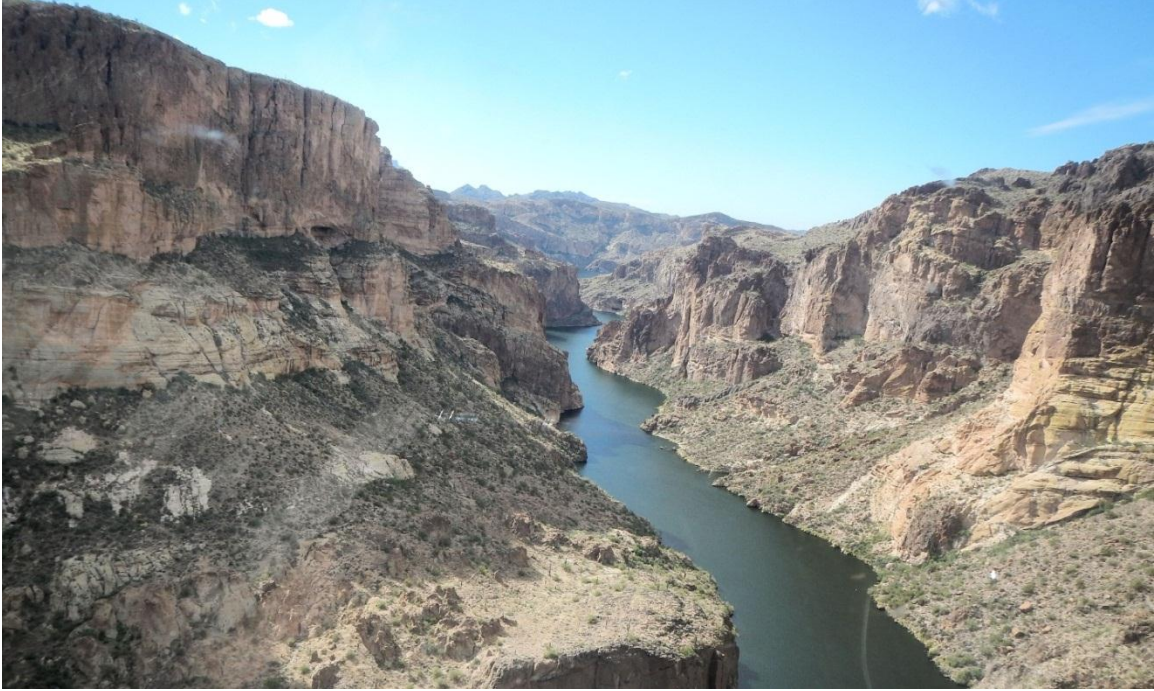
Figure 24. View looking downstream from approximately 4 miles below Horse Mesa Dam showing the canyon-bound character of the reach (Photo by B. Mussetter, October 29, 2013). Note that the water shown in this photo is much deeper than it would have been under *ordinary and natural conditions* because of the backwater effects of Mormon Flat Dam.

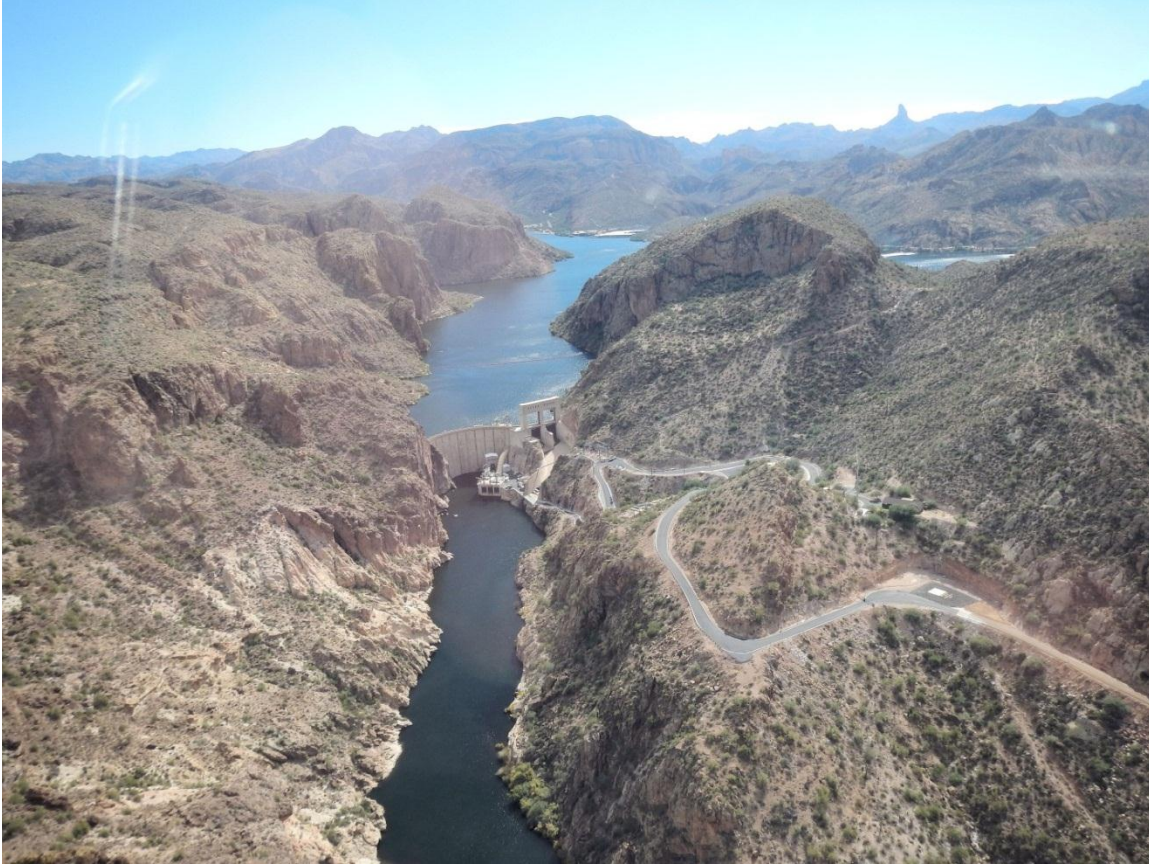
Figure 25. View looking upstream of Mormon Flat Dam showing the canyon-bound character of the reach (Photo by B. Mussetter, October 29, 2013). Note that the water shown in this photo downstream from the dam is much deeper than it would have been under *ordinary and natural conditions* because of the backwater effects of Stewart Mountain Dam.
