**Presentation to ANSAC**

Bob Mussetter, Ph.D., P.E.

# **Definition of Navigability**

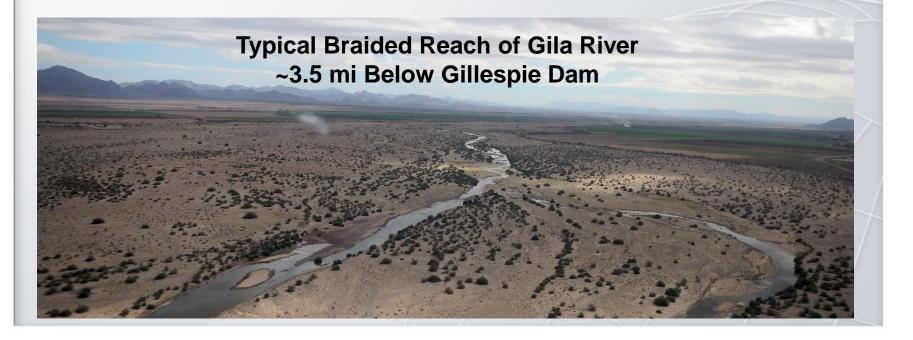
# **Channel Pattern IS Relevant to Navigability**

#### Braided channels:

- Wide, shallow cross section
- Multiple, unstable (i.e., shifting) channels
- NOT conducive to boating

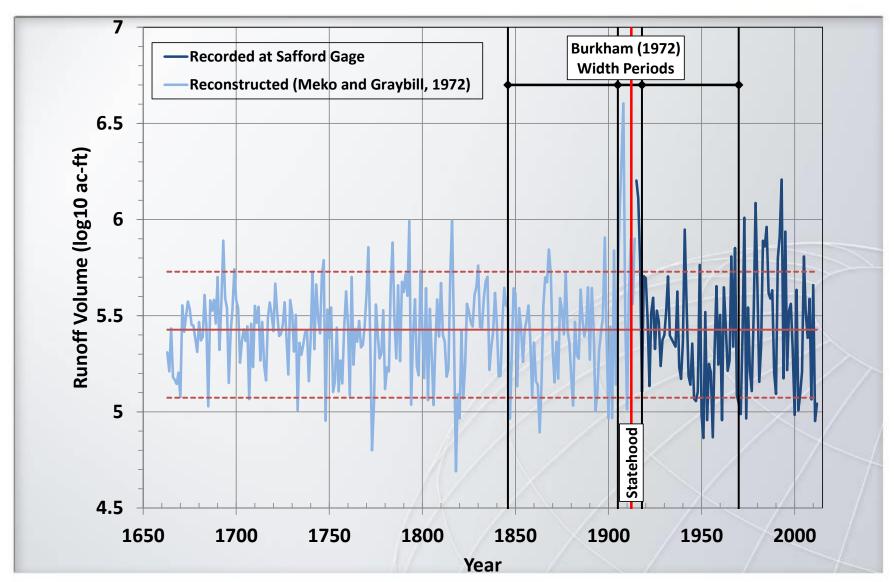
#### Similar Variability in Annual Volume Pre- and Post-statehood

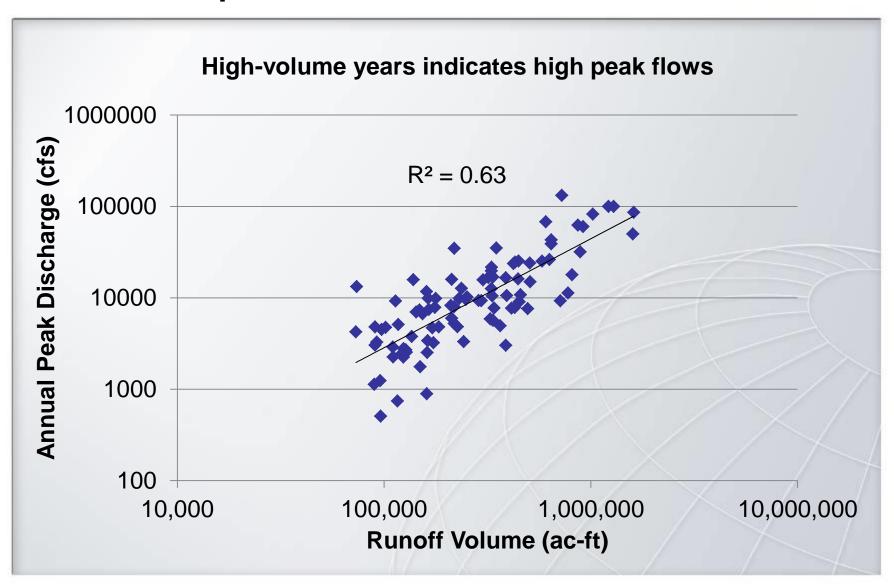
# Annual peak is correlated with annual volume

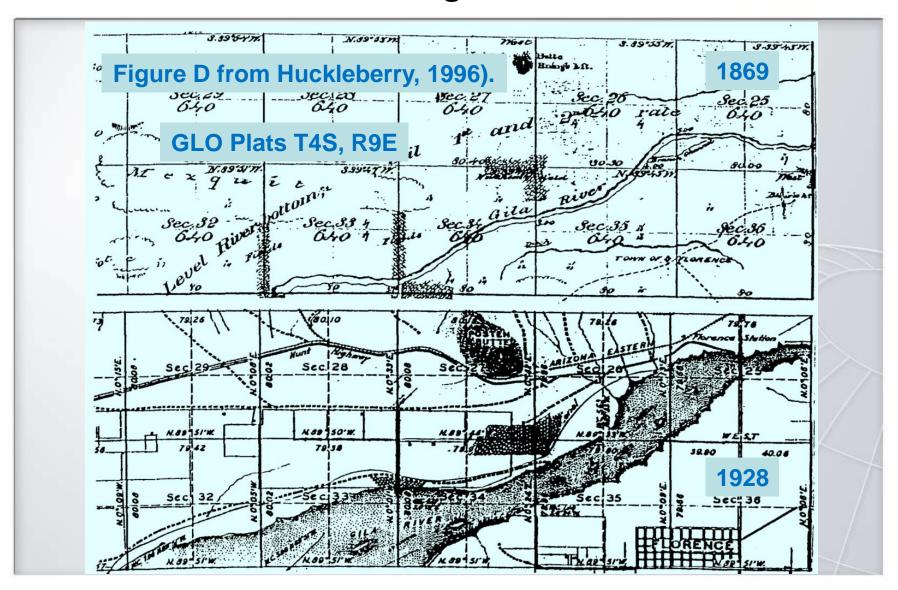
# Flood-induced Changes in Channel Width

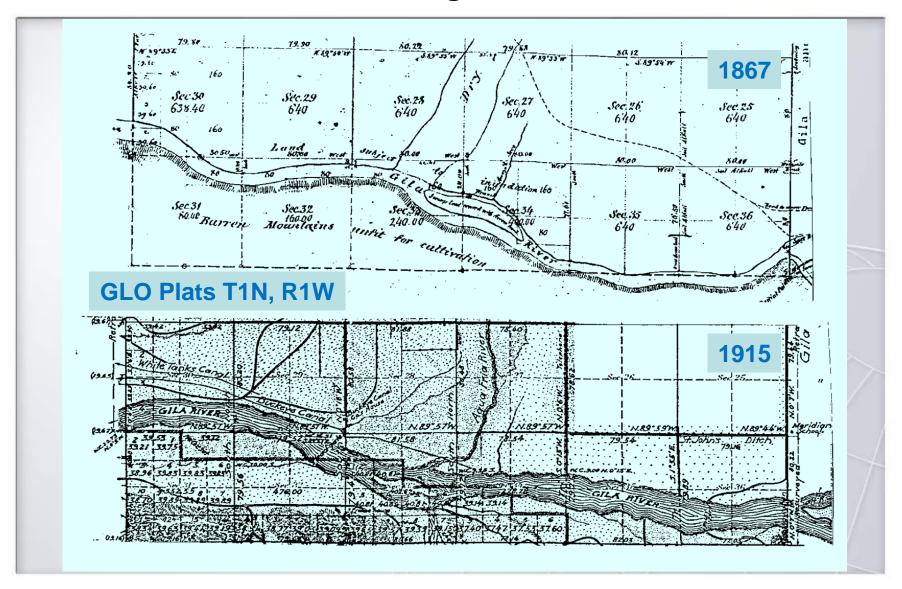
# Flood-induced Changes in Channel Width

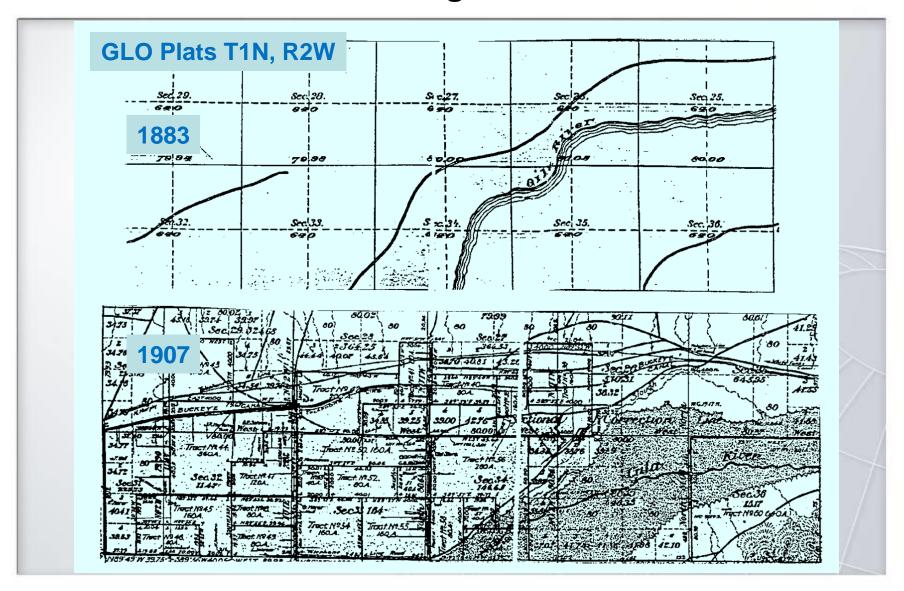
# Flood-induced Changes in Channel Width
