Declaration Navigability of the Verde River

Submitted To: Salt River Project
PO Box 52025
Phoenix, Arizona 85072-2025

Robert A. Mussetter, PhD, PE
TETRA TECH
3801 Automation Way, Suite 100
Fort Collins, CO 80525

October 10, 2014

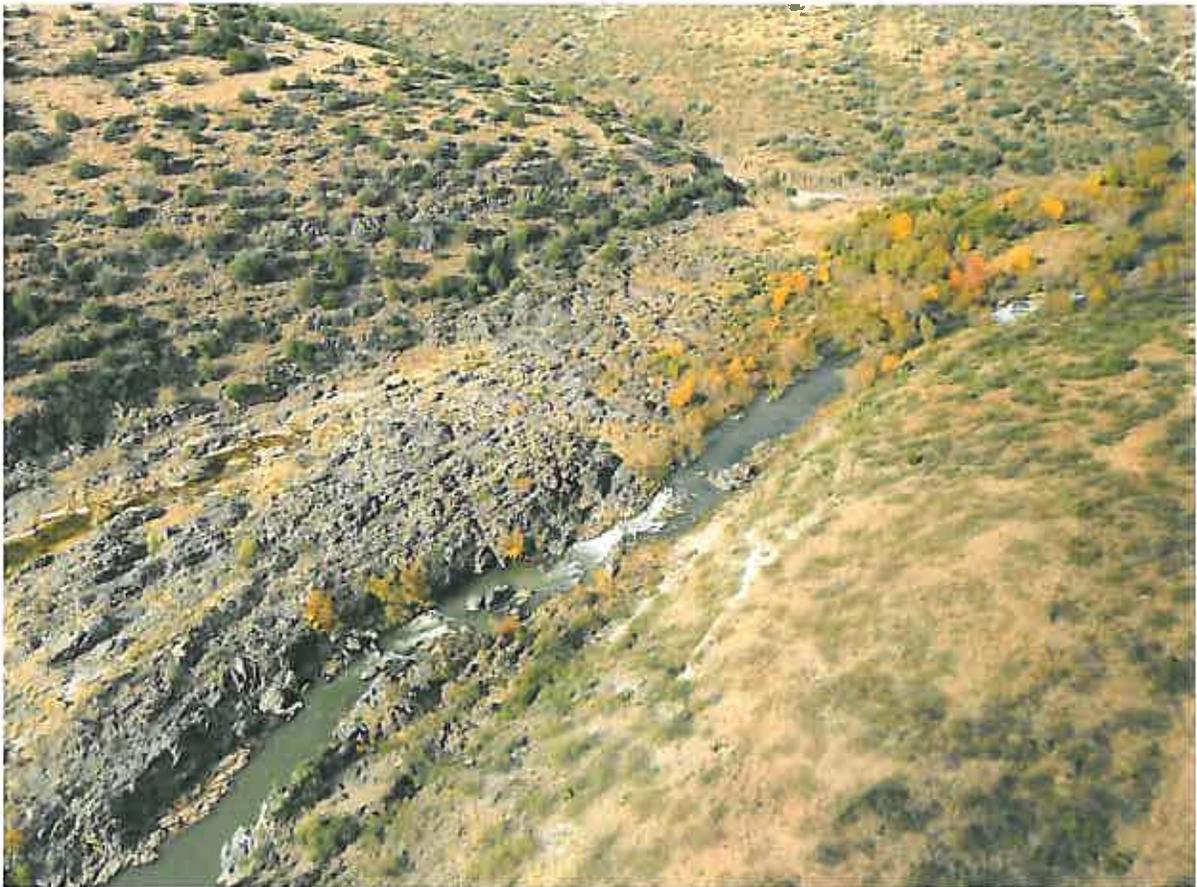
Figure 3. Verde River in the vicinity of Verde Falls and Pre-falls. Bedrock forms bed and banks of channel. Drop across the falls in the center of the photo is about 4 feet. (Photo by R. Mussetter, October 2013)

contact with the bedrock valley wall. The terraces range in age from early-Pleistocene (i.e., ~0.8M to 2.6M years ago) to late-Holocene (i.e., within the past few thousand years), and they represent former positions of the Verde River bed and floodplain. Most of the terraces are made up of thin veneers of material deposited on erosional surfaces that were carved on top of the bedrock (Figure 7). Due to the thinness of the deposits, the underlying bedrock units are exposed in the bed and banks of the river in many locations, implying that the long-term downcutting trend is continuing at present. These exposures exert strong local control on the longitudinal profile of the river (Figure 3).

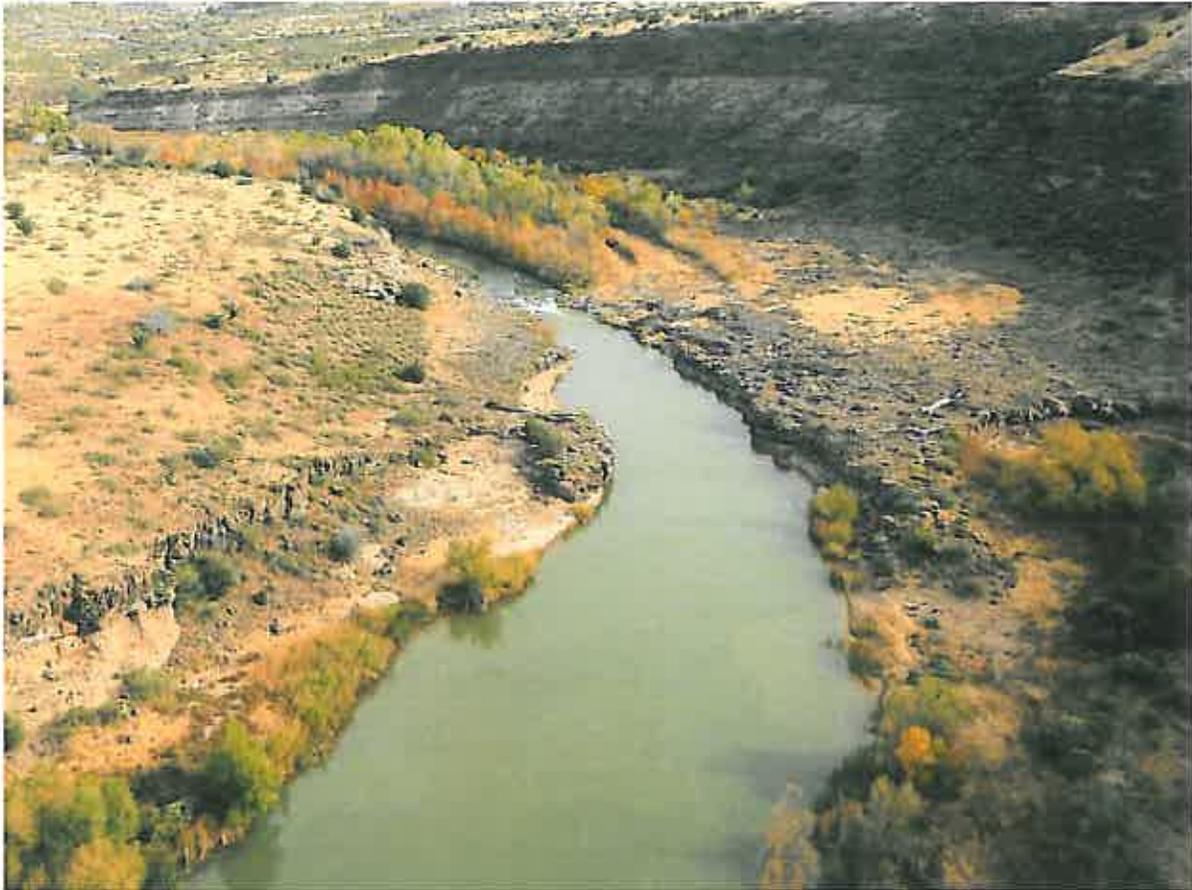
Figure 7. Verde River between Beasley Flat and Verde Falls. Note strath⁶ terraces along both sides of the river. Also note the shallow, boulder-strewn riffle near the top of the photo. (Photo by R. Mussetter, October 2013)

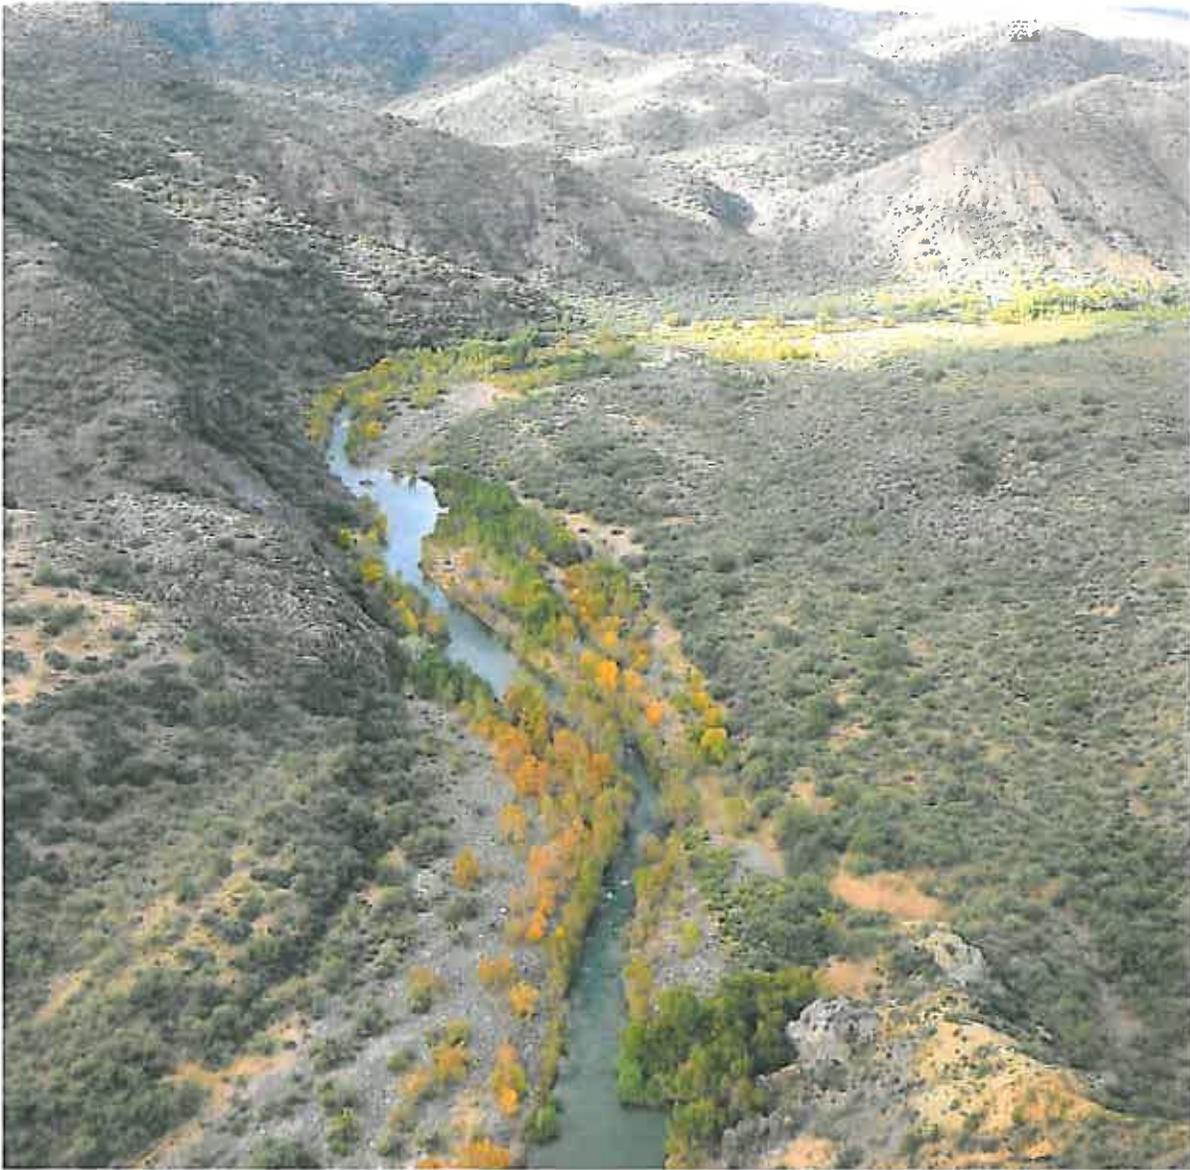
Figure 8. Verde River looking upstream from about 0.8 miles upstream from Verde Hot Spring. Note shallow, boulder-strewn riffle along the cobble/boulder bar in the foreground.

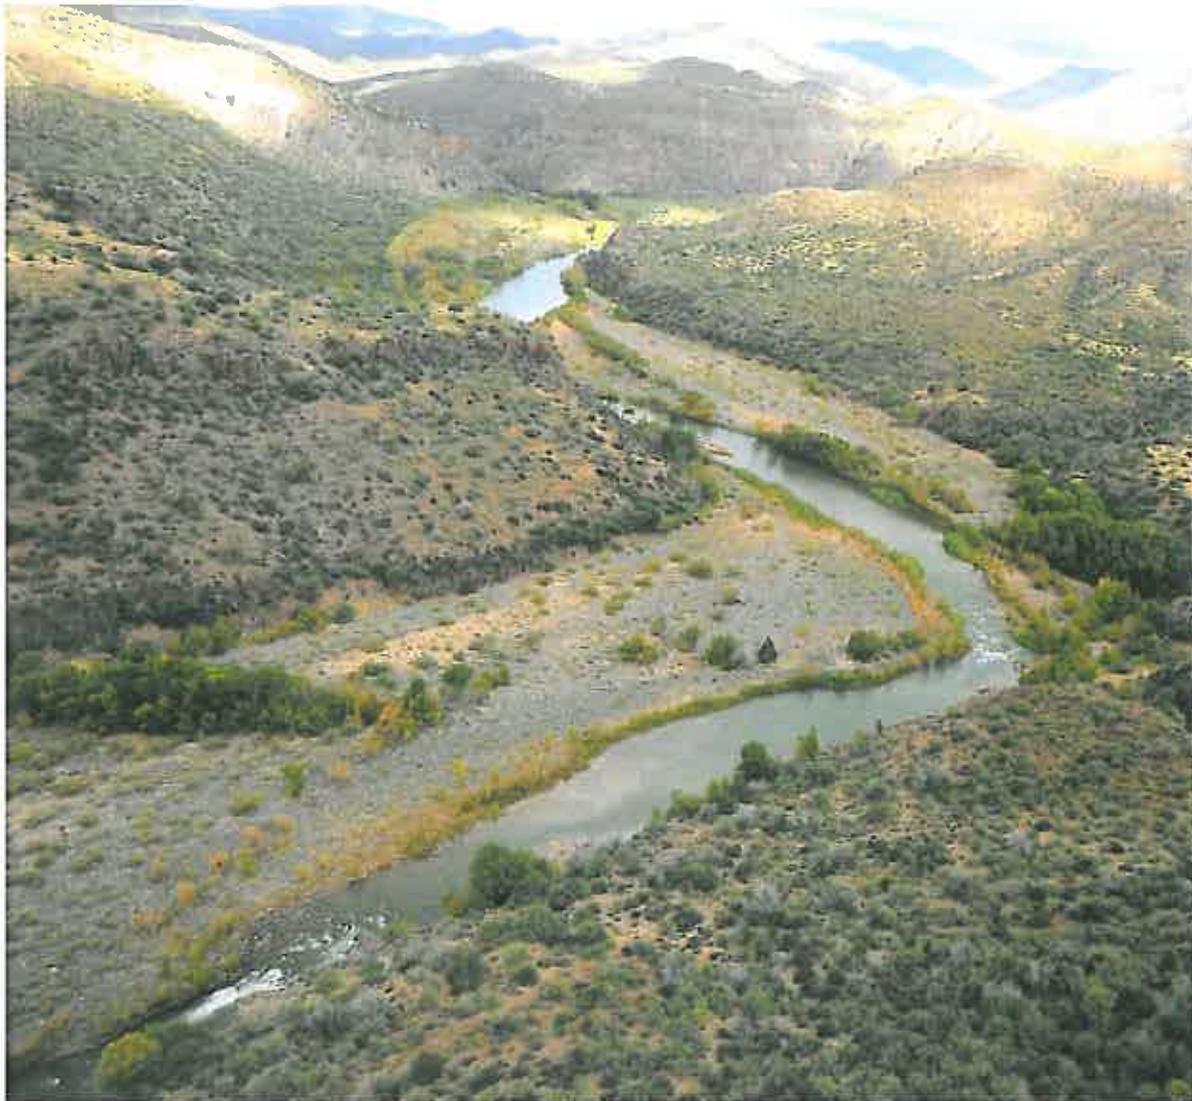
Figure 11. View looking upstream of Shoots and Ladders Rapid (Class III) that is located about 2 miles downstream from the East Verde River confluence in ASLD Segment 4. (Photo by R. Mussetter, October 29, 2013)

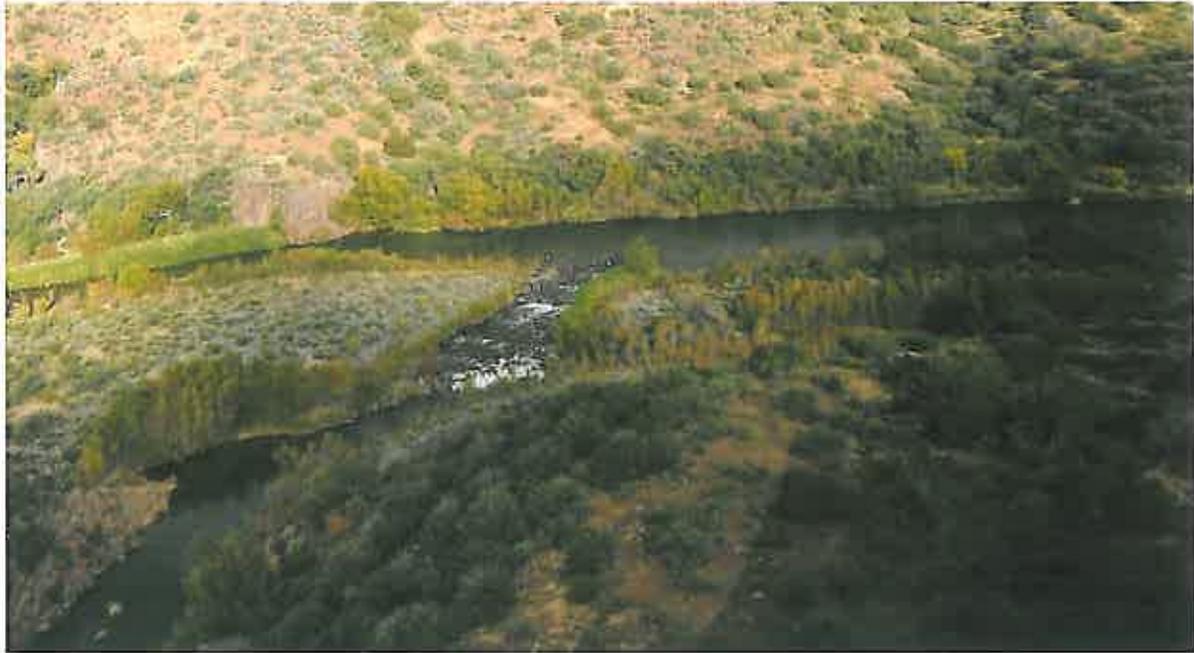
Figure 12. Gnarly Little Rockbar Rapid (Class II) located about 0.7 miles downstream from the Fossil Creek confluence. (Photo by R. Mussetter, October 29, 2013)

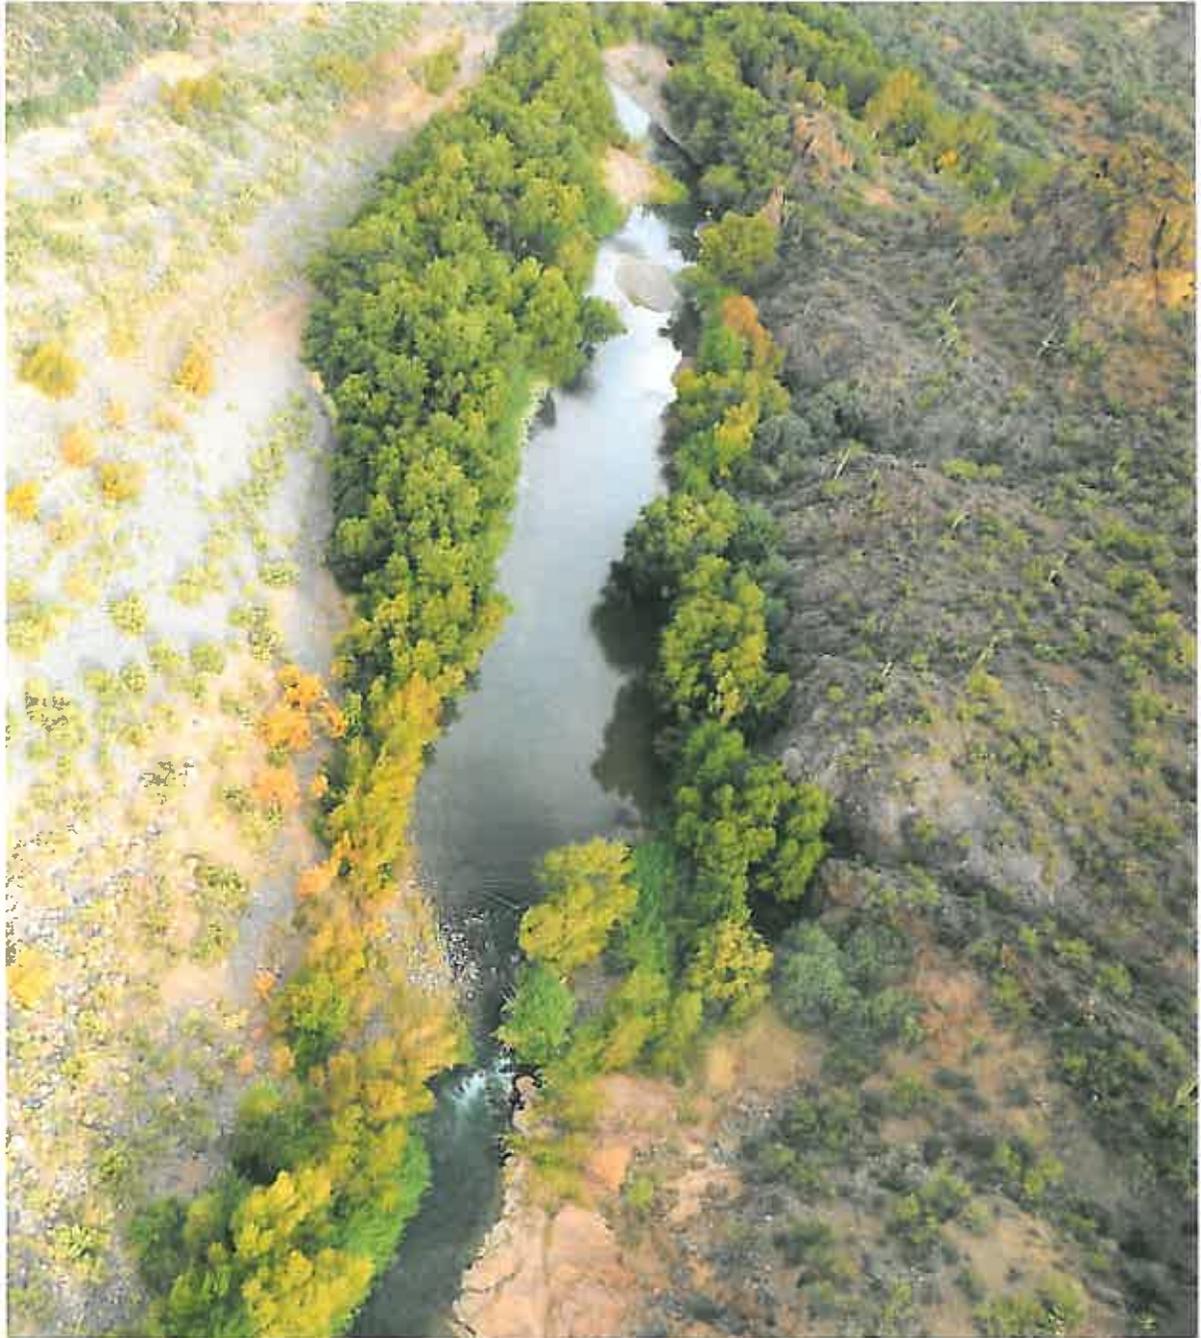
Figure 13. Shallow, boulder-strewn riffle near the Tangle Creek confluence. (Photo by R. Mussetter, October 29, 2013)

Similar to Segment 3, the approximately 35-mile segment of the Verde River between Verde Hot Spring and the head of Horseshoe Reservoir is also entrenched into a deep, relatively narrow canyon. The overall gradient is slightly flatter than Segment 3, but still relatively steep at about 17 feet/mile. According to the USFS Boater's Guide, the reach contains 13 named rapids, 5 of which are rated as Class III and 8 of which are Class II⁹. A typical Class III rapid in this reach is named *Shoots and Ladders* (Figure 11), and typical Class II rapids include *Gnarly Little Rock Bar* (Figure 12). The reach also contains numerous shallow riffles and severely constricted areas in which the bed is strewn with boulder- and cobble-sized material, that would be very difficult to safely navigate at the low to moderate flows that occurred throughout most of the year with the watercraft that were in customary use at and before Arizona became a state (Figures 13 and 14).

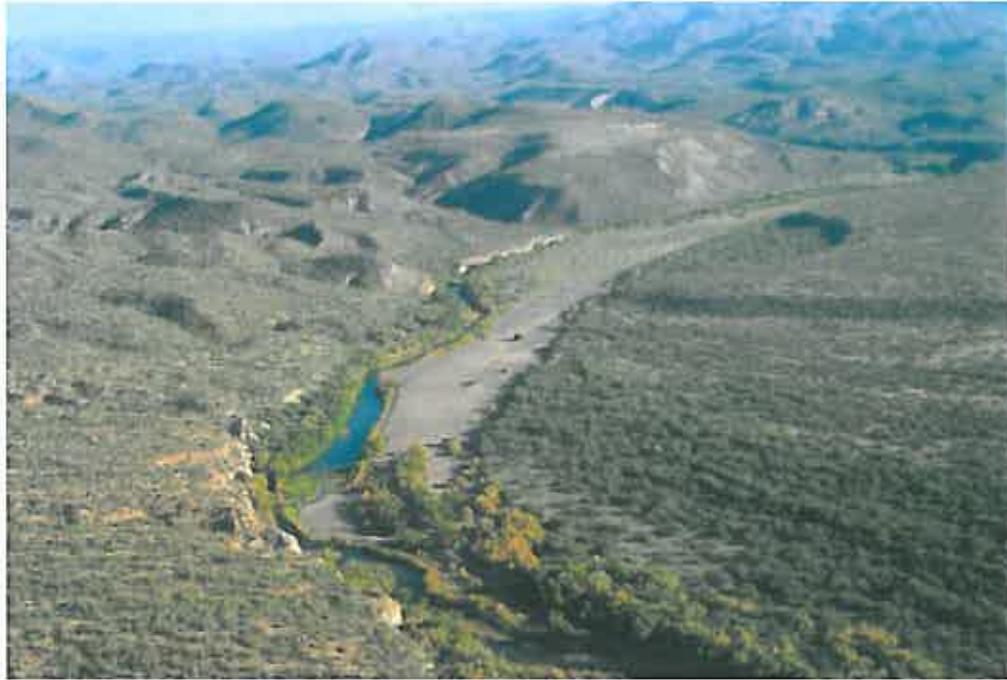
Figure 16. View looking upstream of MEI (2003) Study Site 1, below Tangle Creek. (Photo by R. Mussetter, November 2002)

The total valley width at Site 1 is about 600 feet, and the site is bounded along the left side (downstream view) by a number of Holocene (modern) age terraces (Figure 16). Several older (late- to mid-Pleistocene-age) terraces are located farther back from the river. The right side of the river in the upstream portion of the site is composed of pre-Quaternary basin-fill sediments, but the remainder of the right side is composed of coalesced late- to mid-Pleistocene age terraces and alluvial fans, and late-Holocene-age terraces (Pearthree, 1993). The active channel at this site is about 200 feet wide and flanked by narrow bands of riparian vegetation. In the lower two-thirds of the site, the active channel is flanked along the left bank by a very sparsely vegetated gravel-cobble bar that represents a high-flow chute-channel that is confined on its left margin by a Holocene-age terrace. In the upper third of the site, the chute channel is separated from the main channel by a relatively high-elevation vegetated bar. The downstream hydraulic control for the site is created by a constriction caused by the presence of erosion-

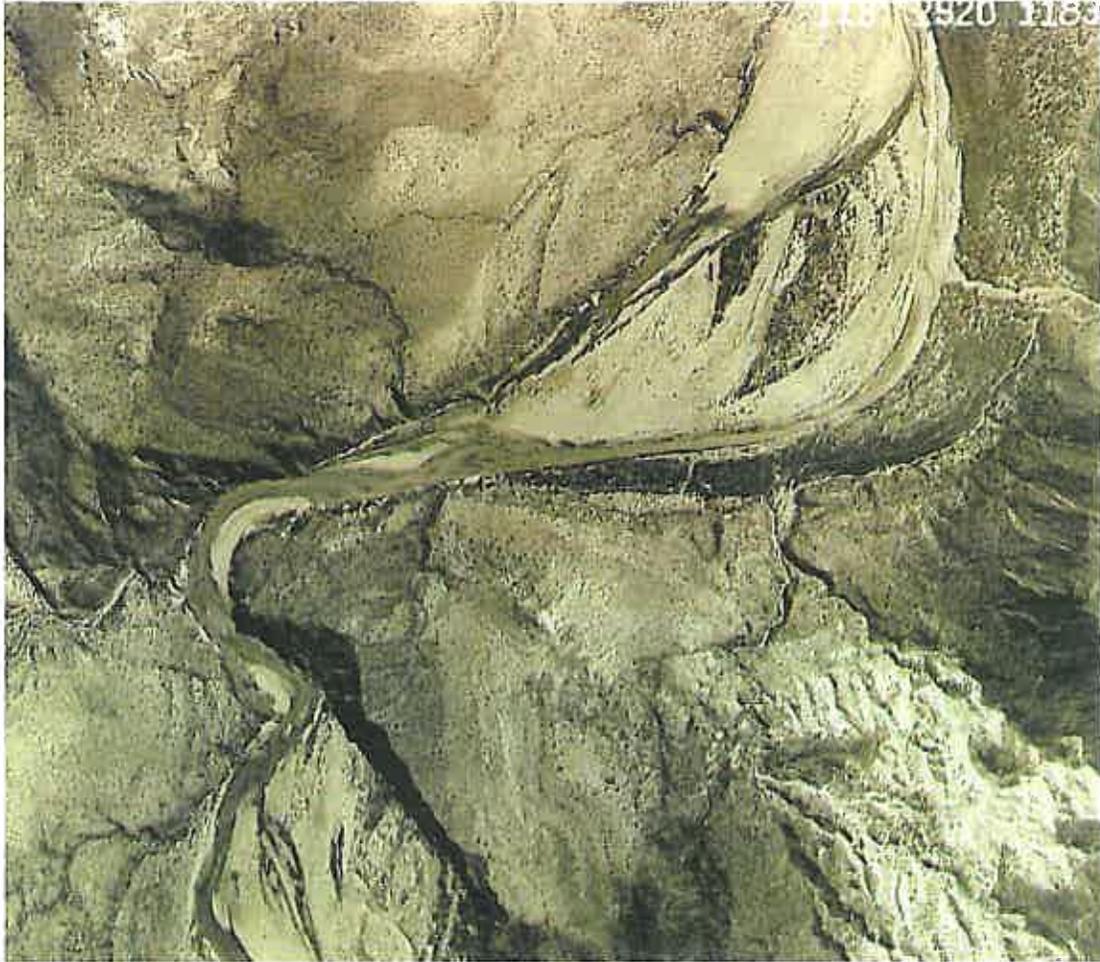
Figure 20. Verde River at Horseshoe Dam site (T7N, R6E, Sec 2). 1934 aerial photograph showing braided channel pattern and constriction, as a result of geologic control. Note that channel occupies entire width of valley.

The Verde River valley becomes less confined in ASLD Segment 5, providing more potential for lateral adjustment, and widening and braiding under un-regulated flow conditions. In portions of his 2004 report and testimony before this Commission, Dr. Schumm emphasized the braided character of the river in this portion of the reach. A series of high discharge years (1889, 1890, 1891) appears to have caused major channel erosion, and this was continued by the high discharge years of 1905, 1906, 1907, and 1909 (Schumm, 2004; **Figure 19**). The 1934 aerial photographs show that the active channel of the Verde River channel was wide, occupying the entire valley floor (**Figures 20 through 22**). Under present conditions, this portion of the reach is island-braided, a condition that developed during the mid-20th Century due to flow regulation and reduction in the peak flows by the upstream reservoirs (Graybill and Nials, 1989) (**Figures 23 through 25**).

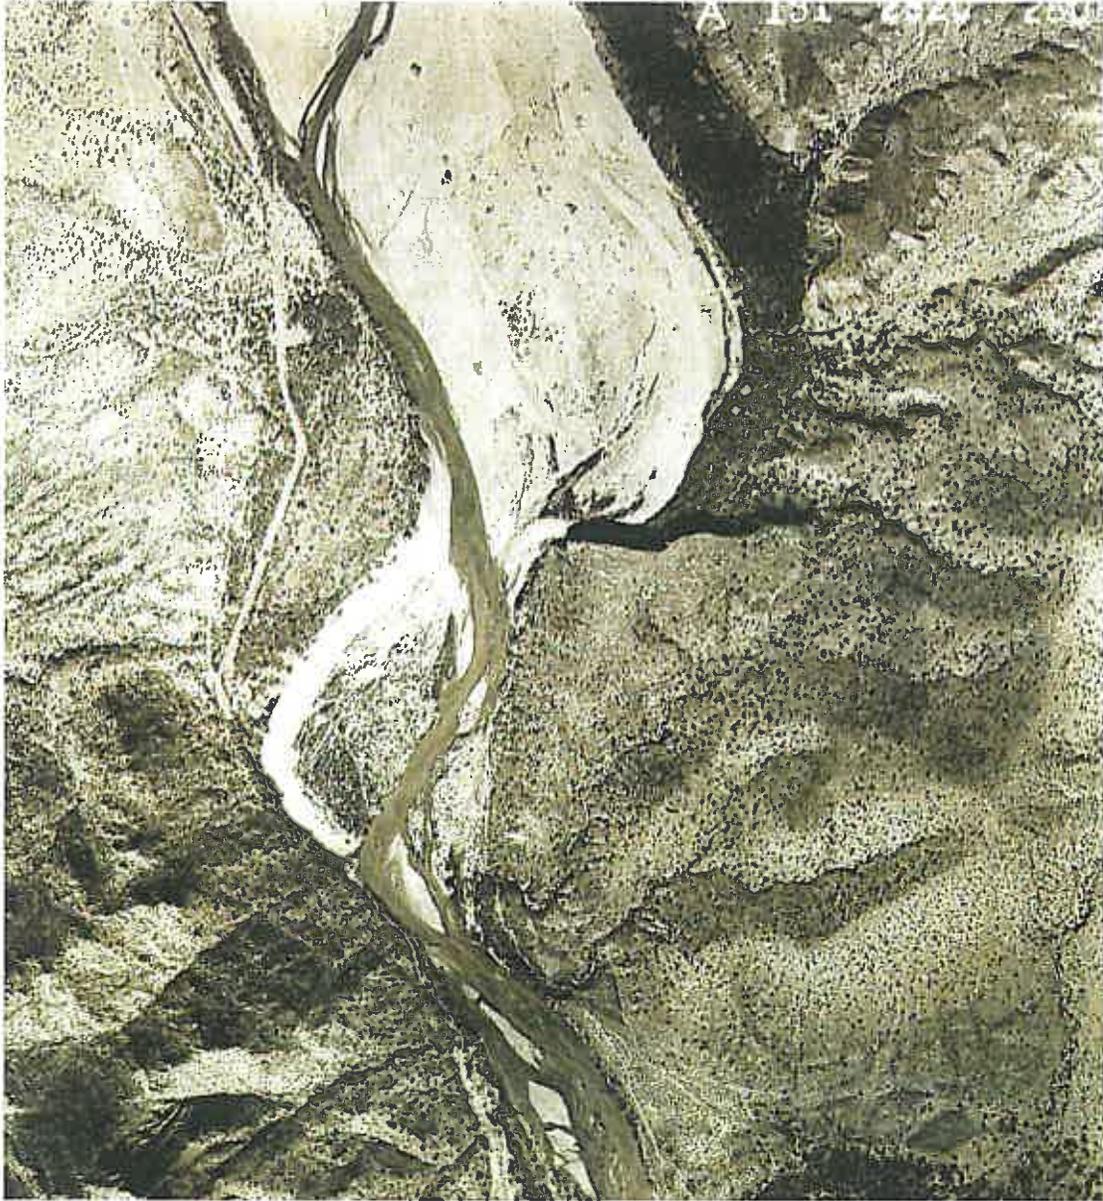
Figure 21. Verde River at “bottom of Fort McDowell Indian Reservation” (T3N, R7E, Sec 31). 1934 aerial photograph showing braided channel pattern and constriction, as a result of geologic control. Note that the channel occupies the entire width of the valley.

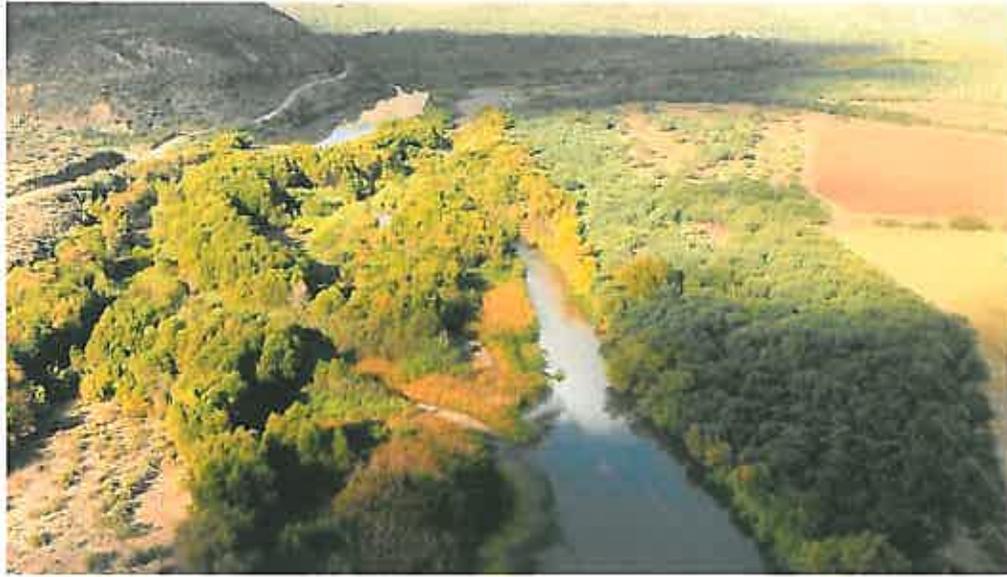
Figure 23. Island-braided reach of the Verde River about 2.5 miles downstream from Horseshoe Dam. (Photo by R. Mussetter, October 29, 2013)

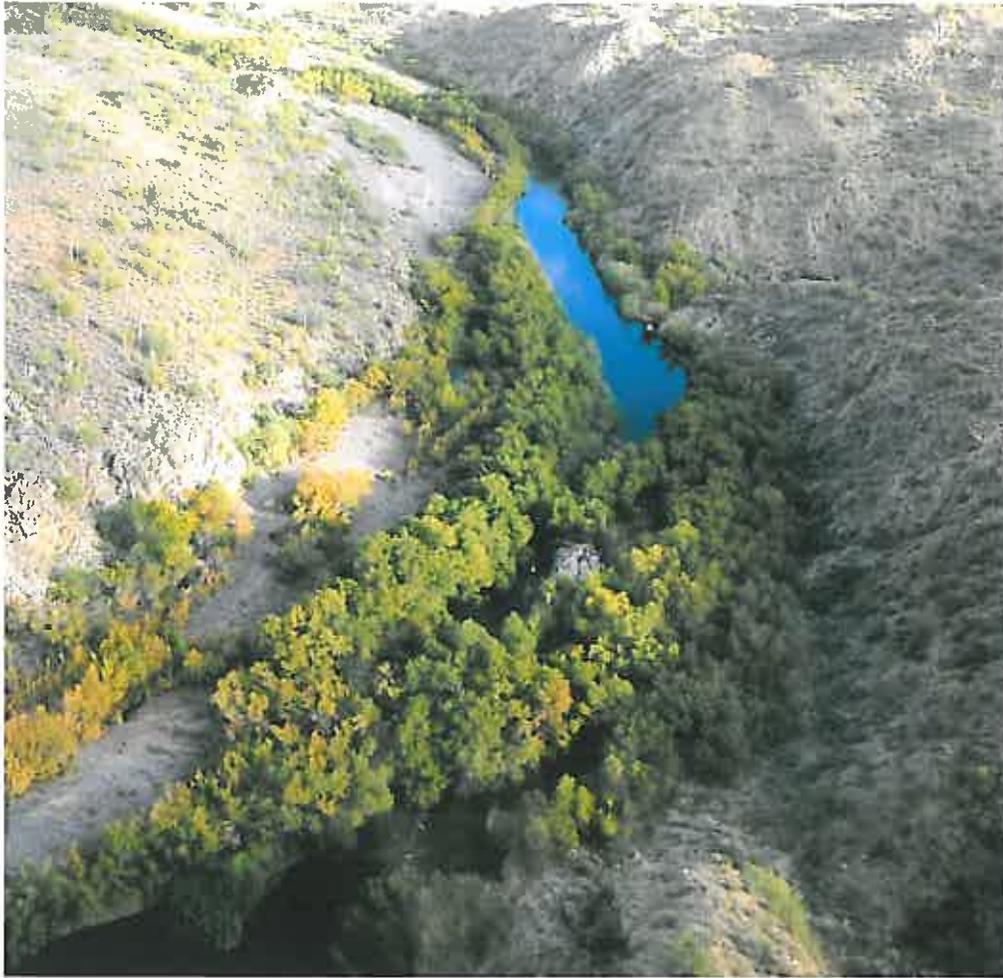
Figure 24. Island-braided and bedrock-controlled reach of the Verde River about 4.5 miles downstream from Bartlett Dam. (Photo by R. Mussetter, October 29, 2013)

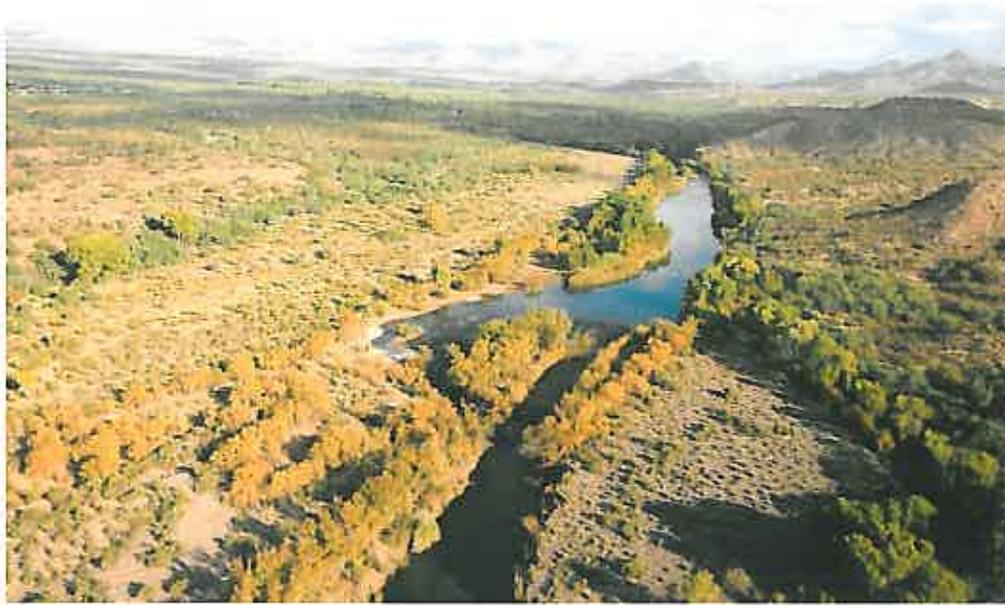
Figure 25. View looking upstream of an island braided reach of the Verde River near the community of Rio Verde. (Photo by R. Mussetter, October 29, 2013)

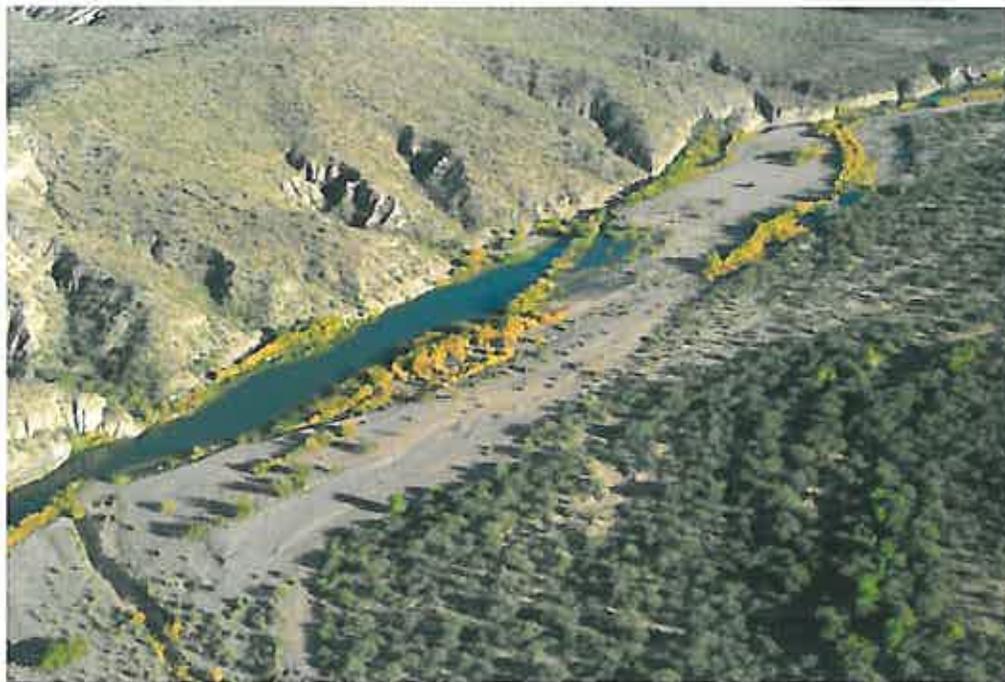
Figure 26. MEI (2003) Study Site 2, approximately 3 miles downstream from Horseshoe Dam. (Photo by R. Mussetter, November 2002)

MEI (2003) Study Site 2 is located about 3 miles downstream from Horseshoe Dam within an approximately 2,000 wide section of the Verde River valley (**Figure 26**). The active (i.e., unvegetated) channel through the site averages about 450 feet wide. The site is located in a depositional zone upstream from a valley constriction that is located about 1 mile downstream. The constriction is caused by an outcropping of erosion-resistant basin-fill on the right bank and older, alluvial terraces and tributary fan sediments on the left bank. Two large tributaries that episodically deliver significant quantities of sediment to the river further enhance the

depositional nature of the site. Sediments delivered by the right bank arroyo at the site have formed a large alluvial fan that has prograded out onto the valley floor. The left valley wall throughout the site is composed of basin-fill sediments that also crop out on the right valley wall immediately downstream of the site. The right valley wall along most of the site is composed of old alluvial and fan sediments into which the present arroyo is inset. Morphologically, the site is characterized by an approximately 200-foot-wide low-flow channel that is fringed by riparian vegetation. A large, sparsely vegetated cobble-gravel bar separates the main channel from a chute channel that is located on the margin of the valley floor and runs along the base of the bounding alluvial fan and terraces for much of the length of the site. The active and chute channels are flanked by thin strands of riparian vegetation.

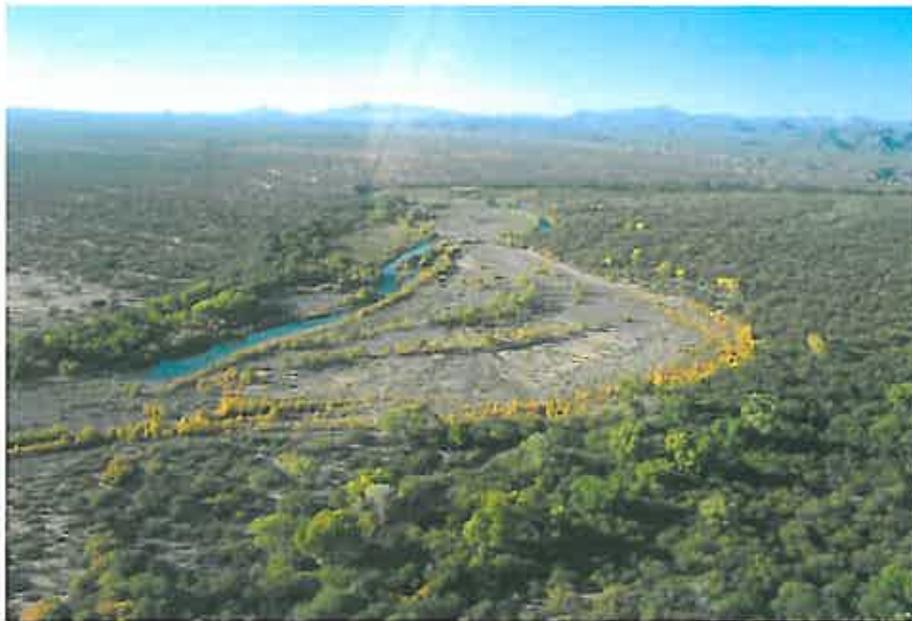
Figure 29. MEI (2003) Study Site 3, approximately 7 miles downstream from Bartlett Dam. (Photo by R. Mussetter, November 2002)

Site 3 is located about 6.5 miles downstream from Bartlett Dam in a section of the Verde River valley that is about 4,000 feet wide (**Figure 29**). The active channel at the site is about 600 feet wide, and it is flanked on the left side by the younger Lehi (Holocene) terrace that was overtopped by the large floods that occurred in the early part of the 20th century. The upper portion of the site is flanked by the older Lehi terrace, but the remainder of the site is flanked by both late- and early-Pleistocene age alluvial sediments that are dissected by a number of relatively small active arroyos. The older Lehi terrace does not appear to have been overtopped by the large floods of the early part of the 20th century. The site is located in a depositional zone upstream from a valley constriction located about one mile downstream that is caused by older, erosion-resistant alluvial deposits in the right bank and outcrop of the Needle Rock Formation on the left bank (Skotnicki, 1996). Morphologically, the site is characterized by an approximately 500-foot-wide active channel that is separated from a chute channel that runs along the left side of the site for most of its length by a sparsely vegetated gravel-cobble bar.
