Arizona State Land Department September, 2014

Presentation to ANSAC: Verde River Navigability

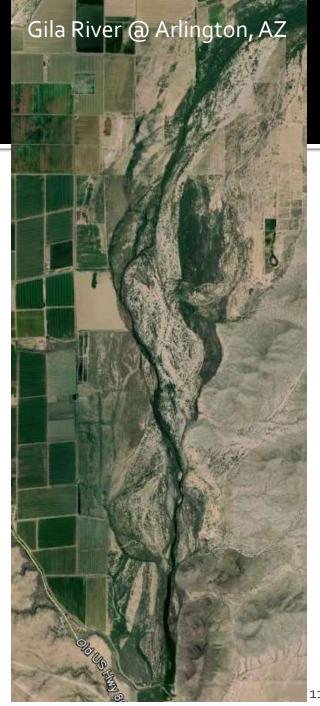
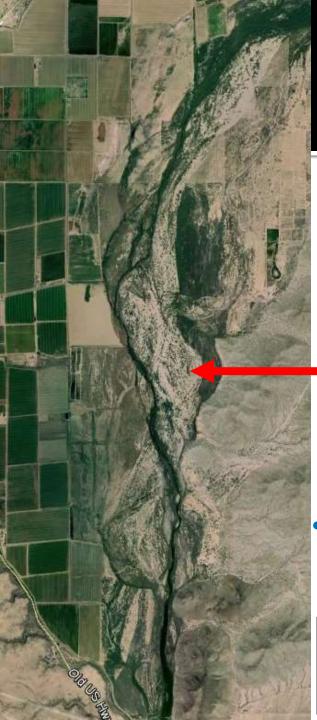
Gila River @ Arlington, AZ

Compound Channels

< < Braided Flood Channel

Non-braided main channel > >

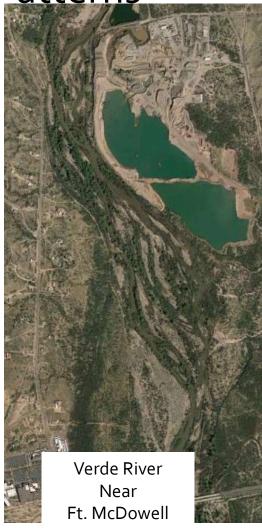
Meandering

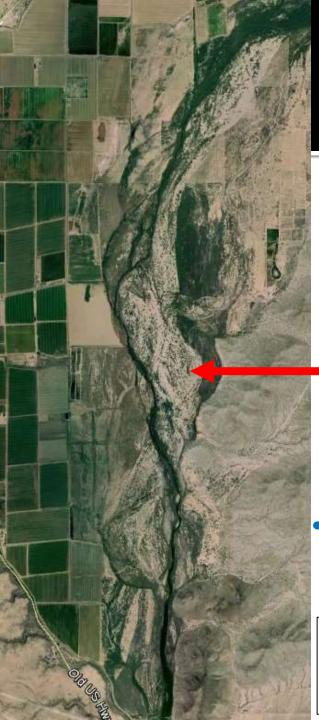
Gila River @ Arlington, AZ

Braided or Meandering

Boating occurs on ordinary flows in the main channel, not on the flood channel.

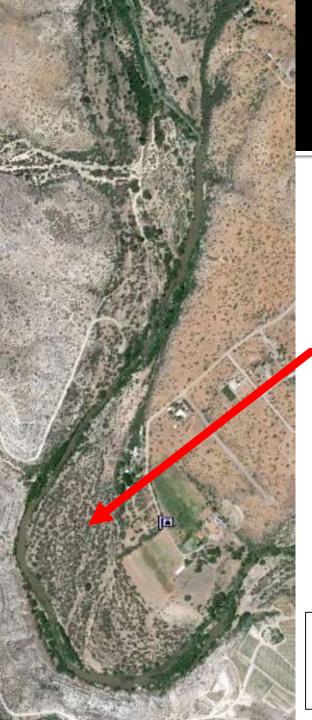
Verde River in Verde Valley

Braided or Meandering

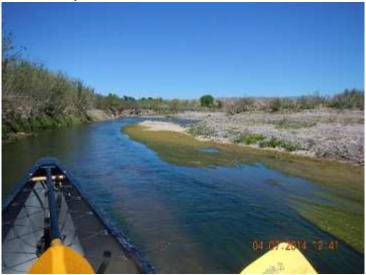
Gila River near Apache Grove

- Sand Bars
 - Raised area of sand at or near the water surface
 - Occupies part of the stream bed channel

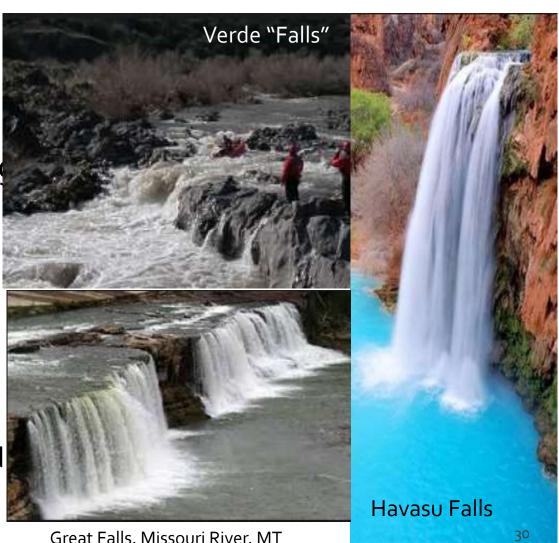
Great Falls, Missouri River, MT

- Definition: River flow over a vertical drop.
- Not drowned out at his flow
- Permanent feature
- Rapids are less steep, may be drown out
- None on Gila, Salt, or Verde River in AZ
 - Some Rapids are named "falls"

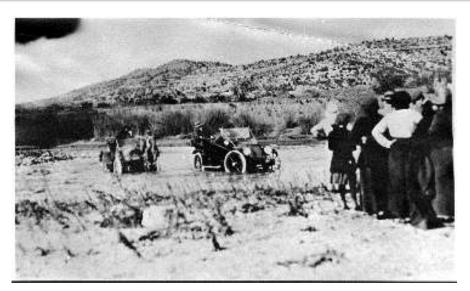
- Definition: A ford is a shallow place with good footing where a river or stream may be crossed by wading or inside a vehicle..
- May occur naturally
- Implies most reaches not ford-able

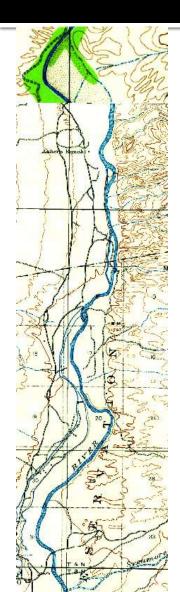
USGS Topographic Maps Cave Creek, AZ Quadrangle, 1930

- Verde River mostly shown as single channel
- Solid line
- Channel in same location as 2014
- No rapids listed on map
- Some ford crossings
- Trail along river downstream of Fossil Springs
- Communities:
 - OK Ranch (@ East Verde)
 - JM Ranch (d/s Lime Creek)

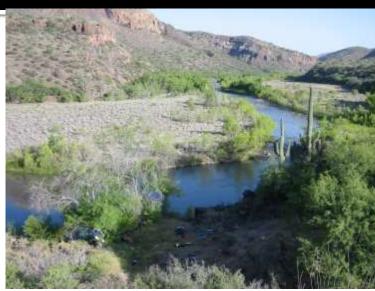
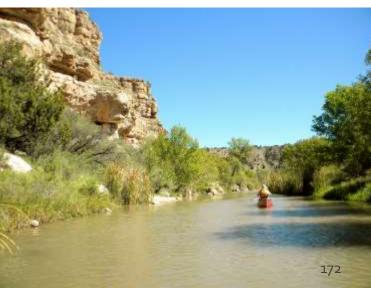
- Rating Curves vs. Real Rivers – Profiles
 - Pool & riffle sequences
 - Pools deeper than riffles
 - Channel slope
 - Steeper = shallower, generally
 - Channel width
 - Narrower = deeper, generally

- Rating Curves vs. Real Rivers: Real Depths?
 - Gauges not located in pools
 - Pools comprise most of river length
 - Gauge based ratings more typical of riffles
 - Best Estimates:
 - Field based experience over entire river segment
 - ASLD Rating Curves:
 - Underestimate depths observed in field
 - Still meet Federal boating minimum depths
